## Facility Condition Assessment Summary Report

### Finletter School

School District of Philadelphia  
**S727001;Finletter**  
Final  
**Site Assessment Report**  
January 31, 2017

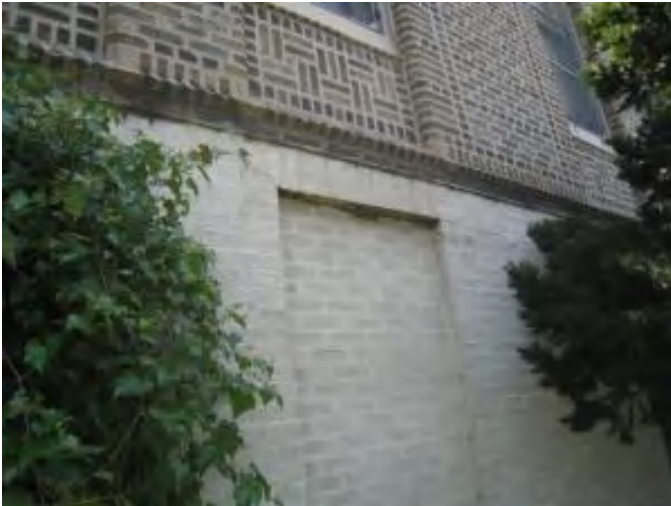
**System: B2010 - Exterior Walls**

**Location:** brick exterior walls

**Distress:** Building Envelope Integrity

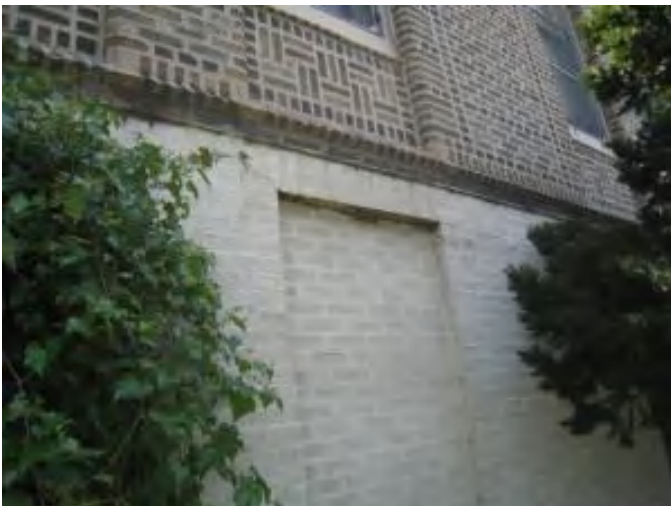
**System: B2010 - Exterior Walls**

**Location:** Front Street side of bldg

**Distress:** Appearance

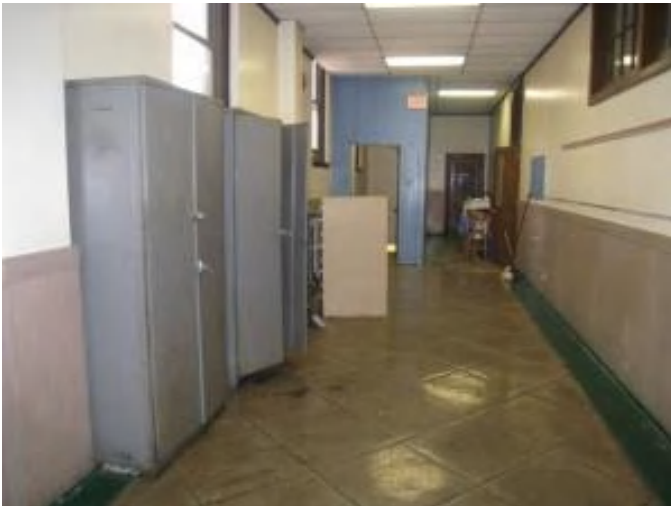
**System: C1010 - Partitions**

**Location:** corridors, above classroom doors

**Distress:** Building / MEP Codes

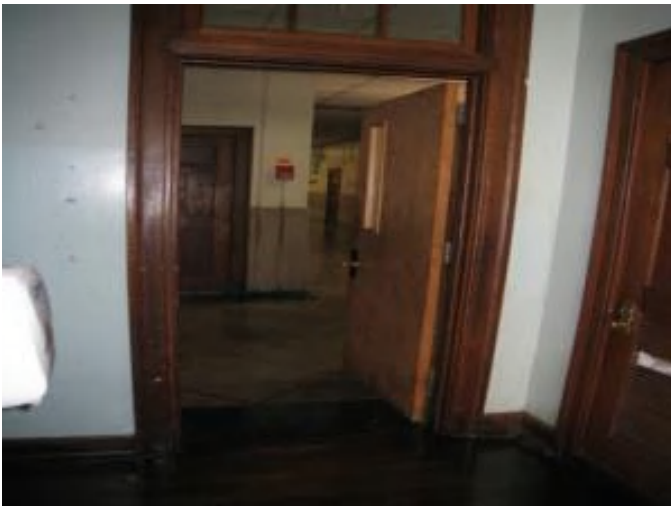
**System: C1020 - Interior Doors**

**Location:** classrooms and offices

**Distress:** Security Issue

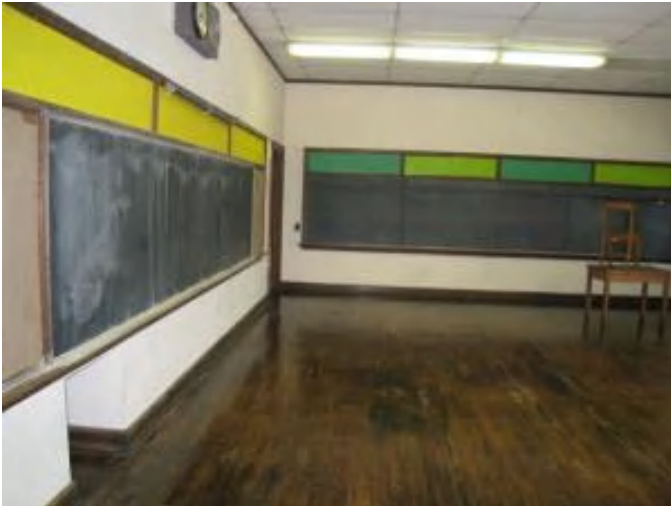
**System: C3020414 - Wood Flooring**

**Location:** classrooms and offices

**Distress:** Appearance

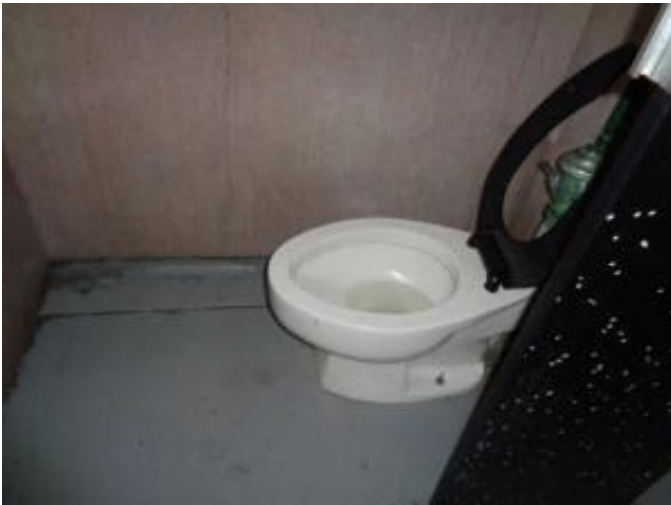
**System: D2010 - Plumbing Fixtures**

**Location:** Throughout the building

**Distress:** Beyond Service Life

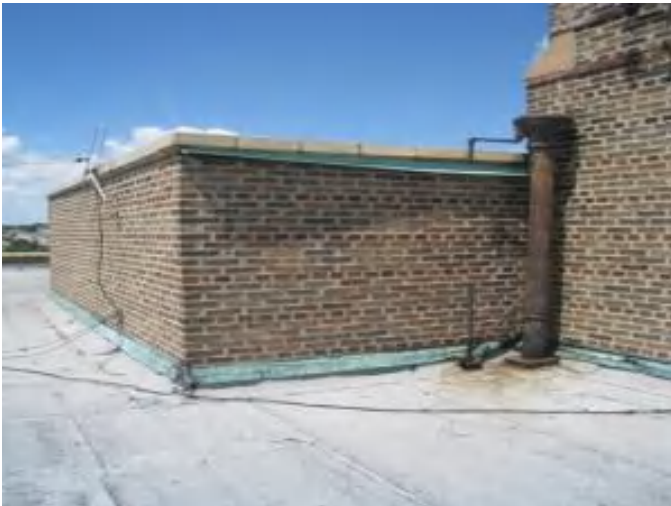
**System: D2040 - Rain Water Drainage**

**Location:** Roof

**Distress:** Building / MEP Codes

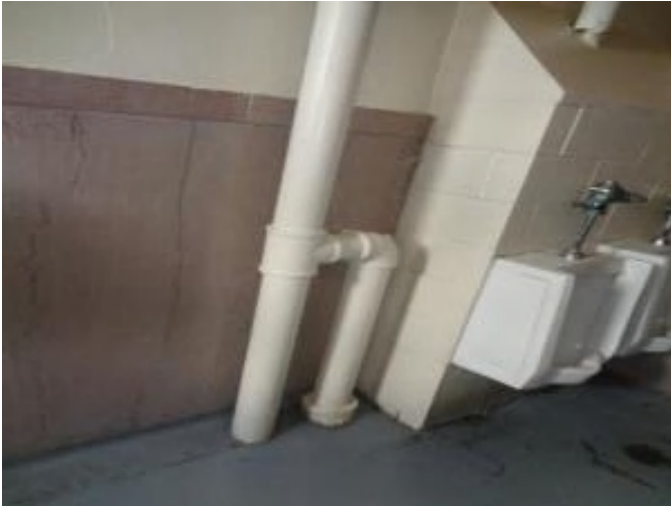
**System: D2030 - Sanitary Waste**

**Location:** Throughout the building

**Distress:** Beyond Service Life

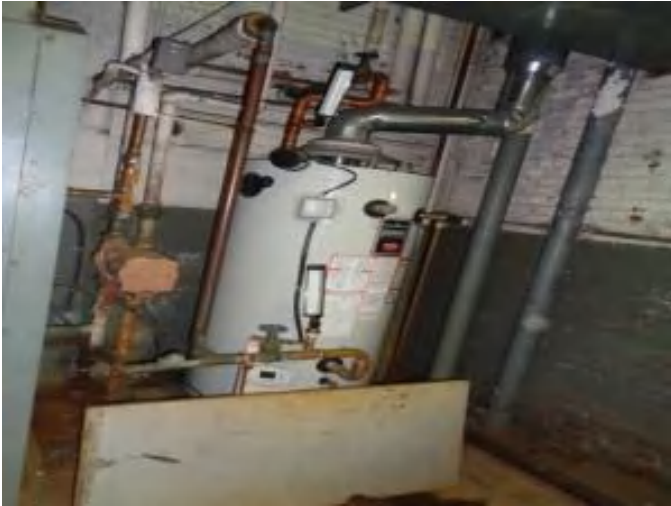
**System: D2020 - Domestic Water Distribution**

**Location:** Boiler Mechanical Equipment Room

**Distress:** Beyond Service Life

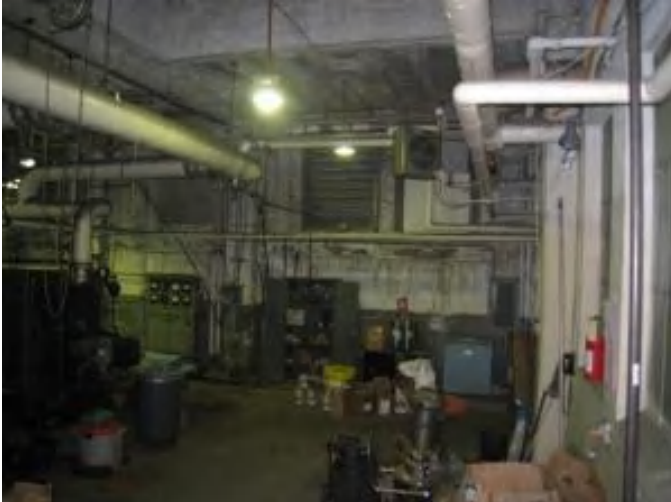
**System: D3020 - Heat Generating Systems**

Heat Generating Systems - Steam is generated in the main building by two Weil McLain oil fired boilers. The boilers appear to be at the end of their serviceable life and should be replaced within the next 5 years. Hot water is generated in the Little School House by two Burnham model V1106W boilers with dual fuel Powerflame burners, each having gross output of 1069 MBH. The boilers in the Little School House appear to be in satisfactory condition and should not need replacement for the next 10 years.

**Location:** Boiler Mechanical Equipment Room

**Distress:** Beyond Service Life

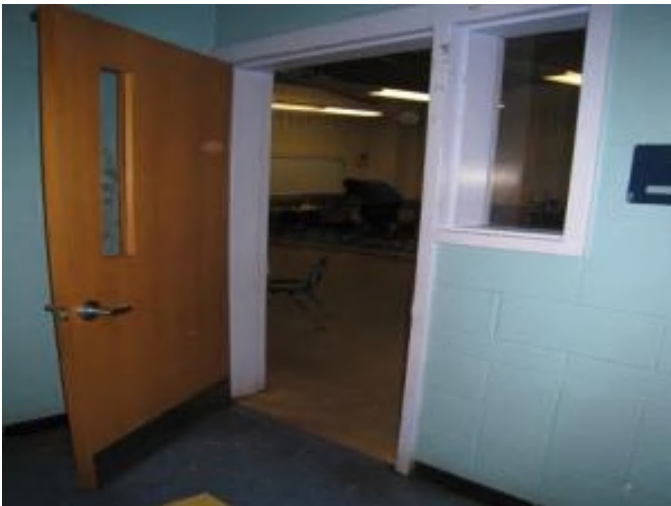
**System: C1020 - Interior Doors**

**Location:** LSH - all classrooms and office doors  
**Distress:** Security Issue  
**Category:** 1 - Health & Safety  
**Priority:** 2 - Response Time (2-3 yrs)  
**Correction:** Provide security hardware for classroom and office doors  
**Qty:** 20.00  
**Unit of Measure:** Ea.  
**Estimate:** \$4,588.73  
**Assessor Name:** Craig Anding  
**Date Created:** 09/03/2015

**Notes:** Provide security hardware for classrooms and offices (20 sets)

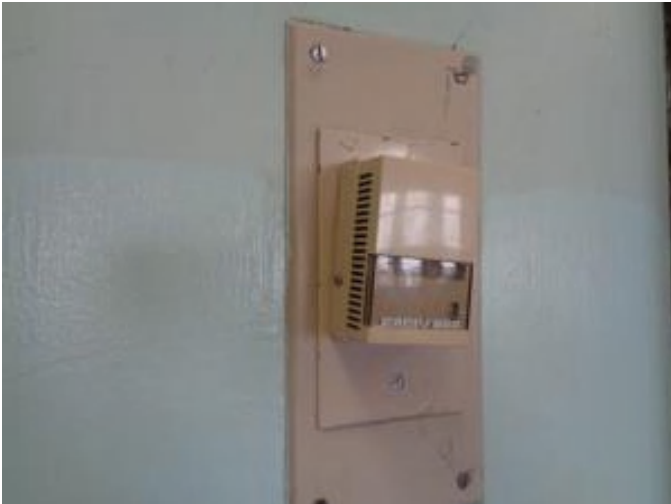
**System: D3060 - Controls & Instrumentation**

**Location:** LSH - Throughout the building

**Distress:** Beyond Service Life

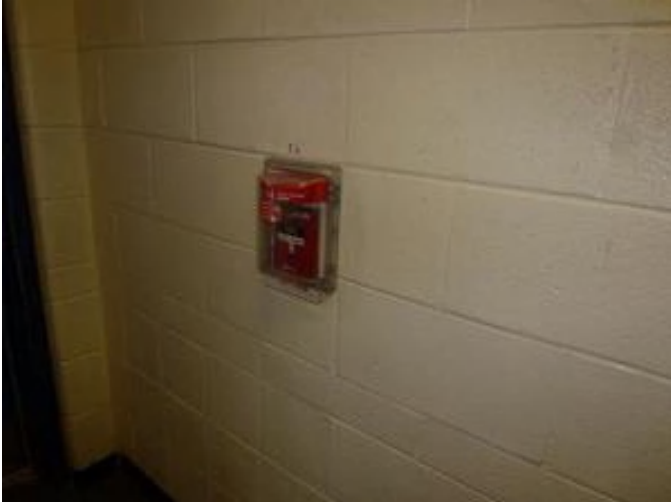
**System: D5030 - Communications and Security**

**Location:** LSH - Entire Building

**Distress:** Beyond Service Life

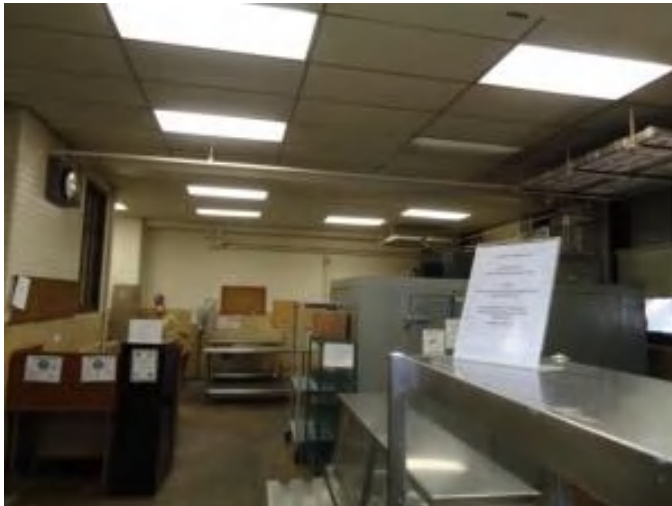
**System: D4010 - Sprinklers**

**Location:** LSH - Kitchen

**Distress:** Building / MEP Codes

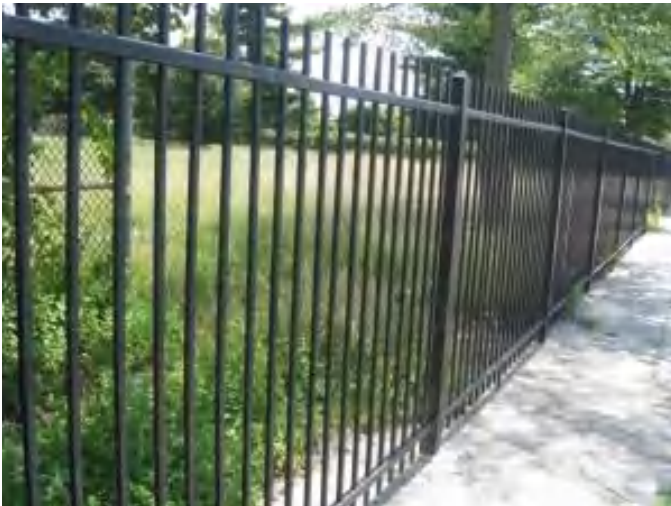
**Location:** site fence

**System: G2040 - Site Development**

**Distress:** Appearance

**Notes:** Repaint damaged wrought iron fencing (500lf)

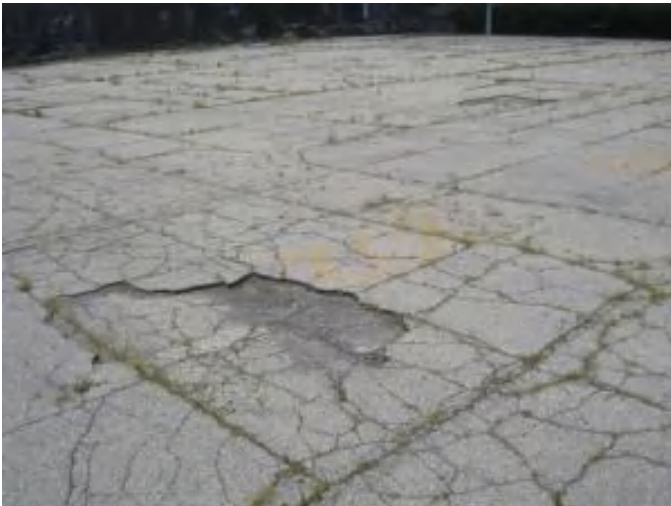
**Location:** parking lot / playground

**System: G2020 - Parking Lots**

**Distress:** Beyond Service Life
