## Facility Condition Assessment Summary Report

### Forrest School

School District of Philadelphia  
**S825001;Forrest**  
Final  
**Site Assessment Report**  
January 31, 2017

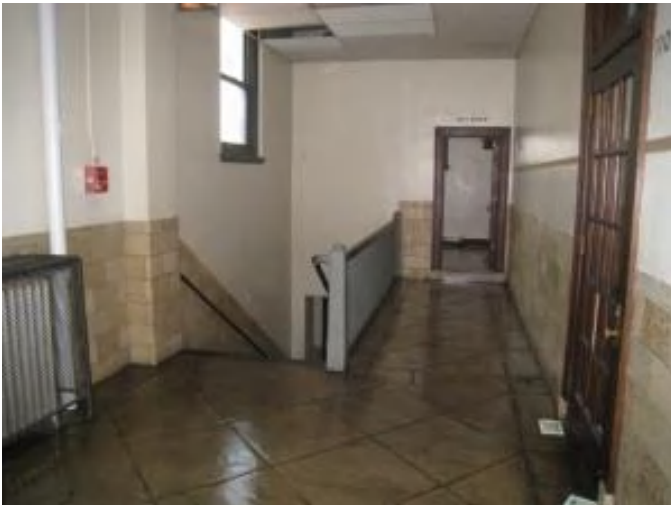
**Location:** open stairs in corridor

**System: C1010 - Partitions**

**Distress:** Building / MEP Codes

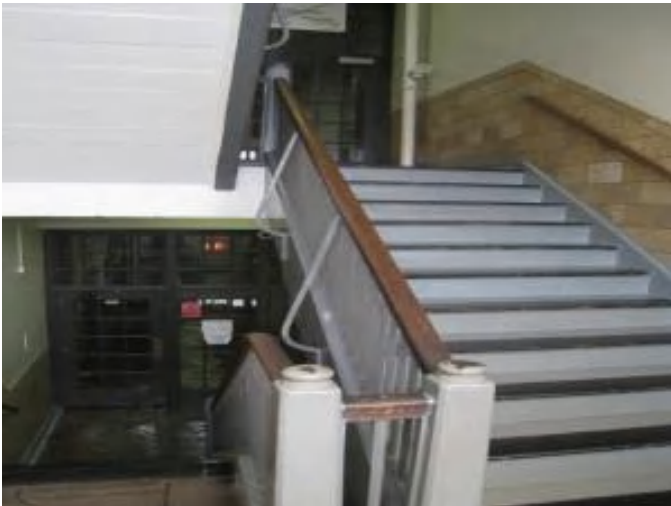
**Location:** stairs

**System: C2010 - Stair Construction**

**Distress:** Building / MEP Codes

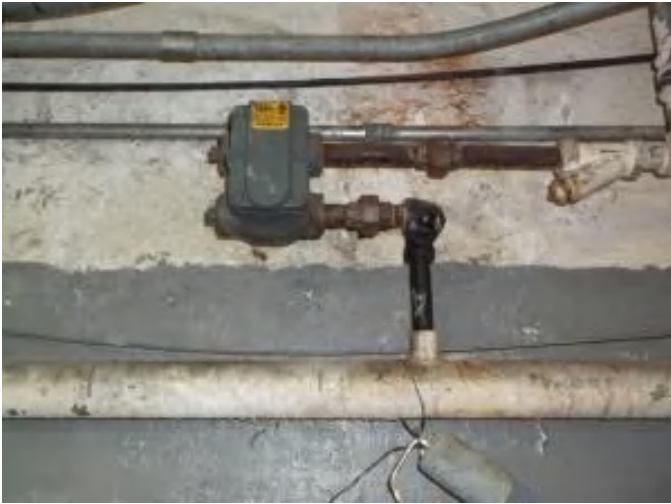
**Location:** Throughout the building

**System: D3040 - Distribution Systems**

**Distress:** Beyond Service Life

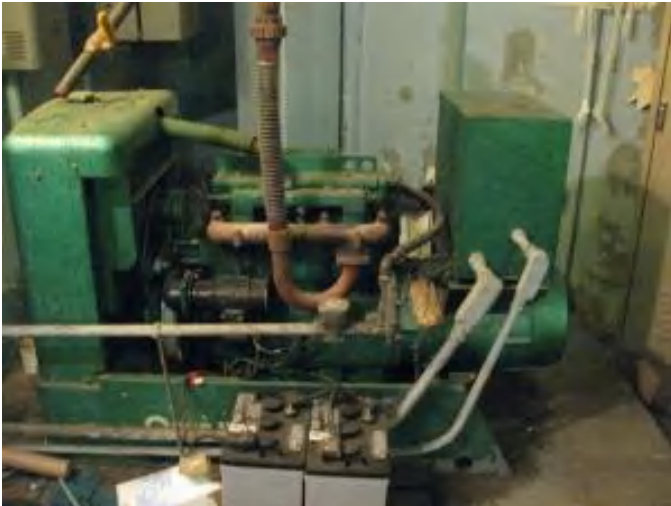
**Location:** Boiler Room

**System: D5090 - Other Electrical Systems**

**Distress:** Beyond Service Life

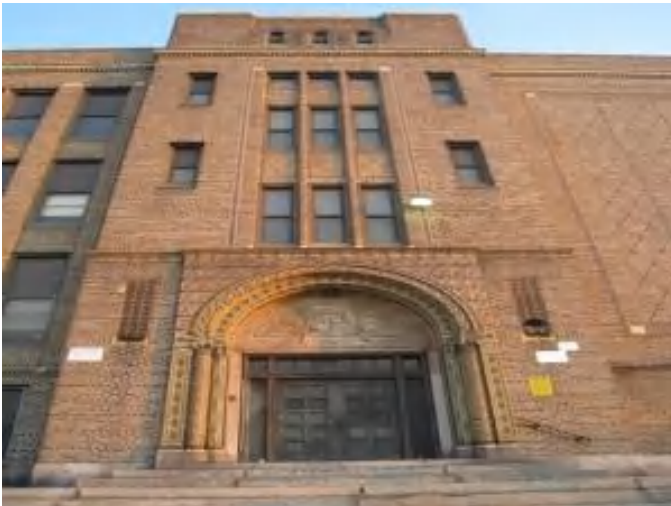
**Location:** exterior windows

**System: B2020 - Exterior Windows**

**Distress:** Beyond Service Life

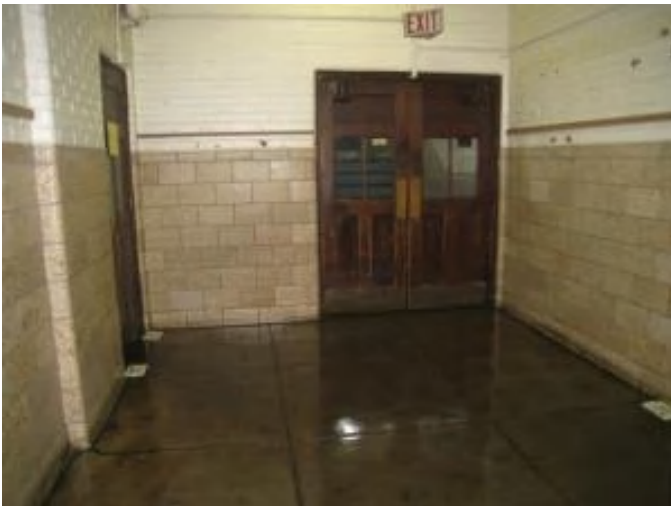
**Location:** basement

**System: C1020 - Interior Doors**

**Distress:** Beyond Service Life

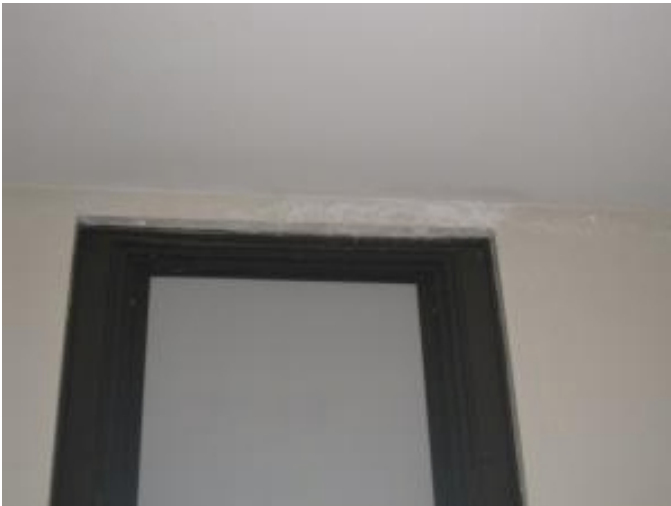
**Location:** classroom and corridor walls

**System: C3010230 - Paint & Covering**

**Distress:** Appearance

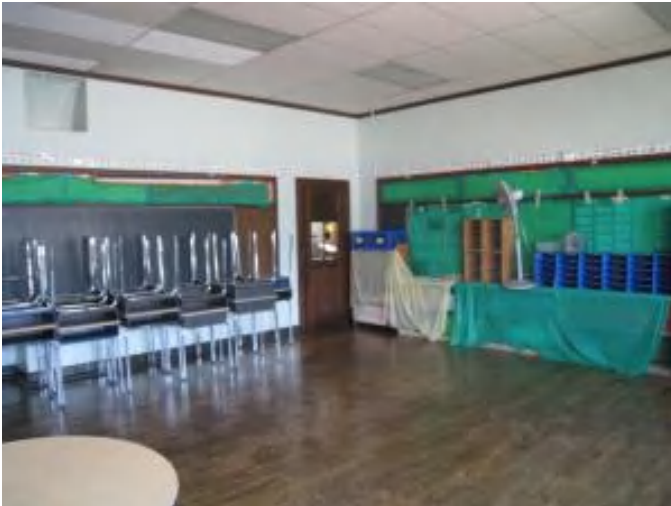
**Location:** classrooms

**System: C3020414 - Wood Flooring**

**Distress:** Appearance

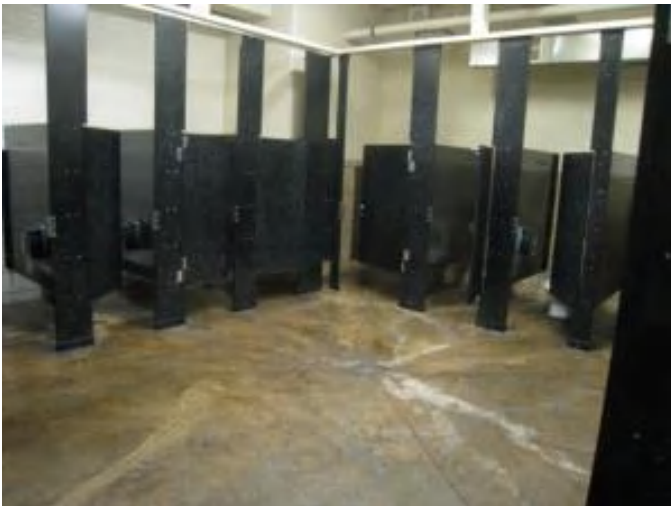
**Location:** basement

**System: C3020415 - Concrete Floor Finishes**

**Distress:** Appearance

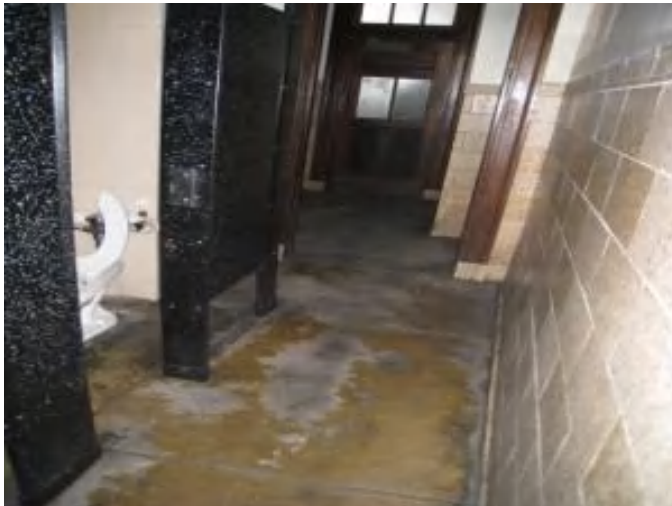
**Location:** Throughout the building

**System: D2010 - Plumbing Fixtures**

**Distress:** Beyond Service Life

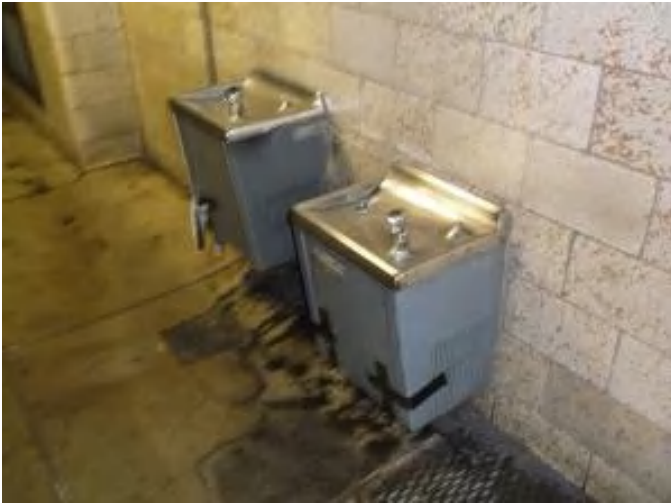
**Location:** Throughout the byilding

**System: D2010 - Plumbing Fixtures**

**Distress:** Beyond Service Life

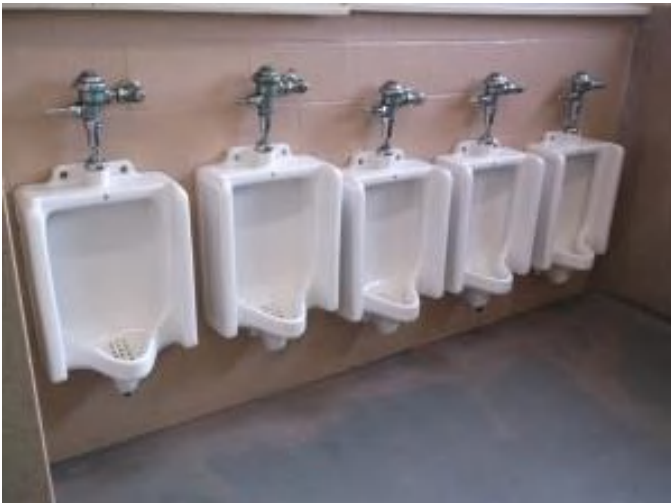
**Location:** Throughout the byilding

**System: D2010 - Plumbing Fixtures**

**Distress:** Beyond Service Life

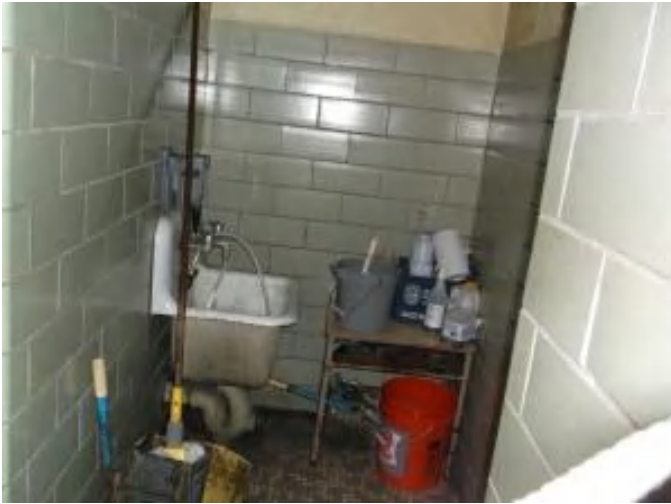
**Location:** Throughout the byilding

**System: D2010 - Plumbing Fixtures**

**Distress:** Beyond Service Life

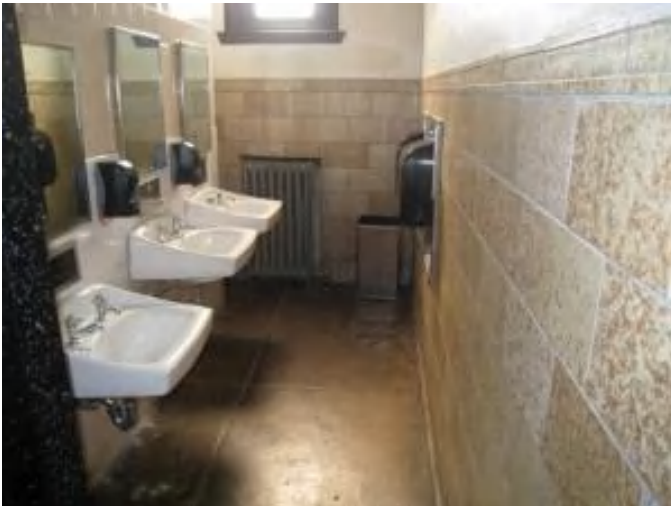
**Location:** Throughout the building

**System: D2010 - Plumbing Fixtures**

**Distress:** Beyond Service Life

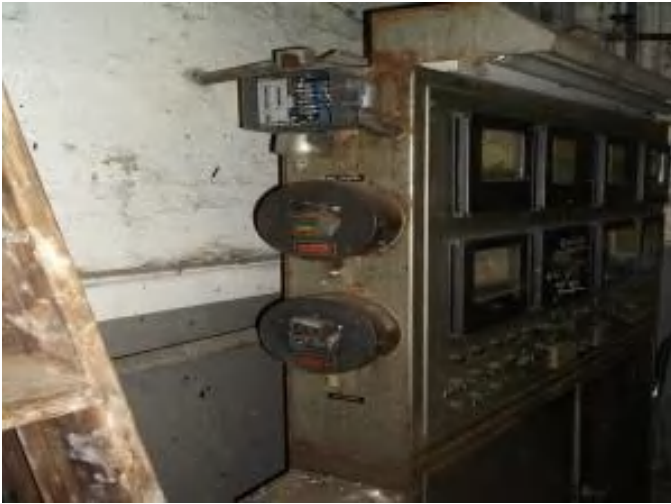
**Location:** Throughout the building

**System: D3060 - Controls & Instrumentation**

**Distress:** Beyond Service Life

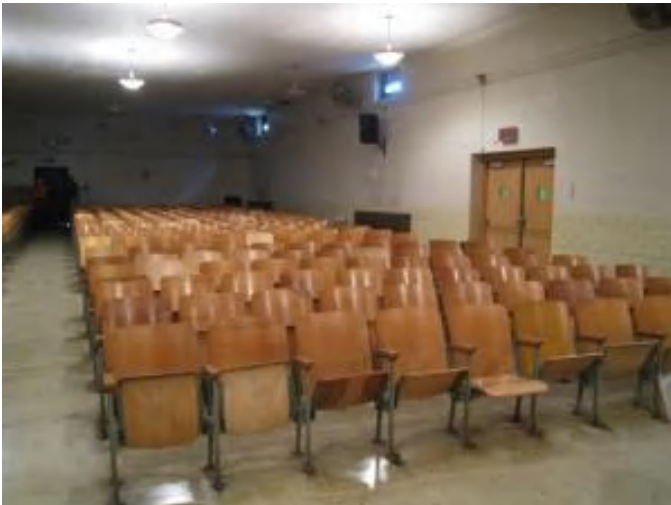
**Location:** auditorium

**System: E2010 - Fixed Furnishings**

**Distress:** Appearance

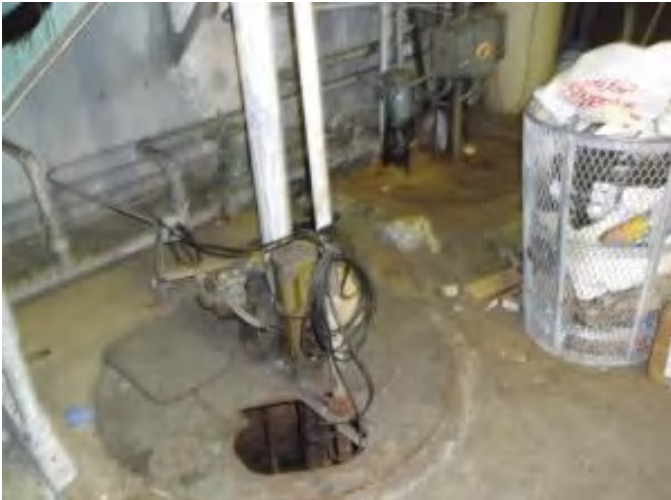
**Location:** Throughout the building

**System: D2030 - Sanitary Waste**

**Distress:** Beyond Service Life

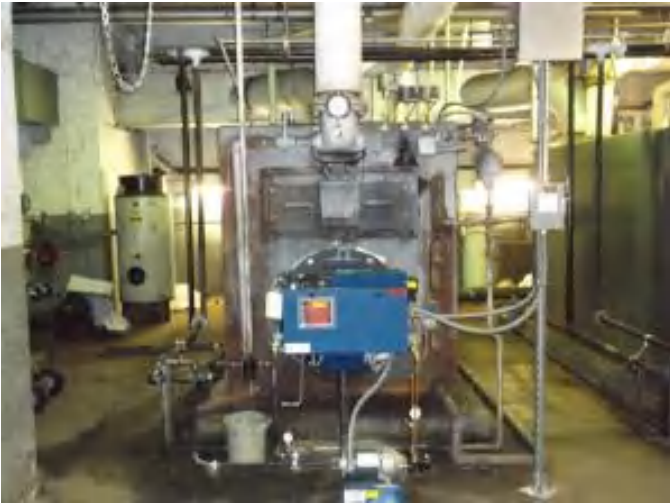
**Location:** Boiler Mechanical Equipment Room

**System: D3020 - Heat Generating Systems**

**Distress:** Beyond Service Life

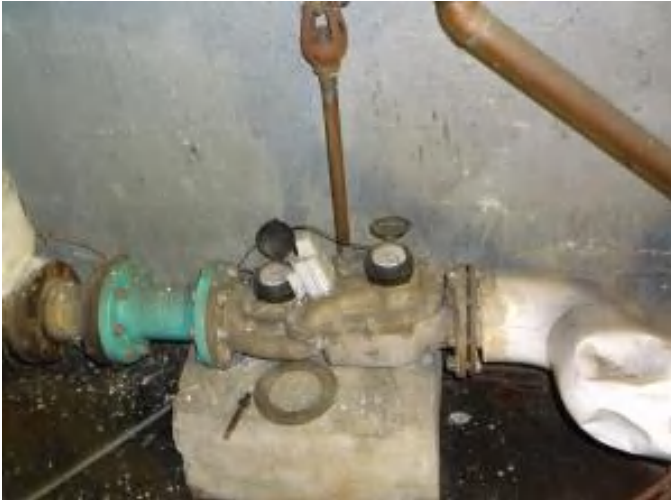
**Location:** Throughout the building

**System: D2020 - Domestic Water Distribution**

**Distress:** Beyond Service Life

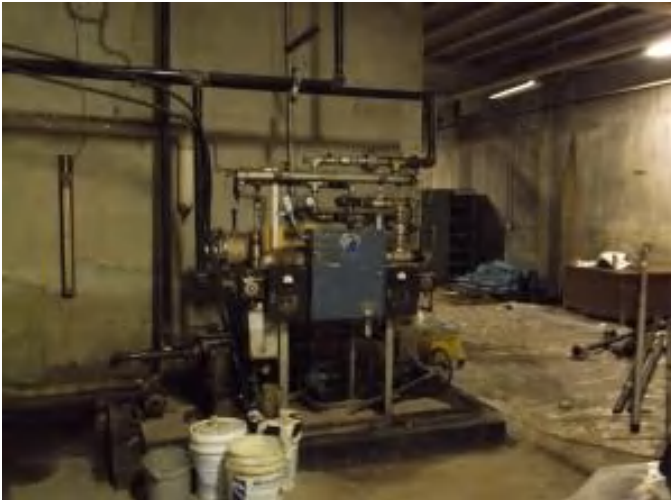
**Location:** Boiler Mechanical Equipment Room

**System: D3020 - Heat Generating Systems**

**Distress:** Beyond Service Life

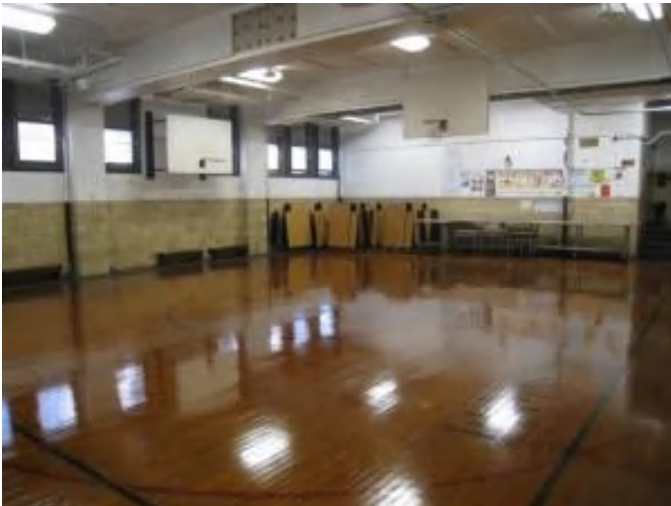
**Location:** Gym

**System: D3040 - Distribution Systems**

**Distress:** Building / MEP Codes

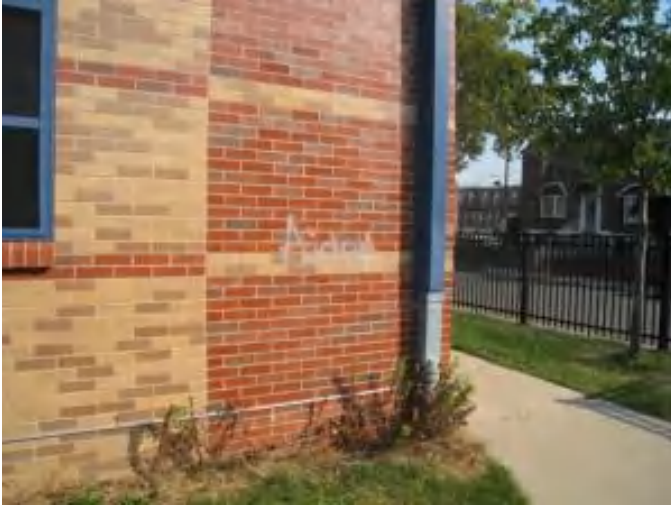
**Location:** PEC corner of building

#### System: B2010 - Exterior Walls

**Distress:** Appearance

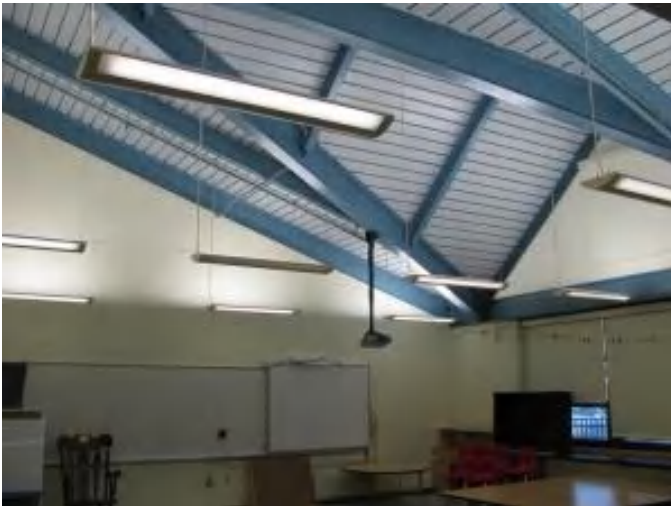
**Location:** PEC Location subject to kid access

#### System: D5020 - Lighting and Branch Wiring

**Distress:** Building / MEP Codes
