### Fox Chase School

# **S826001;Fox Chase**

## **Site Assessment Report**

January 31, 2017

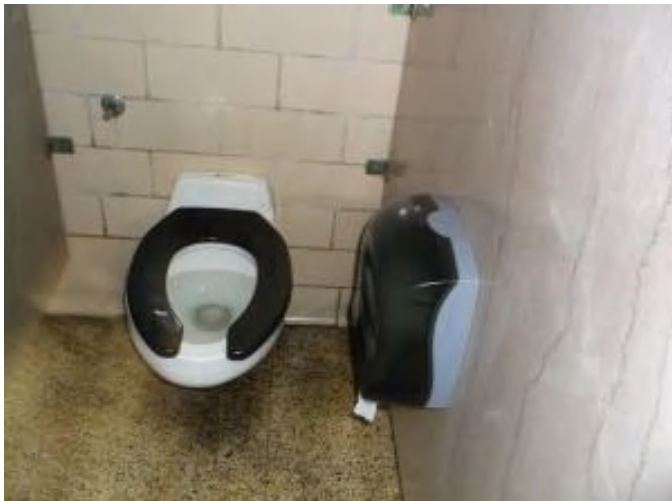
**System: D2010 - Plumbing Fixtures**

**Location:** Throughout the building

**Distress:** Beyond Service Life

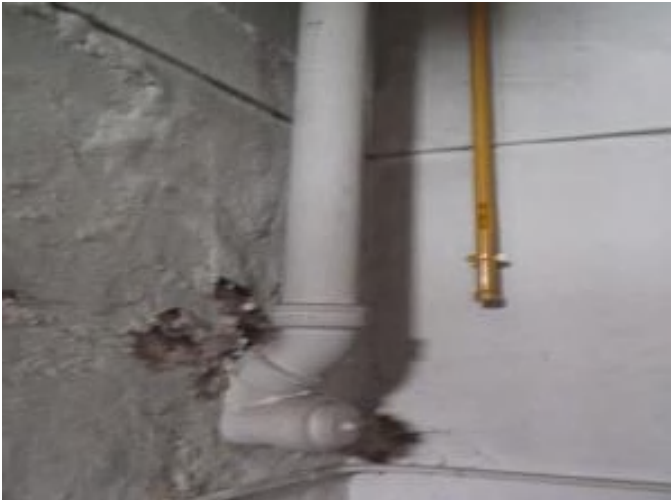
**System: D2030 - Sanitary Waste**

**Location:** Throughout the building

**Distress:** Beyond Service Life

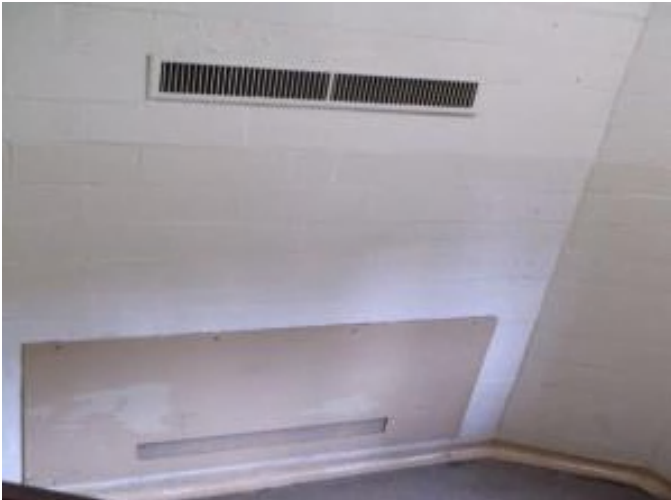
**System: D3040 - Distribution Systems**

**Location:** Throughout the school

**Distress:** Beyond Service Life

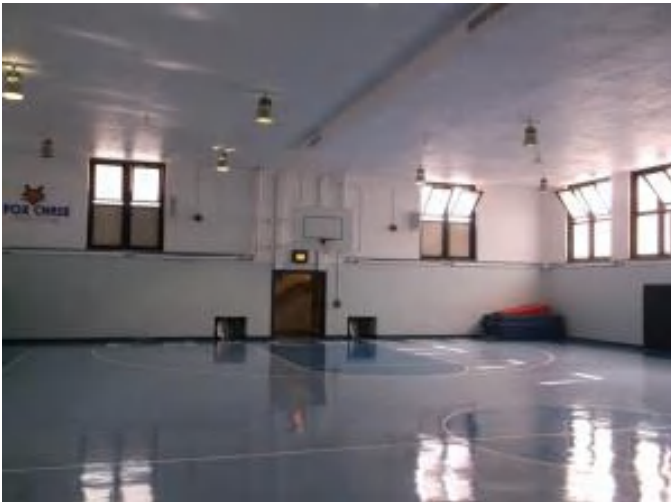
**System: D3040 - Distribution Systems**

**Location:** Roof

**Distress:** Beyond Service Life
