## Facility Condition Assessment Summary Report

### Girls High School

| Address | 1400 W. Olney Ave.<br>Philadelphia, Pa 19141 | Enrollment | 1005 |

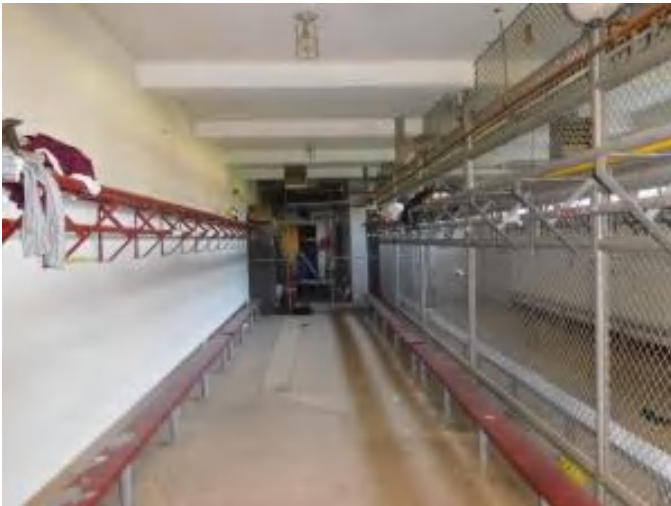
**System: D4010 - Sprinklers**

**Location:** entire building

**Distress:** Life Safety / NFPA / PFD

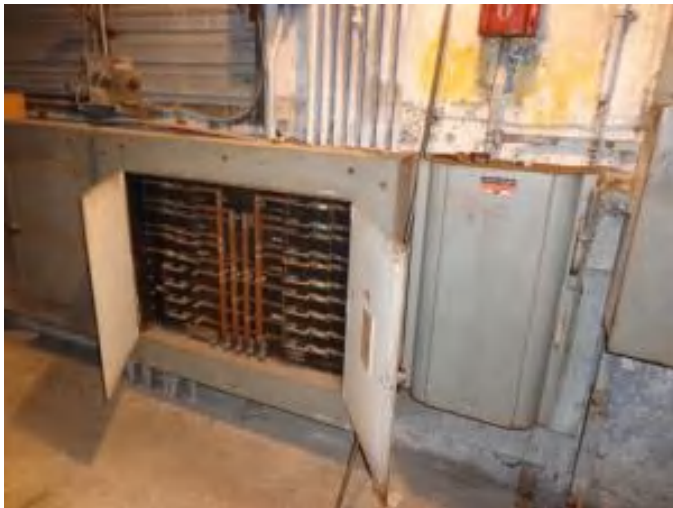
**System: D5010 - Electrical Service/Distribution**

**Location:** Mechanical Room

**Distress:** Beyond Service Life

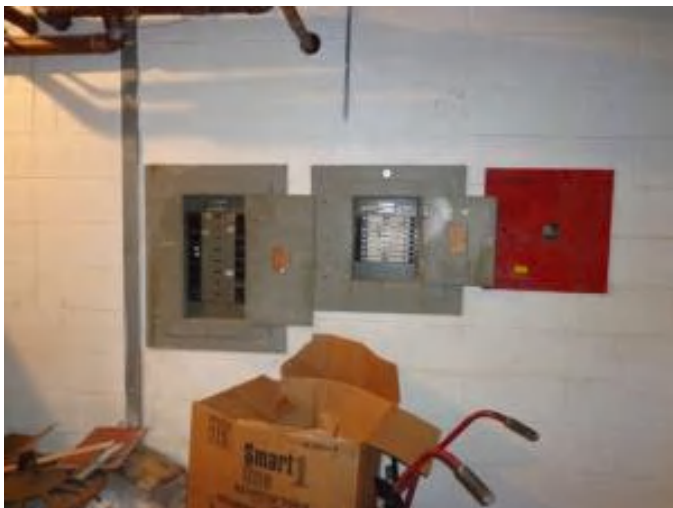
**System: D5010 - Electrical Service/Distribution**

**Location:** Floors 1 and 2

**Distress:** Beyond Service Life

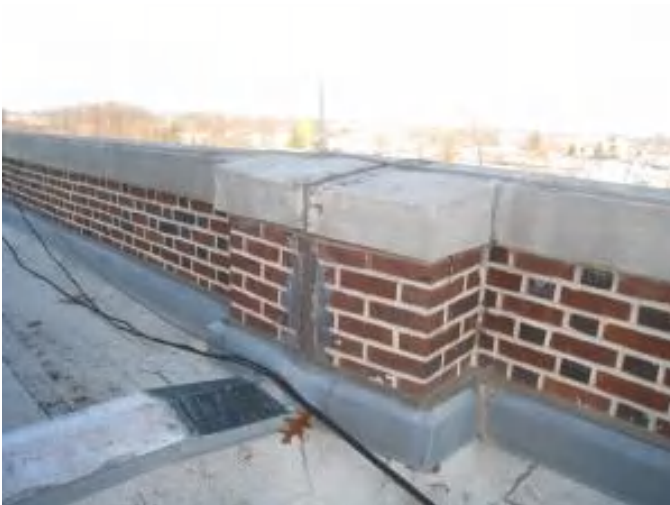
#### System: B2010 - Exterior Walls

**Location:** Girls HS - roof

**Distress:** Failing

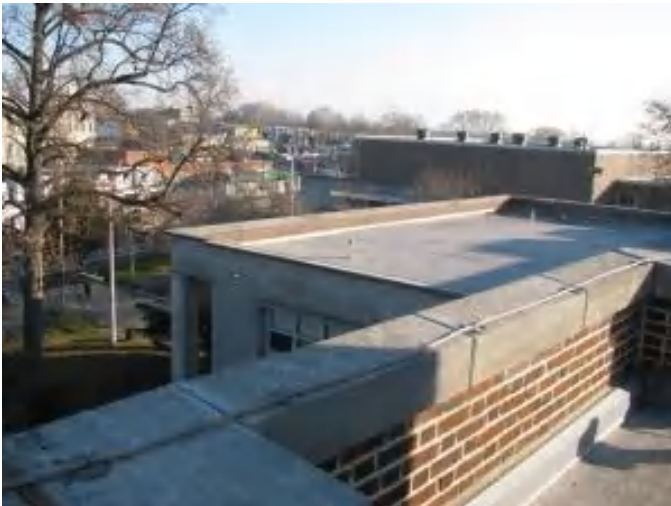
**Location:** Girls Hs- Exterior Building

**System: D5020 - Lighting and Branch Wiring**

**Distress:** Security Issue

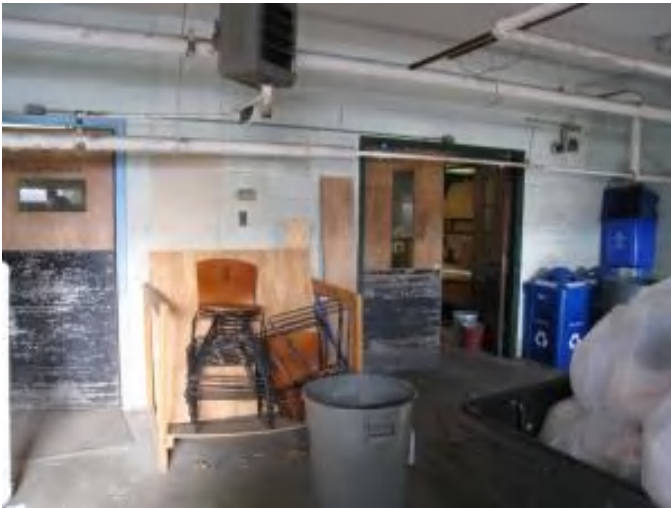
**Location:** Girls HS - basement

**System: C1020 - Interior Doors**

**Distress:** Building / MEP Codes

**Correction:** Remove and replace hollow metal frames and doors

**Notes:** Remove and replace all basement steel doors, frames, and hardware in mechanical rooms; fire rated doors with panic hardware for stairs (100) 3x7 doors

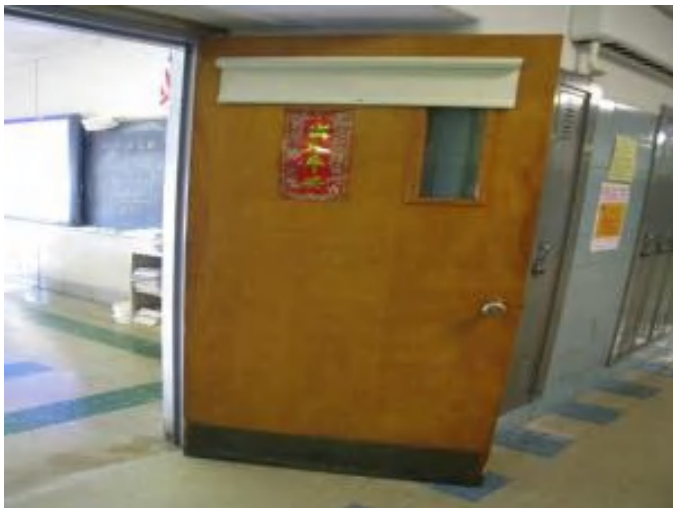
**Location:** Girls HS - corridor doors

**System: C1020 - Interior Doors**

**Distress:** Security Issue

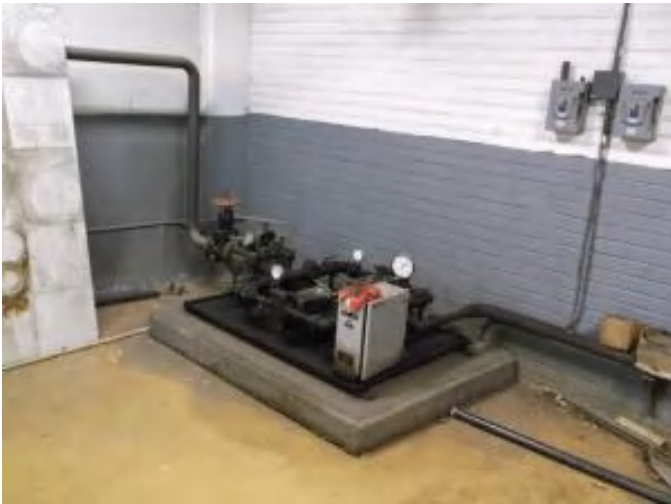
**Location:** Coal/Ash Room

**System: D3020 - Heat Generating Systems**

**Distress:** Beyond Service Life

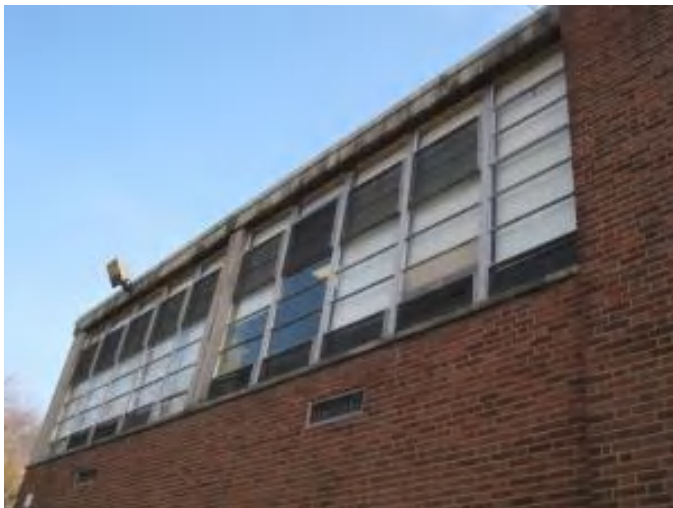
**Location:** Widener - brick and limestone

**System: B2010 - Exterior Walls**

**Distress:** Appearance

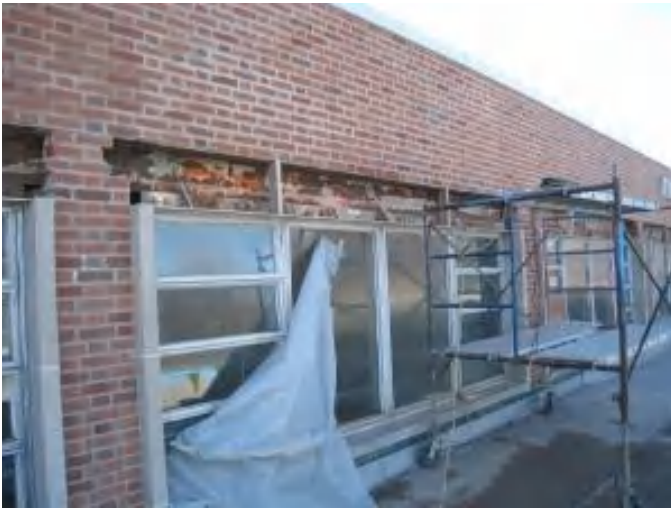
**Location:** Widener - windows

Exterior windows are aluminum frame and single glazed units, that might be original. The frames are corroded, window putty is cracked and failing, and caulking is failing. The Team was told that a full window replacement is underway. Based on the observations made during the field inspection, the existing windows certainly need to be replaced with new insulating high-efficiency glass units as the District has planned.

**System: B2020 - Exterior Windows**

**Distress:** Beyond Service Life

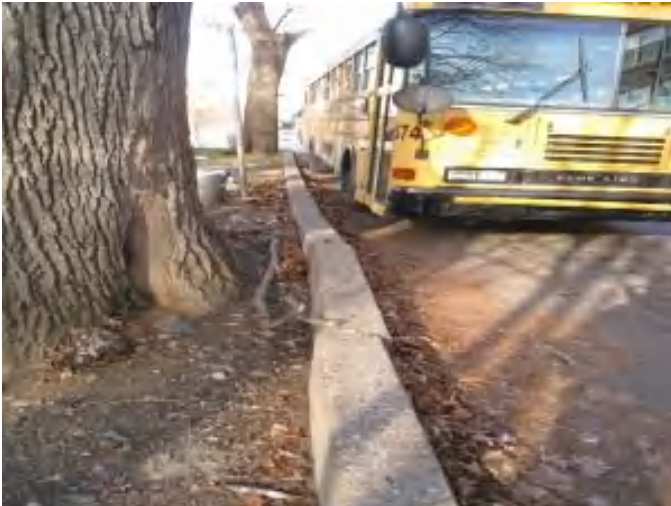
#### System: G2020 - Parking Lots

**Location:** Girls HS - curb along W. Olney drop-off

**Distress:** Damaged

**Correction:** Remove and replace curbing

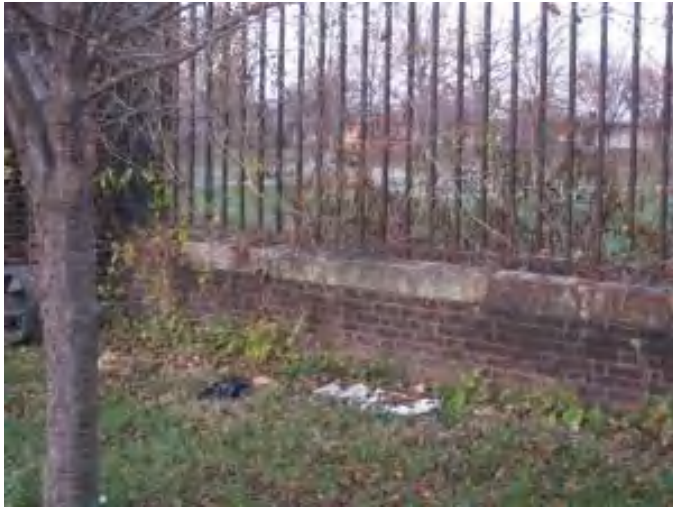
**System: G2040 - Site Development**

**Location:** Widener - site fence, Broad St.

**Distress:** Appearance
