## Facility Condition Assessment Summary Report

### Gratz School

**S401001;Gratz**

**Site Assessment Report**

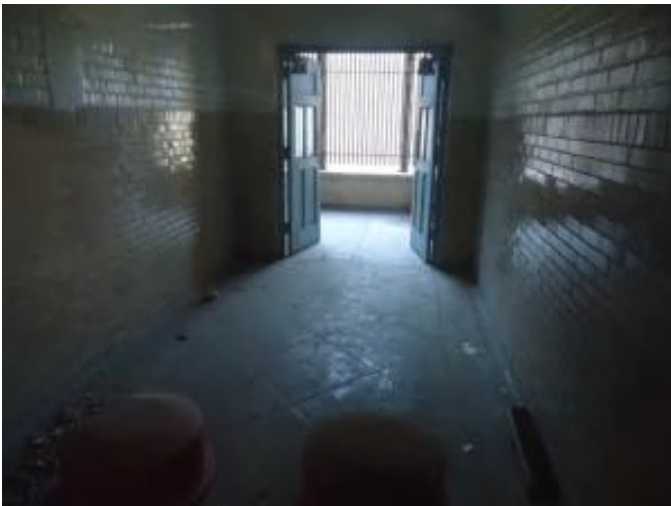
**Location:** Corridor Doors

A large portion of the interior corridor, exit stair doors are not code compliant. Several doors are typically wood or metal in metal frames with transom lites or sidelights, glass glazing. The older doors are generally in good condition considering the age of the application. To restore the door finishes, universal upgrades are required for the older door applications. Remove and replace original door systems with new code compliant fire rated door system.

**Distress:** Life Safety / NFPA / PFD

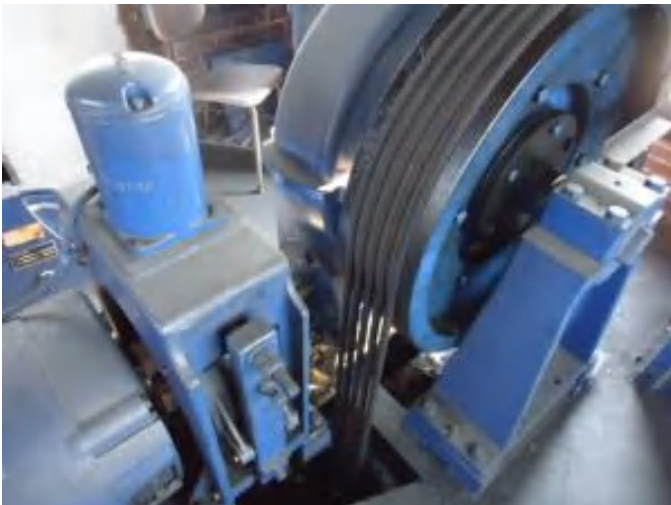
**Location:** West elevator

**Distress:** Beyond Service Life

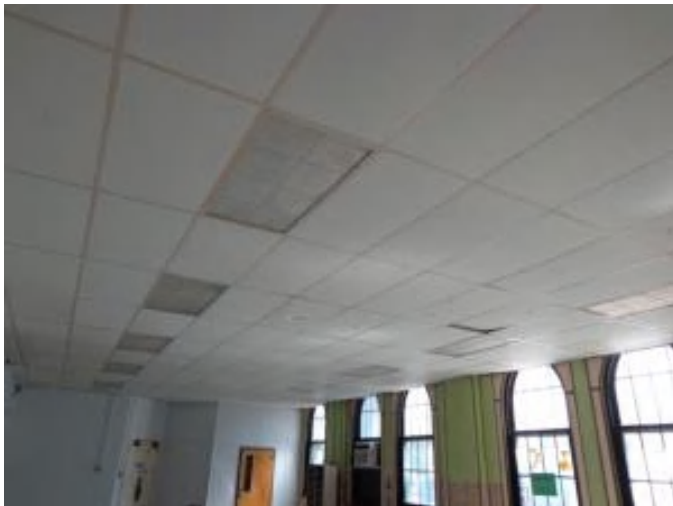
**Location:** Classrooms

**Distress:** Beyond Service Life

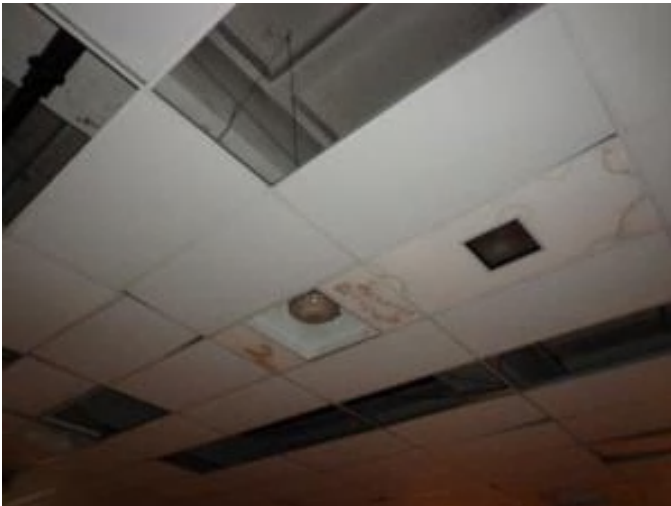
**Location:** Dance Studio

**Distress:** Beyond Service Life

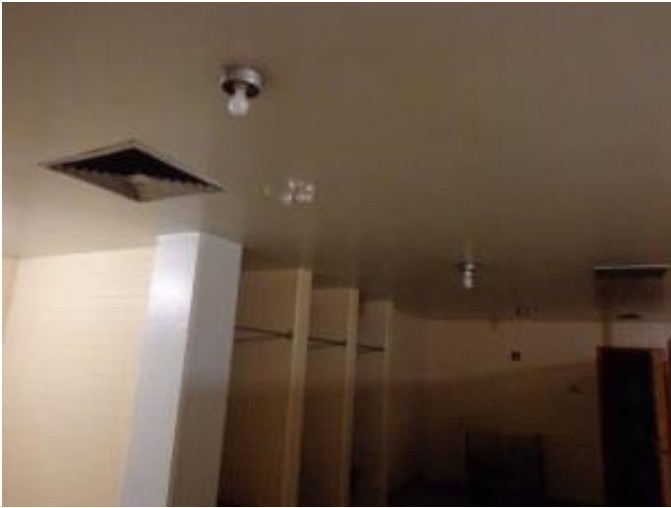
**Location:** 1972 Shower Rooms

**Distress:** Beyond Service Life

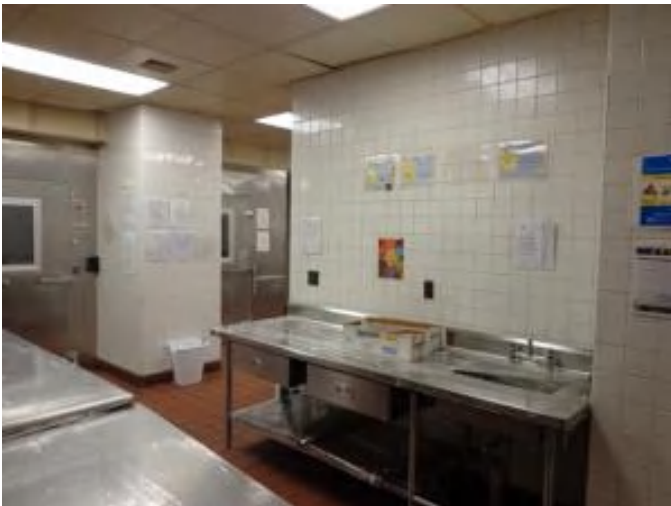
**Location:** Basement Kitchen and various locations

**Distress:** Life Safety / NFPA / PFD

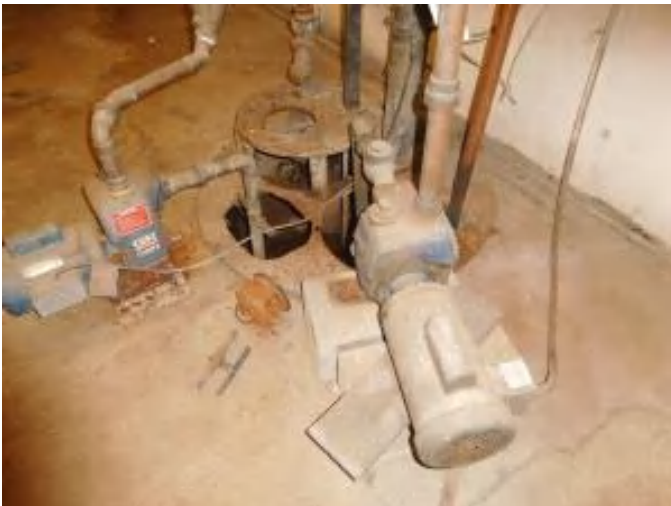
**Location:** entire building

**Distress:** Beyond Service Life

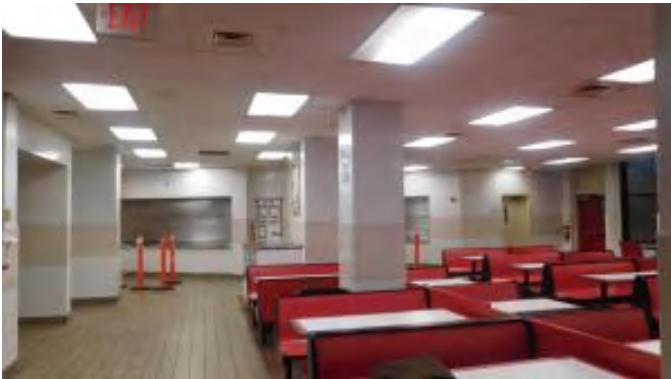
**Location:** cafeteria

**Distress:** Building / MEP Codes

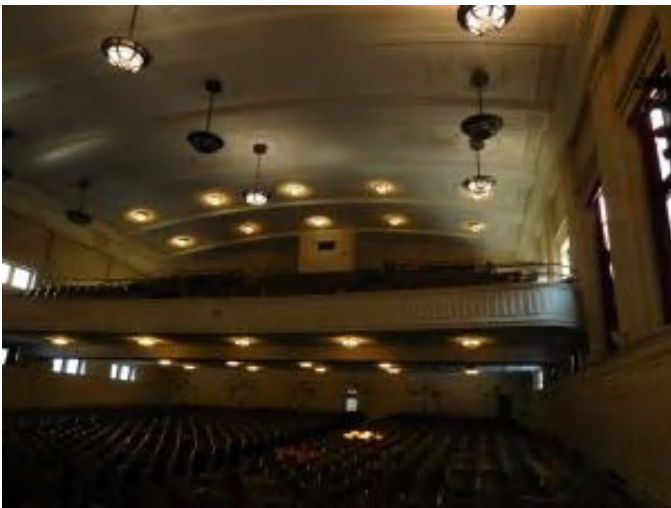
**Location:** auditorium

**Distress:** Building / MEP Codes

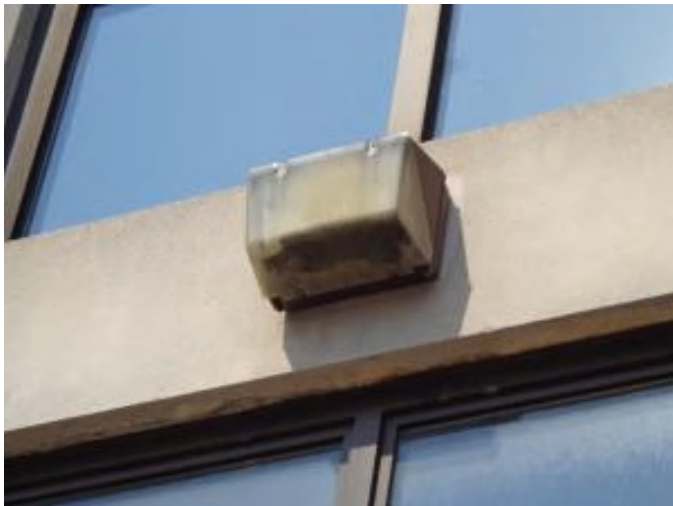
**Location:** Exterior building

**Distress:** Maintenance Required

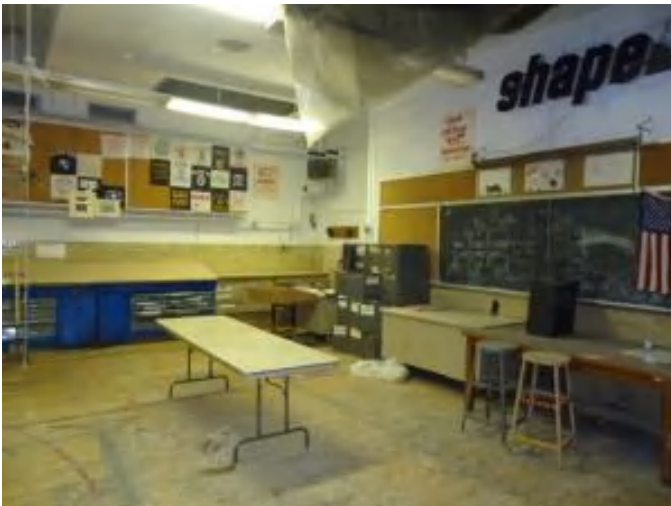
**Location:** Classrooms

**Distress:** Beyond Service Life

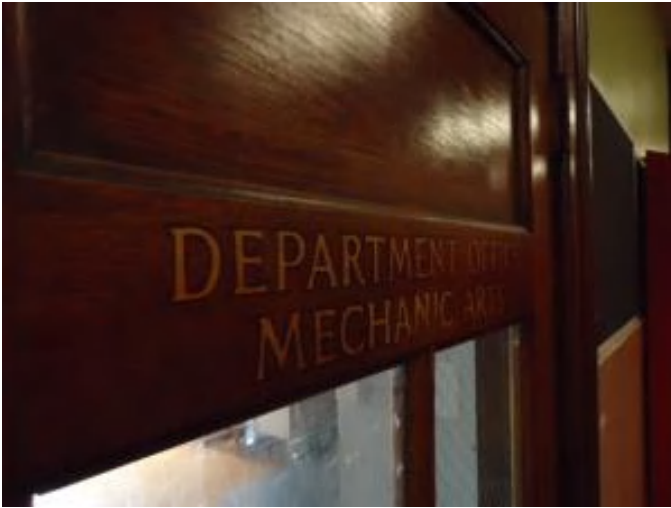
**Location:** Building Wide

**Distress:** Accessibility

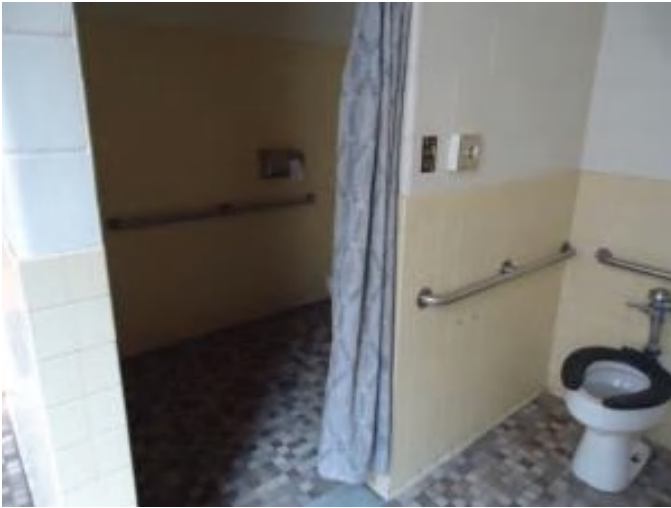
**Location:** Building Wide

The tile wall finishes appear to have been replaced in the early 1990's and are in fair condition. The finish is expected to require upgrade within the next ten years based on the high traffic use in this school. This deficiency provides a budgetary consideration for universal upgrades to the wall tile finish.

**Distress:** Beyond Service Life

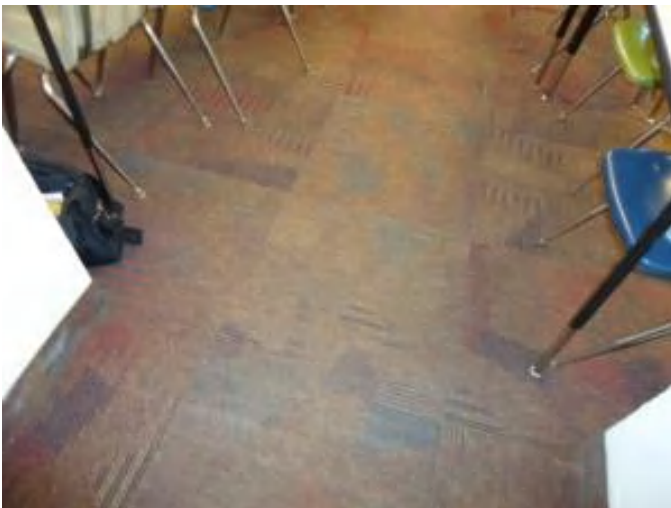
**Location:** Administrative Spaces

The interior carpet finish was installed approximately in 2000 and is in fair condition considering the age and high traffic conditions. This finish will exceed its expected life within the next five years and is recommended for removal and replacement.

**Distress:** Beyond Service Life

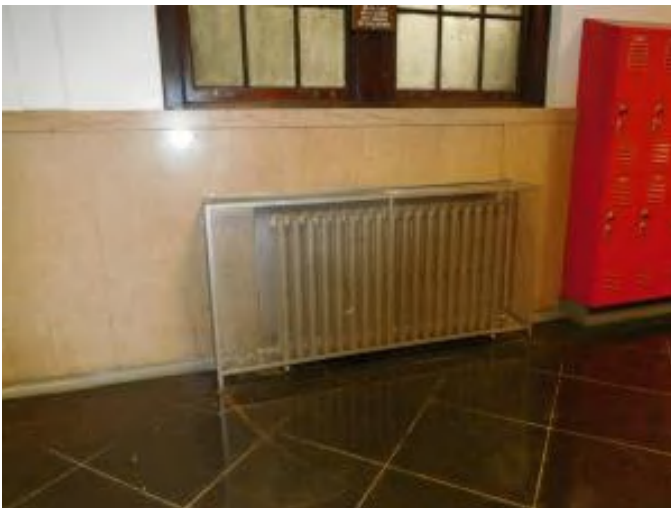
**Location:** original building

**Distress:** Building / MEP Codes

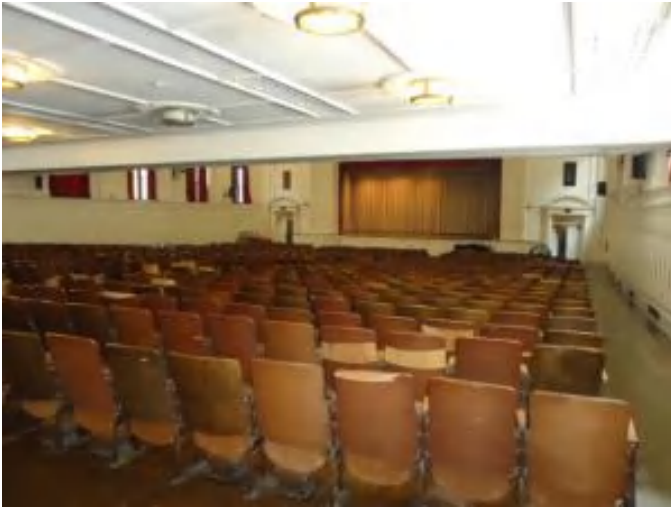
**Location:** Auditorium

The fixed seating for this school is from the original construction. The systems are in fair condition considering the age and usage. This project provides a budgetary consideration for universal upgrades for the fixed seating and furnishing of this school. Ensure that ADA requirements are followed with the new seating layout.

**Distress:** Beyond Service Life

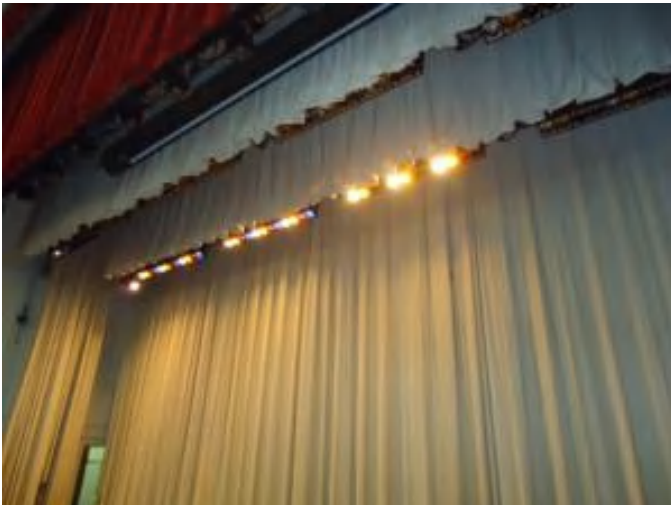
**Location:** Stage

The school stage has a stage curtain assembly that appears to be from the original construction. Modern applications are typically fire-proof applications with adjustable tracks and electric support for operation. The curtains are torn in a few sections and the track is not functioning properly, overall the system is in poor condition. It is recommended that the curtain and track system be upgraded to a new system. Special care should be considered in regards to modern fire proofing for the new installation.

**Distress:** Life Safety / NFPA / PFD

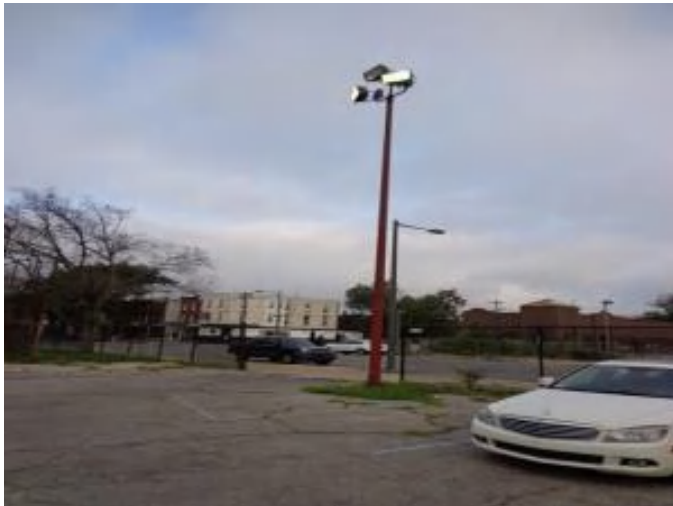
**Location:** Parking Lot

**Distress:** Maintenance Required
