## Facility Condition Assessment Summary Report

### Greenberg School

School District of Philadelphia  
**S843001;Greenberg**  
Final  
**Site Assessment Report**  
January 31, 2017

## Site Assessment Report

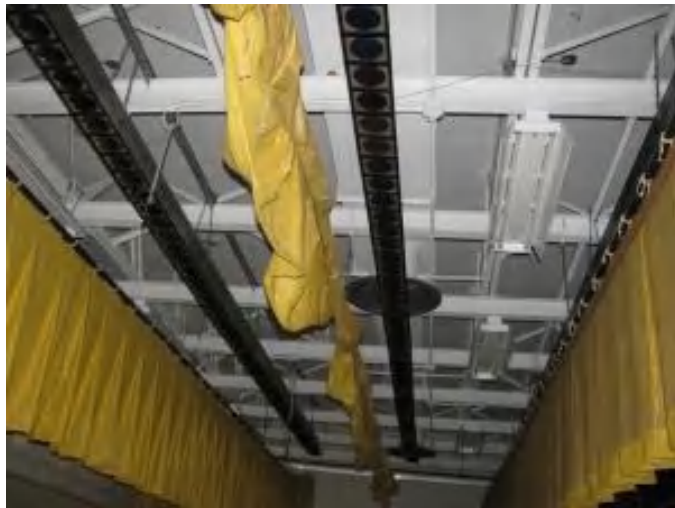
**Location:** Auditorium

**System: E1020 - Institutional Equipment**

**Distress:** Inadequate

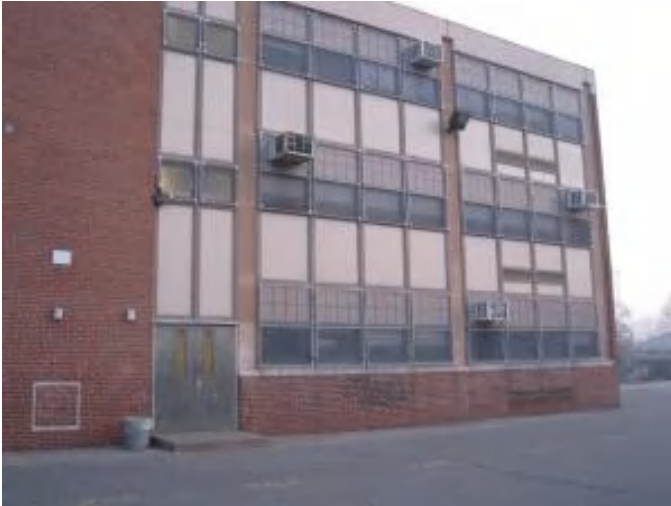
**Location:** exterior univents

**System: B2010 - Exterior Walls**

**Distress:** Damaged

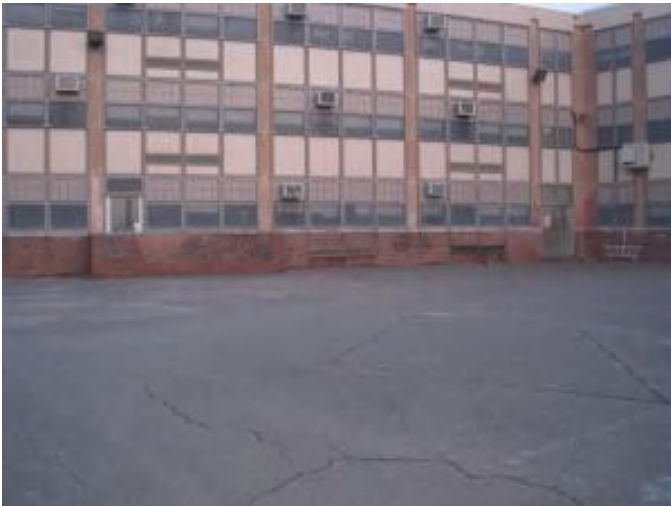
**Location:** exterior univents

**System: B2010 - Exterior Walls**

**Distress:** Damaged

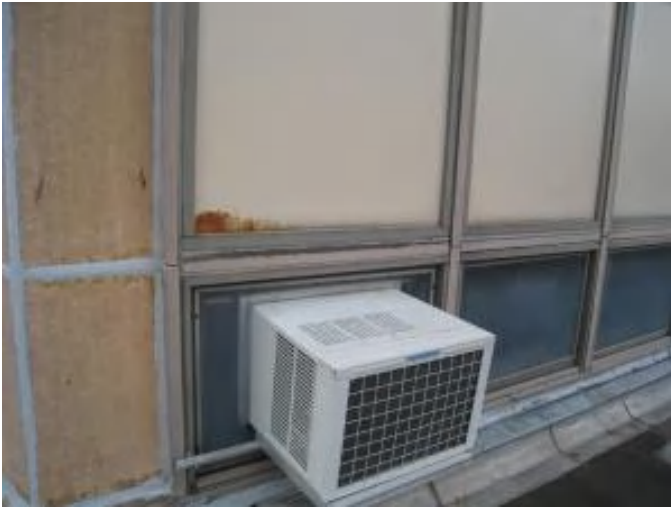
**Location:** exterior windows (panels)

**System: B2010 - Exterior Walls**

**Distress:** Damaged

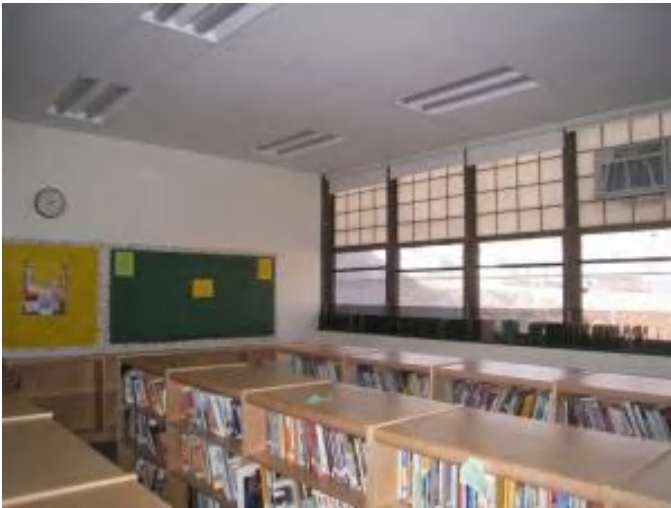
**Location:** exterior windows

Exterior windows on the main building are the 1990's dark anodized frame and single glazed plexiglass replacement units utilized by the District in many schools. The frames are fading and the plexiglass has become etched and cloudy. Windows are difficult to operate and often get stuck open or slam closed. These single glazed units provide almost no insulation value and do not meet today's energy code requirements making them a large source of heat loss. First floor and basement windows have galvanized steel security screens on the exterior facing the street and full height facing the playground, all in good condition. Some of the steel panels between first and second floor windows or under windows along the low roof are rusted and need repainting.

**System: B2020 - Exterior Windows**

**Distress:** Failing

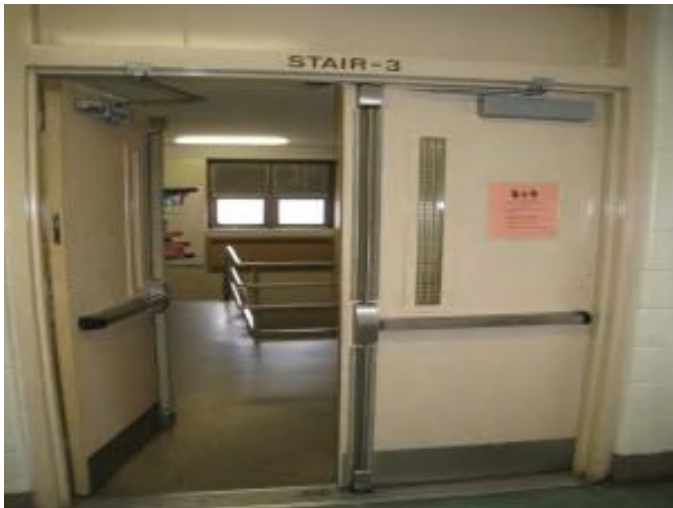
**Location:** stairway and mech room doors

**System: C1020 - Interior Doors**

**Distress:** Appearance

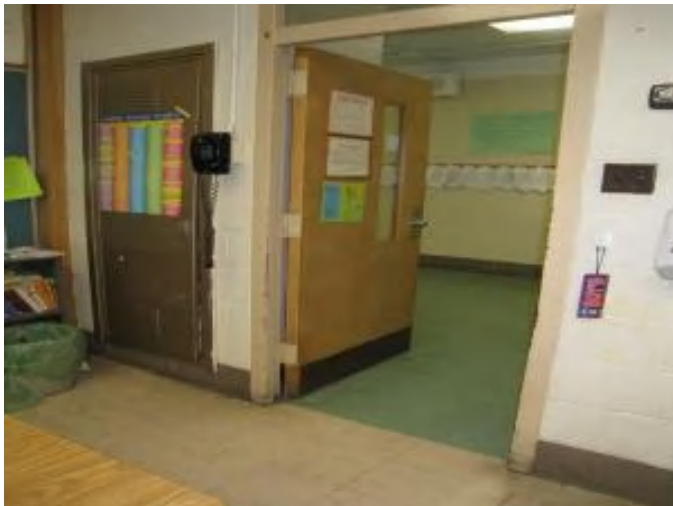
**Location:** corridor classroom and office doors

Interior doors in the main building classrooms, offices, storage rooms, and bathrooms are solid wood oak veneer doors and steel frames. Many of these wood doors have narrow lite wired glass vision panels where vision is desirable. Classroom doors have wired glass transoms over the doors and some doors have security screens. Most wood door surfaces are worn and damaged in need of replacement; classroom doors do not have closers, required by code on fire-rated corridor doors. Steel door frames are in good enough condition that they could be repainted. Classroom, office, and special function room doors throughout the building have old nob-style locksets. Since none of the classroom doors can be locked from the inside of the classroom, as required today for lock-down security, door hardware and door panels need to be replaced. Stairway, cafeteria, and auditorium doors are steel doors with wired glass vision panels and steel door frames. These doors and frames have panic hardware which latches as required by today's codes. Doors appear to be in fair condition with some dents and scratches in door panels and rust at the bottom of frames. Interior basement doors in the mechanical room are also hollow metal steel doors with steel frames. Steel interior doors and frames are in good enough condition to be repaired and repainted.

**System: C1020 - Interior Doors**

**Distress:** Security Issue

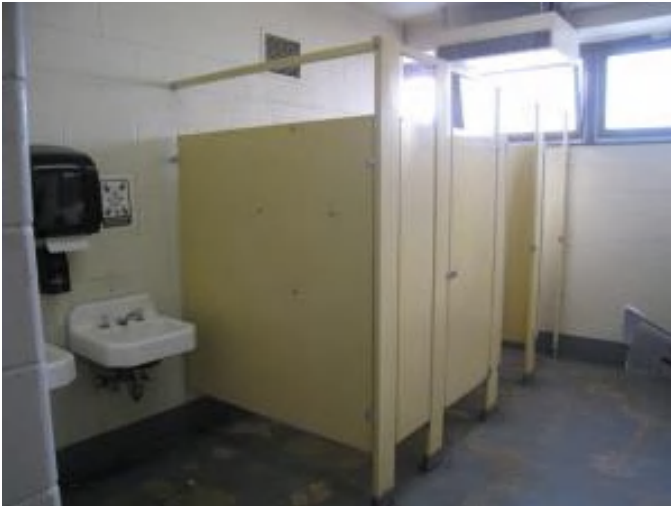
**Location:** toilet rooms

**System: C1030 - Fittings**

**Distress:** Inadequate

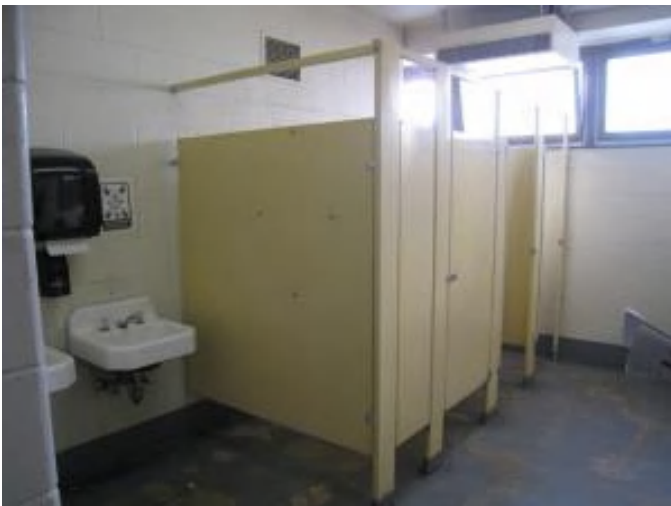
**Location:** toilet rooms

**System: C1030 - Fittings**

**Distress:** Beyond Service Life

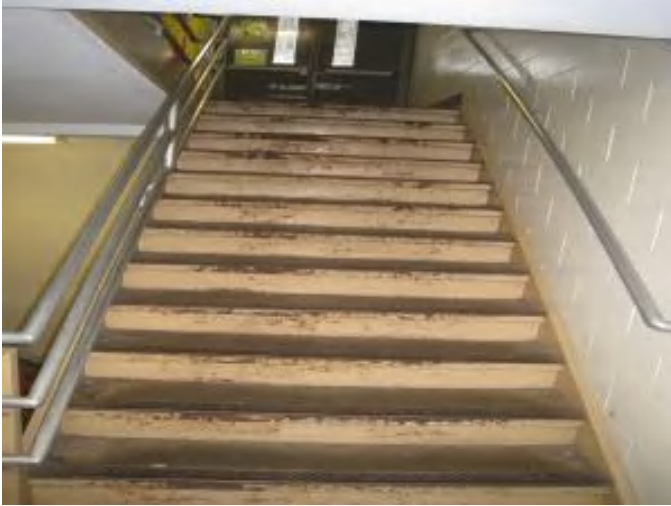
**Location:** stairways

**System: C3010230 - Paint & Covering**

**Distress:** Failing

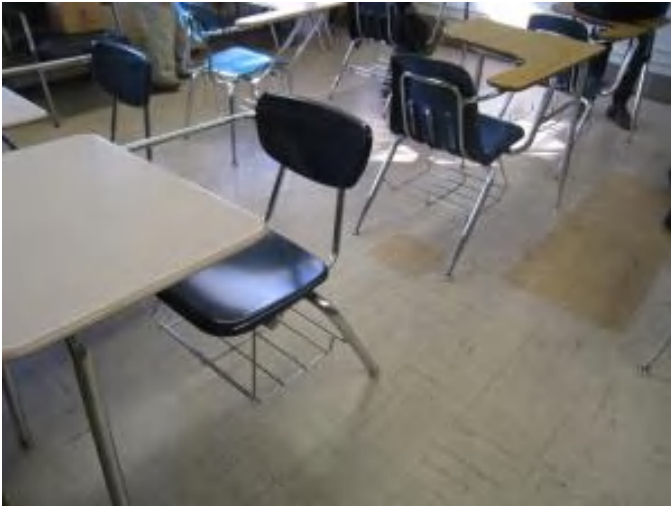
**Location:** floors

Floor finishes in most classrooms, all corridors, the lobby, auditorium, and the auditorium stage consist of vinyl asbestos tile (VAT). These floors at first appear to be in good condition, but upon closer inspection have many cracks, broken tiles, and mismatched replacement tiles. The rooms with VAT floors should be tested for asbestos and they should be properly removed and

**System: C3020413 - Vinyl Flooring**

**Distress:** Failing

replaced with new VCT. The cafeteria, gymnasium, main school offices and a few classrooms have vinyl composition tile (VCT) in place of the original VAT. These office floors have been well maintained and do not appear to need replacement, but the cafeteria and gymnasium floors are worn and need to be replaced. The main office conference room is finished with carpet and needs to be replaced. The kitchen has a quarry tile floor which is highly durable and in good condition. Basements, stairs, and toilet rooms have sealed concrete finishes which are in need of stripping, cleaning, and resealing; toilet rooms in particular should have a clean finish to promote the appearance of cleanliness. The library has new carpet which is in good condition. Bomb Shelter room floors have unfinished dirt floors with a concrete walk pathway down the middle. These spaces can remain as is.

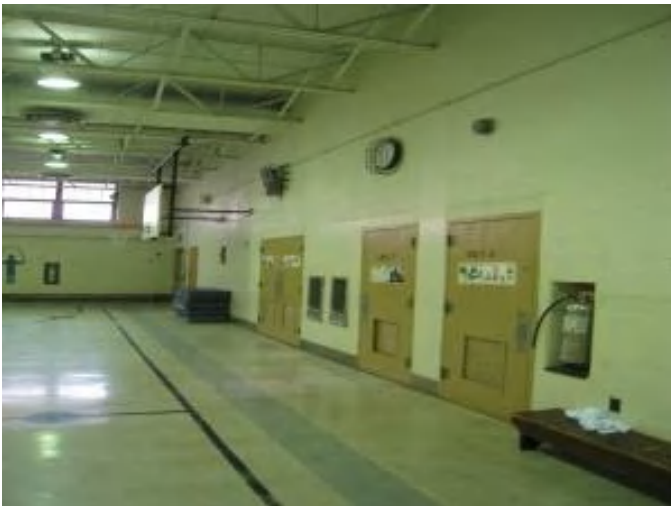
**Location:** gym and cafeteria floors

**System: C3020413 - Vinyl Flooring**

**Distress:** Damaged

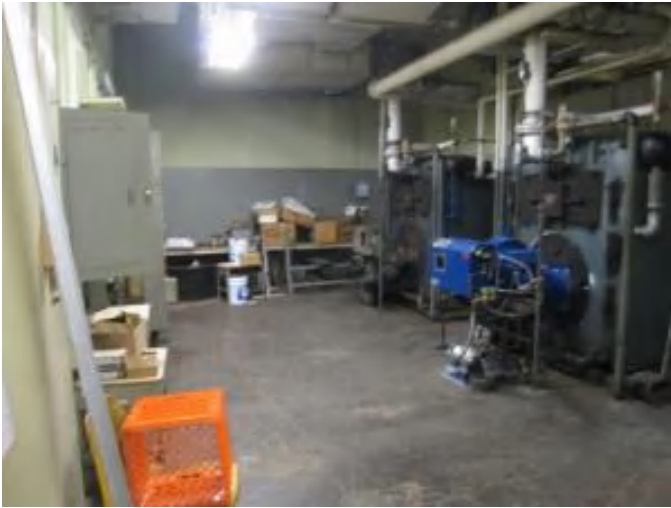
**Location:** concrete floors

**System: C3020415 - Concrete Floor Finishes**

**Distress:** Appearance

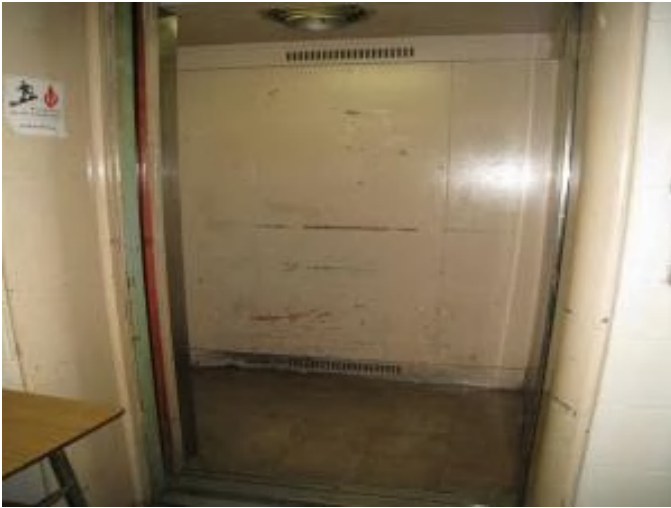
**Location:** elevator

There is a small 1200lb capacity 4 stop traction elevator in the building. Being an older model, its controls and floor indications do not provide audible and tactile notifications, as required in new ADA compliant elevator cabs. Finishes in the cab are worn. The elevator's operation is not always reliable. In light of the elevator's age and lack of ADA features, the district should replace the elevator.

**System: D1010 - Elevators and Lifts**

**Distress:** Beyond Service Life

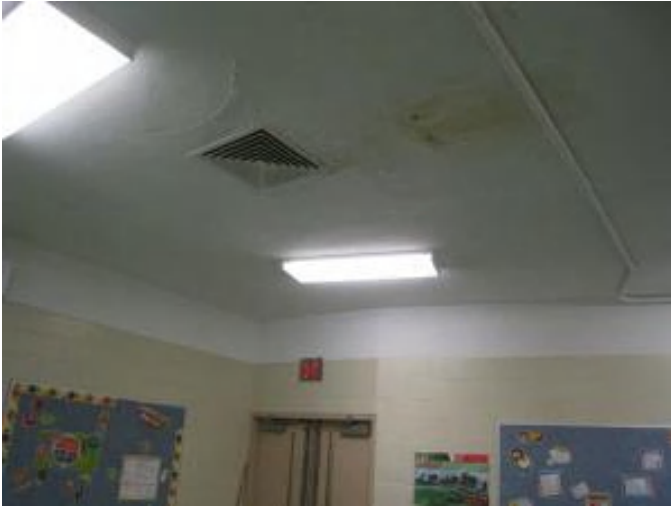
**Location:** ceilings

**System: C3030 - Ceiling Finishes**

**Distress:** Appearance

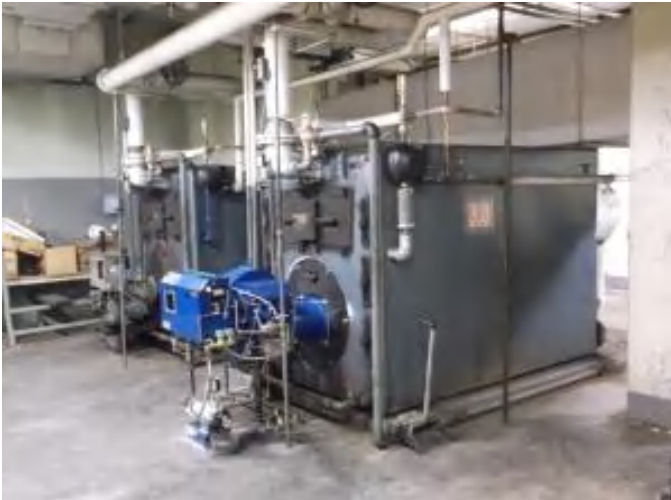
**Location:** Boiler Room

Hot water for heating the building is generated by three (3) 80 HP Weil McLain cast iron sectional boilers installed in 1964. One boiler is equipped with its original power burner designed to operate on fuel oil, which should be replaced at it is beyond the anticipated

service life. Burners have been replaced on the other two units and are equipped with solid state flame sensing controls. Burner oil pumps are loose and not driven by the fan motor. The supply line to the oil gun is equipped with dual solenoid valves and a basket strainer. Combustion air makeup is supplied by louvers equipped with motorized dampers. Cast iron sectional boilers have an anticipated service life of 35 years or more; these units have been in service more than 50 years. The District should budget to replace these boilers as they appear in poor condition.

**System: D3020 - Heat Generating Systems**

**Distress:** Beyond Service Life

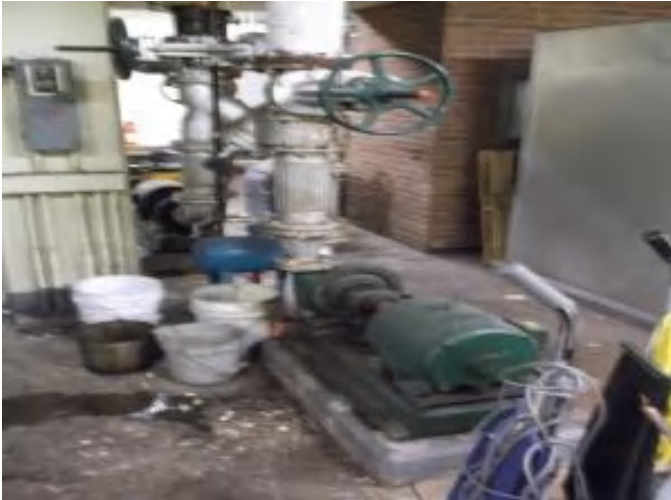
**Location:** Boiler Room

**System: D3020 - Heat Generating Systems**

**Distress:** Beyond Service Life

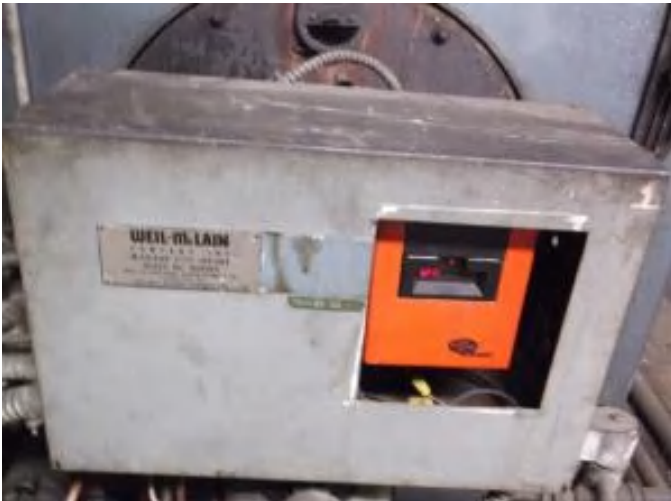
**Location:** Boiler Room

**System: D3020 - Heat Generating Systems**

**Distress:** Beyond Service Life

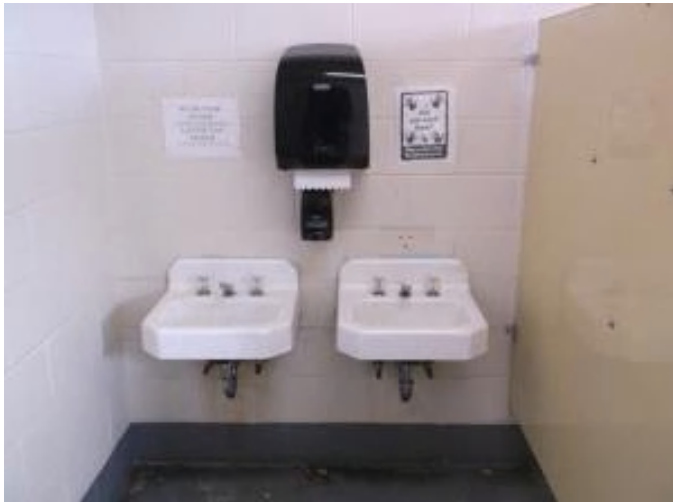
**Location:** Restrooms

**System: D2010 - Plumbing Fixtures**

**Distress:** Beyond Service Life

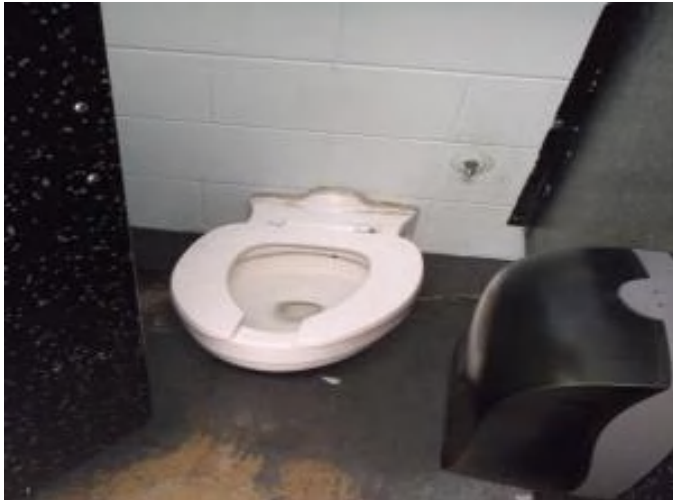
**Location:** Restrooms

**System: D2010 - Plumbing Fixtures**

**Distress:** Beyond Service Life

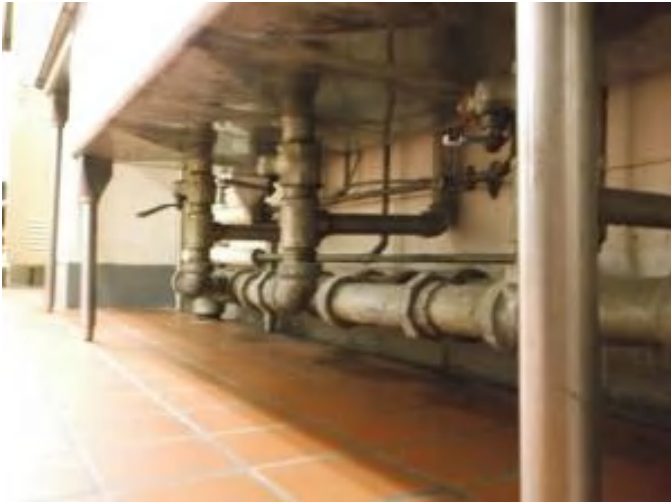
**Location:** Throughout Building

The original sanitary and storm drain piping is galvanized steel with threaded fittings. Roof drain leaders run through the building and connect to an underground storm sewer system on the site. The roof has a zero parapet so overflow drains are not required. These piping systems have been in service for more than 50 years and will require more frequent attention from the maintenance staff as time passes. The District should hire a qualified contractor to examine the sanitary waste and storm drain piping using video cameras to locate and replace any damaged piping and to further quantify the extent of potential failures.

**System: D2030 - Sanitary Waste**

**Distress:** Beyond Service Life

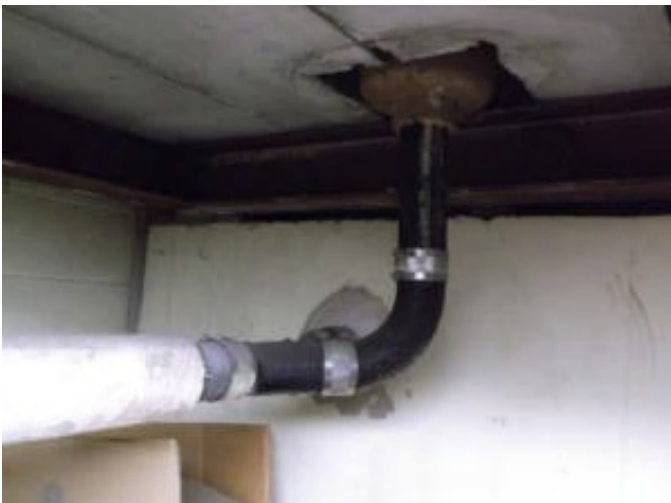
**Location:** Throughout Building

**System: D2040 - Rain Water Drainage**

**Distress:** Beyond Service Life

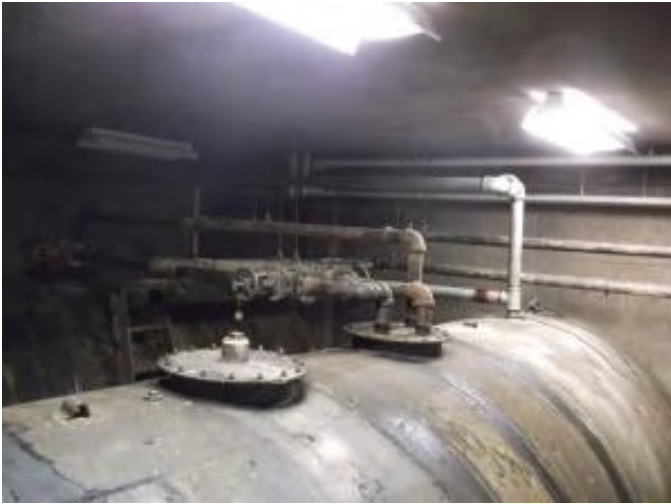
**Location:** Site

The reserve oil supply is stored in two 6,000 gallon single wall steel tanks. The tanks are located in the grass area on the Sharon Lane side of the building. They are not equipped with automatic leak detection and monitoring. Duplex pumps located in the boiler room circulate oil through the system. Natural gas is supplied to the burner pilots, but oil is used as the primary fuel. The District does not receive credit from the gas utility as an interruptible service. The current supply of oil should be tested for quality on a regular schedule. Oil storage tanks have an anticipated service life of 20 years. The District should budget for replacing these tanks in the next few years.

**System: D3020 - Heat Generating Systems**

**Distress:** Beyond Service Life

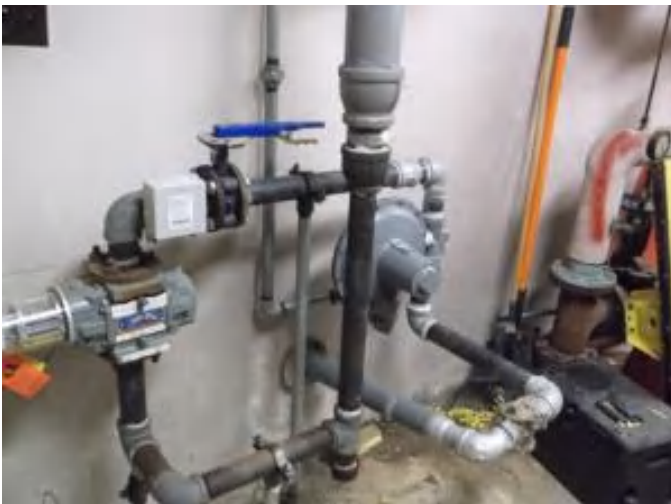
**Location:** Site

**System: D3020 - Heat Generating Systems**

**Distress:** Energy Efficiency

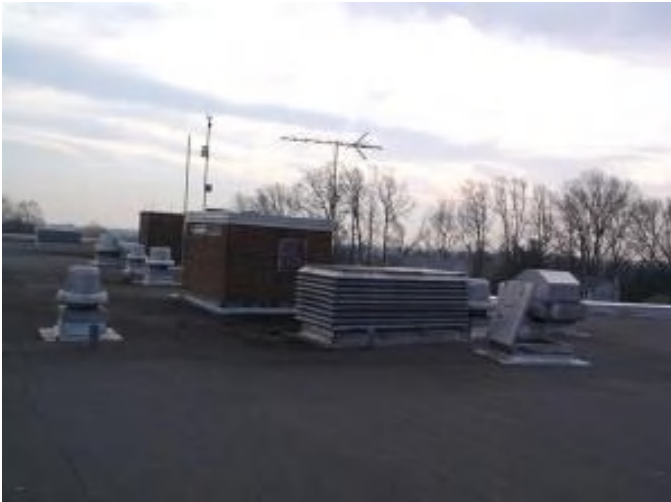
**Location:** Kitchen

**System: D3040 - Distribution Systems**

**Distress:** Energy Efficiency

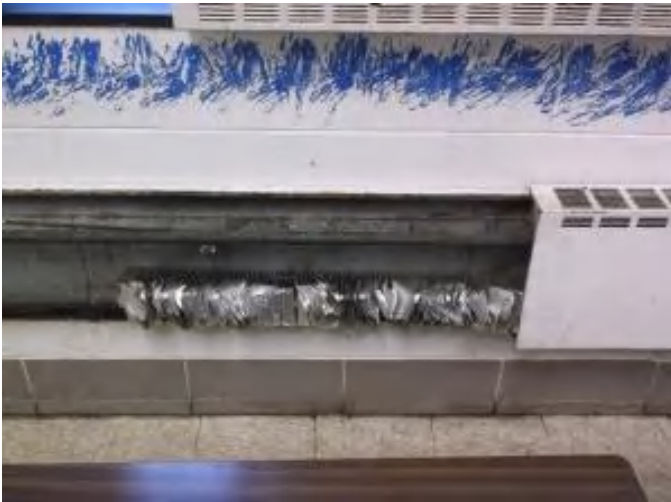
**Location:** Throughout Building

**System: D3040 - Distribution Systems**

**Distress:** Damaged

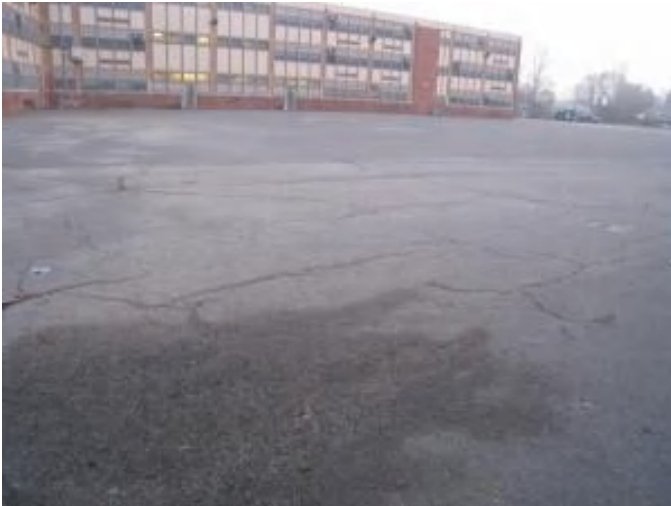
**Location:** playground and parking lots

#### System: G2020 - Parking Lots

**Distress:** Damaged

**Notes:** Crackfill and seal asphalt parking lot and play area (1,000ft cracks; 40,000sf seal)

**Correction:** Fill pavement cracks and reseal parking lot - including striping - change the LF of crack repair if it is severe

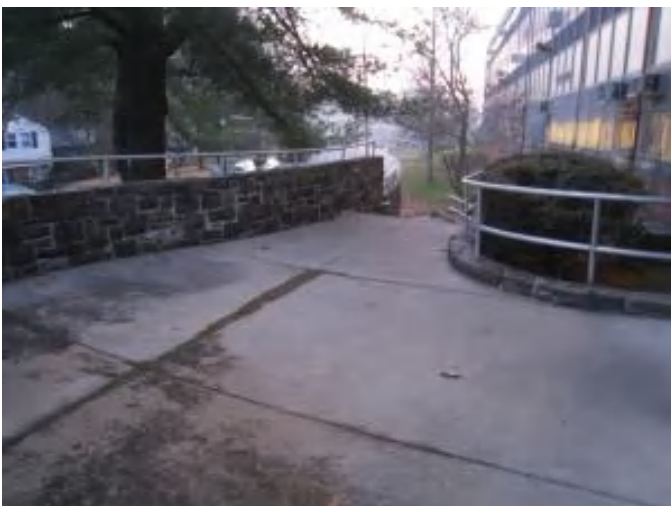
**Location:** sidewalk

#### System: G2030 - Pedestrian Paving

**Distress:** Damaged

**Notes:** Repave broken sidewalk around building (2,000sf)

**Correction:** Remove and replace concrete sidewalk or concrete paving - 4" concrete thickness

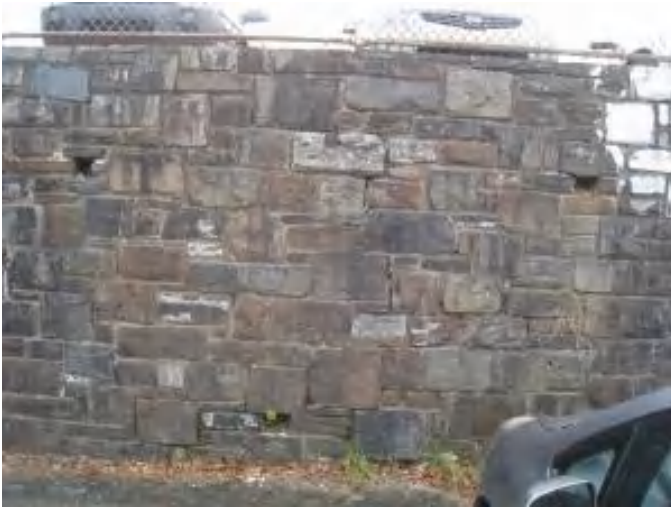
**Location:** parking lot retaining wall

**System: G2040 - Site Development**

**Distress:** Failing

**Correction:** Repair and regrout stone retaining wall - LF of wall - up to 4' tall

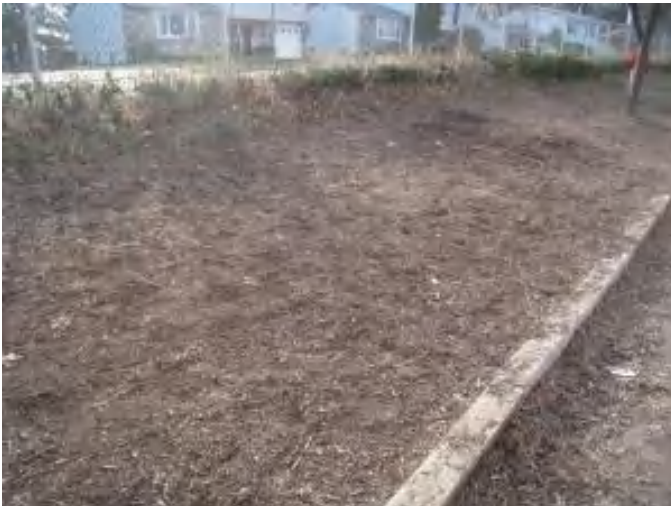
**Location:** playground

**System: G2050 - Landscaping & Irrigation**

**Distress:** Damaged

**Correction:** Replace landscape beds - including irrigation - small areas

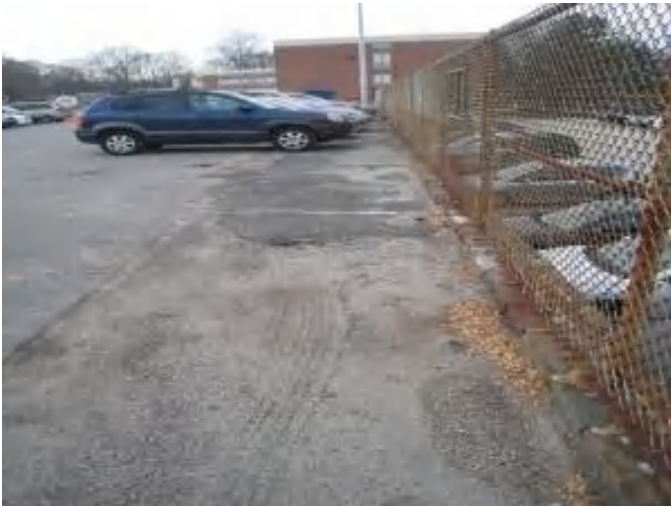
**Location:** parking lots - upper and lower

**System: G2020 - Parking Lots**

**Distress:** Failing
