## Facility Condition Assessment Summary Report

### Hancock School

School District of Philadelphia  
**S818001;Hancock**  
Final  
**Site Assessment Report**  
January 31, 2017

School District of Philadelphia  
**S832001;LaBrum**  
Final  
**Site Assessment Report**  
January 31, 2017

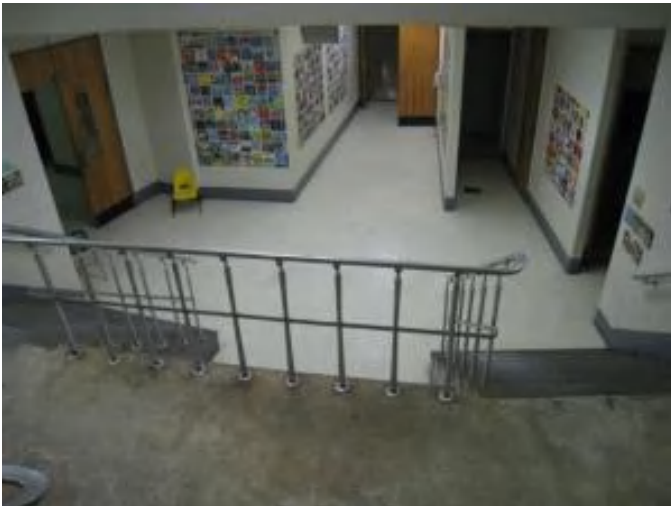
**Location:** main lobby stairs

#### System: C2010 - Stair Construction

**Distress:** Life Safety / NFPA / PFD

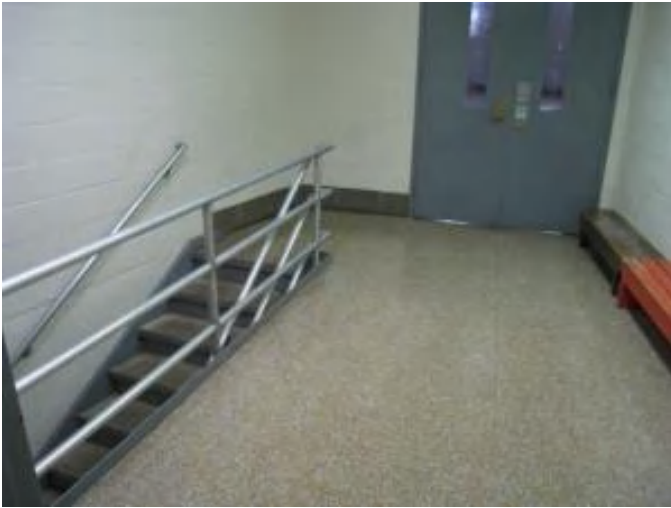
**Location:** stairways

**System: C2010 - Stair Construction**

**Distress:** Life Safety / NFPA / PFD

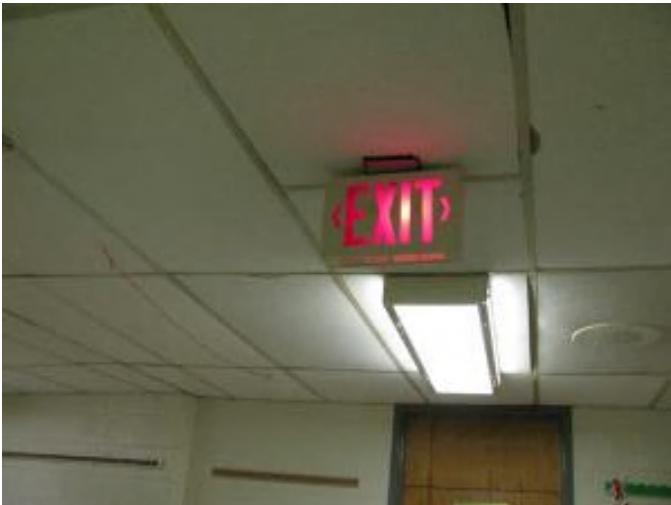
**Location:** Entire Building

**System: D5020 - Lighting and Branch Wiring**

**Distress:** Life Safety / NFPA / PFD

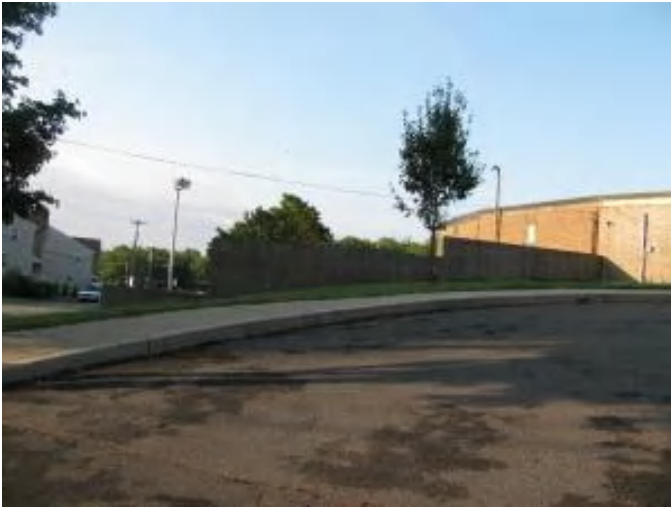
**Location:** Entire Building

**System: D5030 - Communications and Security**

**Distress:** Security Issue

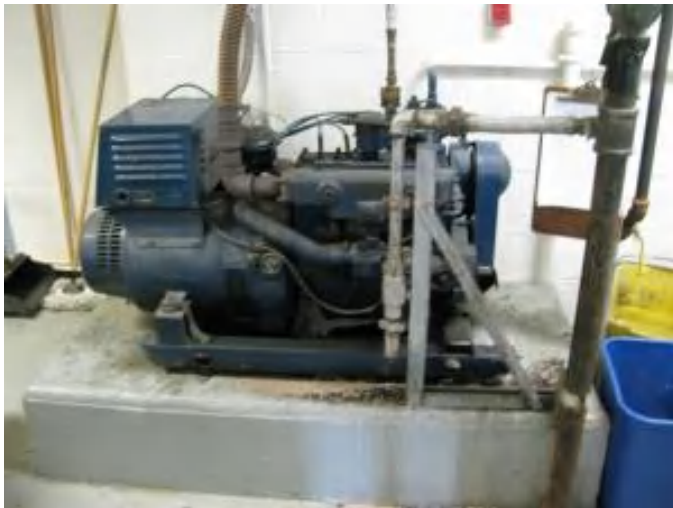
**Location:** Basement

**System: D5090 - Other Electrical Systems**

**Distress:** Beyond Service Life

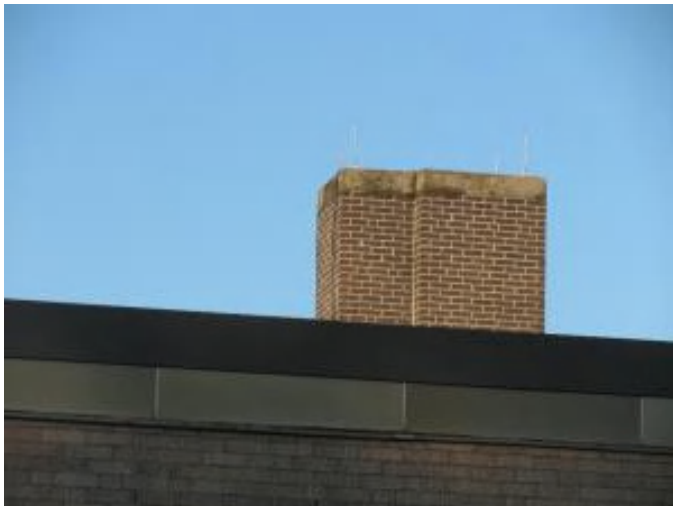
**Location:** Roof

**System: D5090 - Other Electrical Systems**

**Distress:** Life Safety / NFPA / PFD

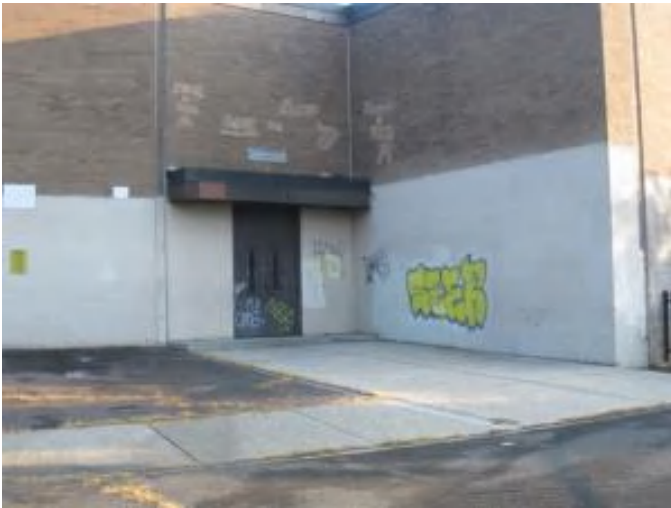
**Location:** exterior lower level wall (painted)

**System: B2010 - Exterior Walls**

**Distress:** Appearance

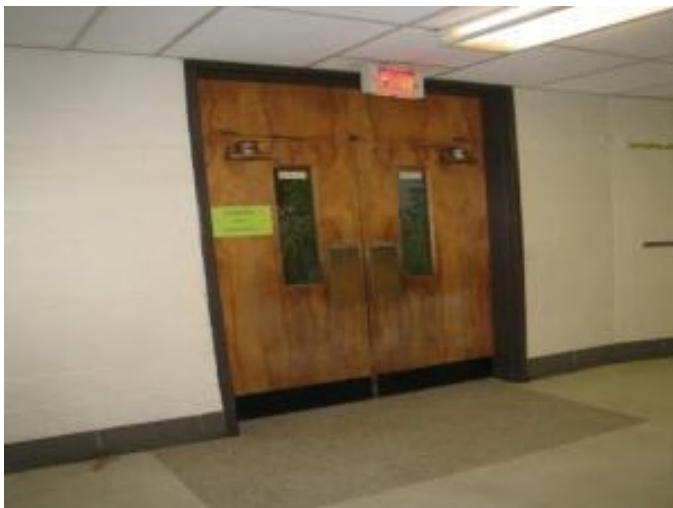
**Location:** interior doors

**System: C1020 - Interior Doors**

**Distress:** Beyond Service Life

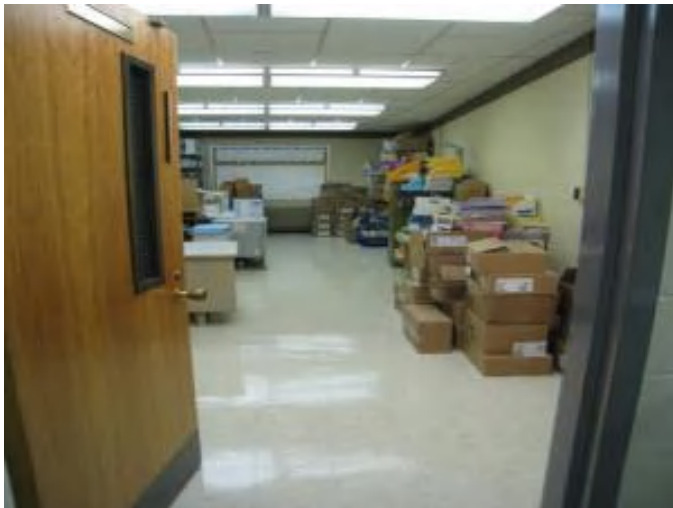
**Location:** interior doors

**System: C1020 - Interior Doors**

**Distress:** Building / MEP Codes

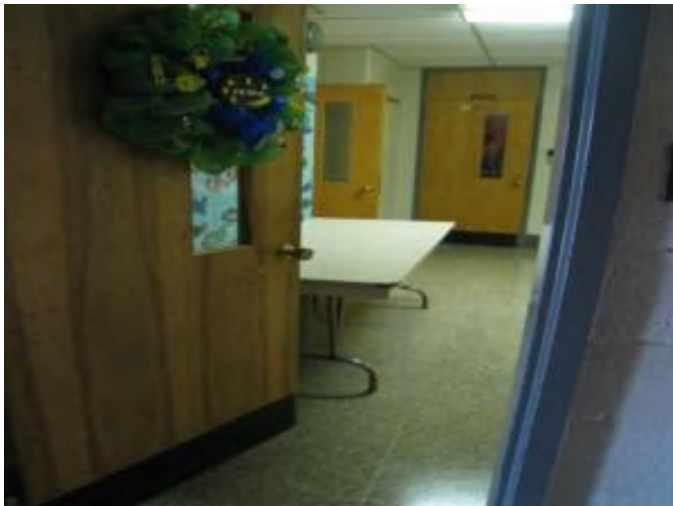
**Location:** classrooms and offices

**System: C1020 - Interior Doors**

**Distress:** Security Issue

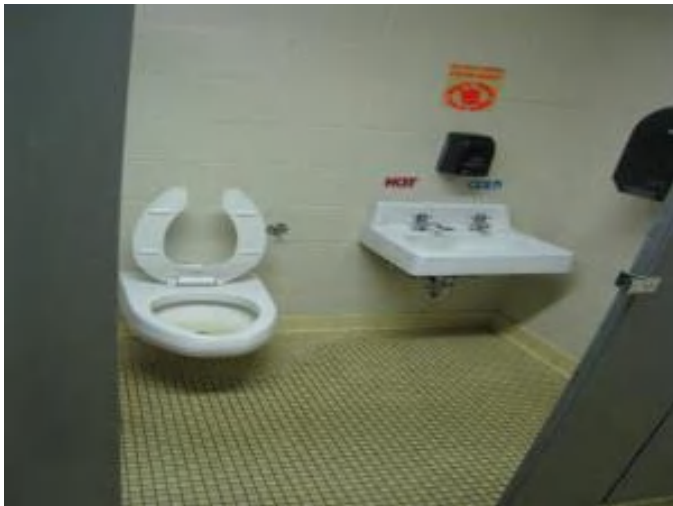
**Location:** toilet rooms

**System: C1030 - Fittings**

**Distress:** Accessibility

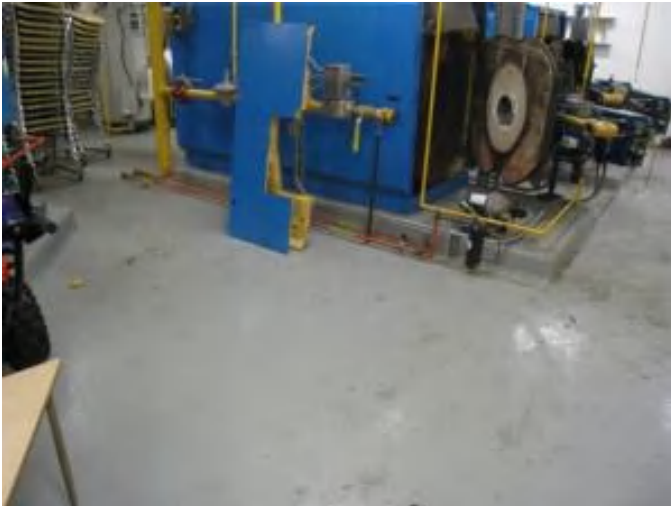
**Location:** mechanical areas

**System: C3020415 - Concrete Floor Finishes**

**Distress:** Appearance

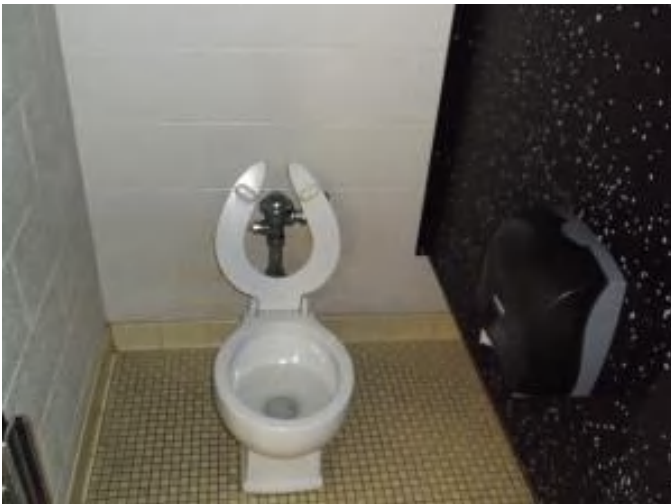
**Location:** Throughout the building

**System: D2010 - Plumbing Fixtures**

**Distress:** Beyond Service Life

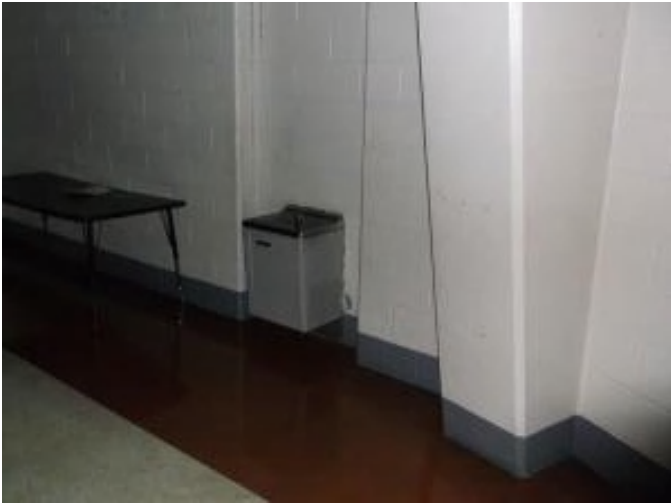
**Location:** Throughout the building

**System: D2010 - Plumbing Fixtures**

**Distress:** Beyond Service Life

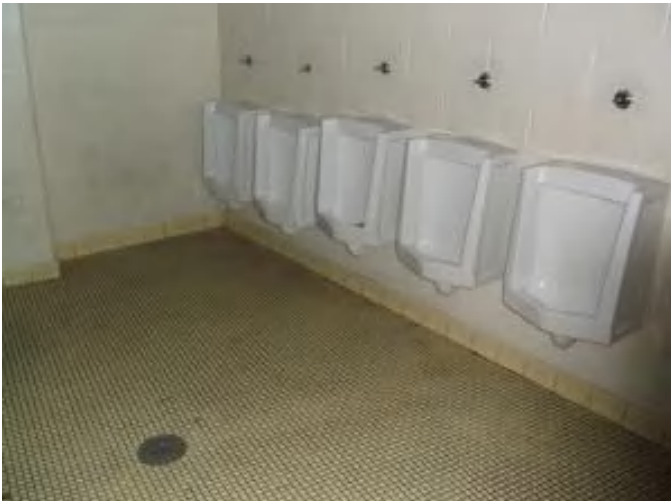
**Location:** Throughout the building

**System: D2010 - Plumbing Fixtures**

**Distress:** Beyond Service Life

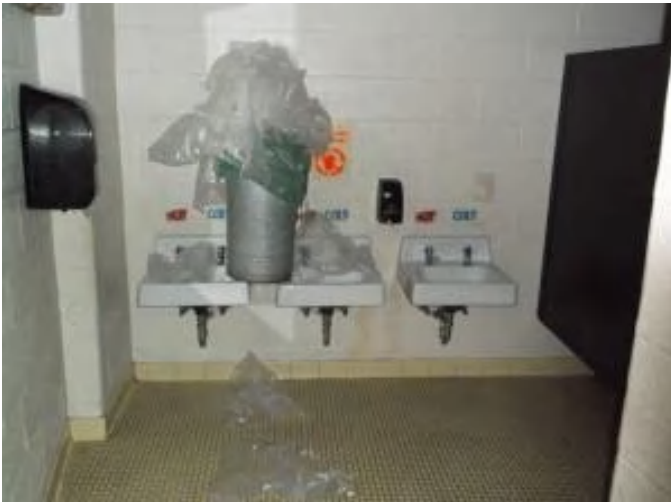
**Location:** Throughout the building

**System: D2010 - Plumbing Fixtures**

**Distress:** Beyond Service Life

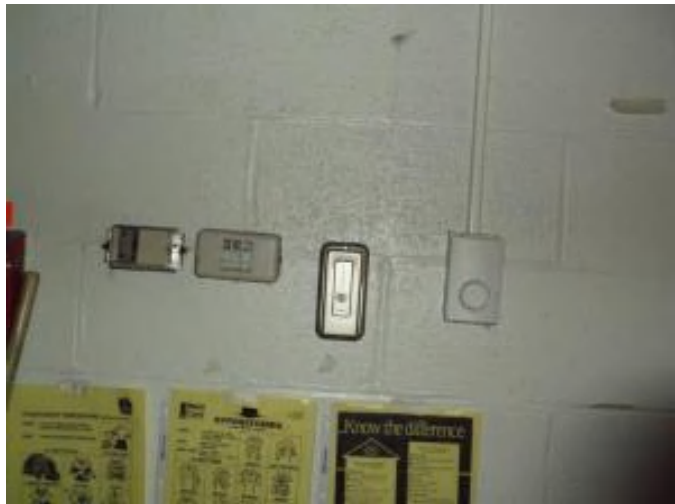
**Location:** Throughout the building

**System: D3060 - Controls & Instrumentation**

**Distress:** Beyond Service Life

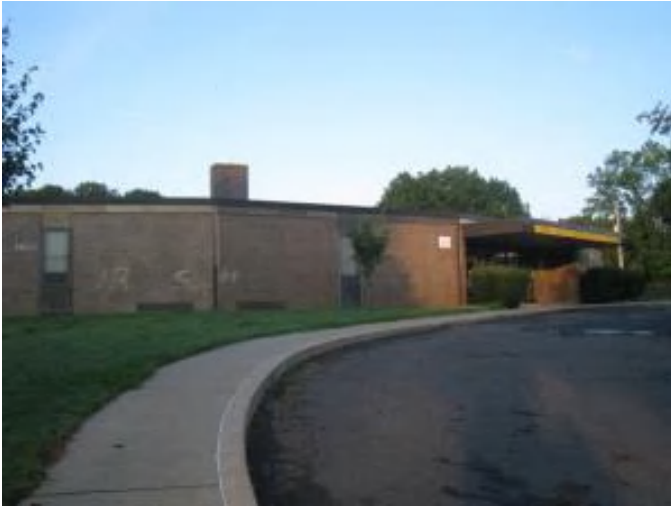
**Location:** exterior wall

**System: B2010 - Exterior Walls**

**Distress:** Appearance

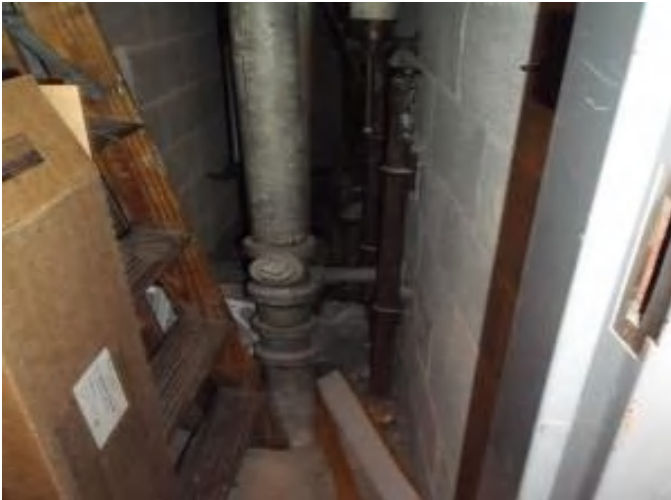
**Location:** Throughout the building

**System: D2030 - Sanitary Waste**

**Distress:** Beyond Service Life

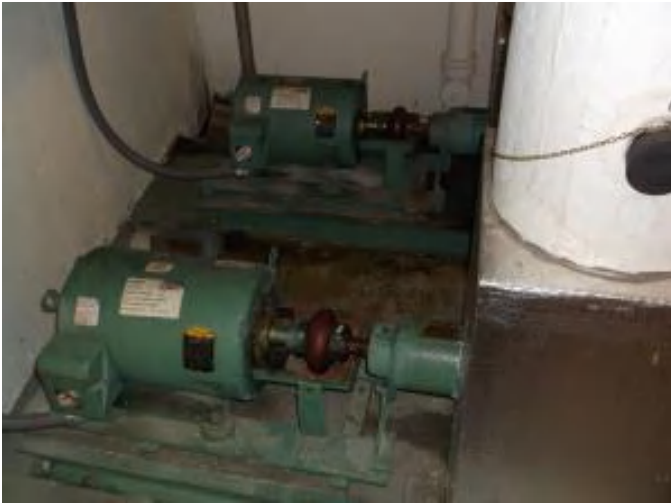
**Location:** Throughout the building

**System: D3040 - Distribution Systems**

**Distress:** Beyond Service Life

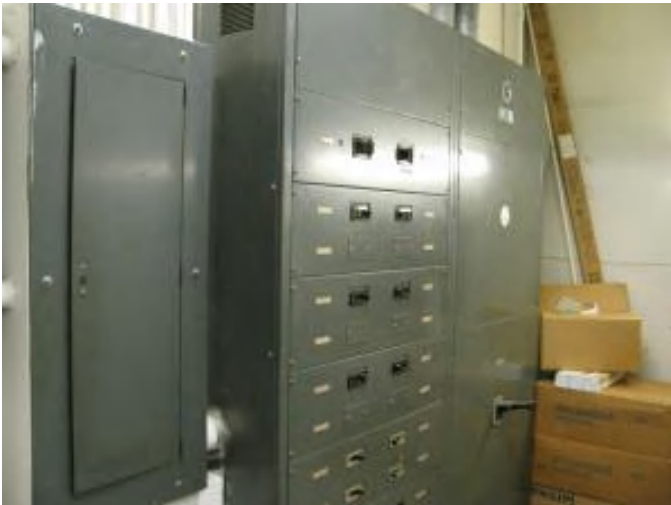
**Location:** Basement

**System: D5010 - Electrical Service/Distribution**

**Distress:** Beyond Service Life

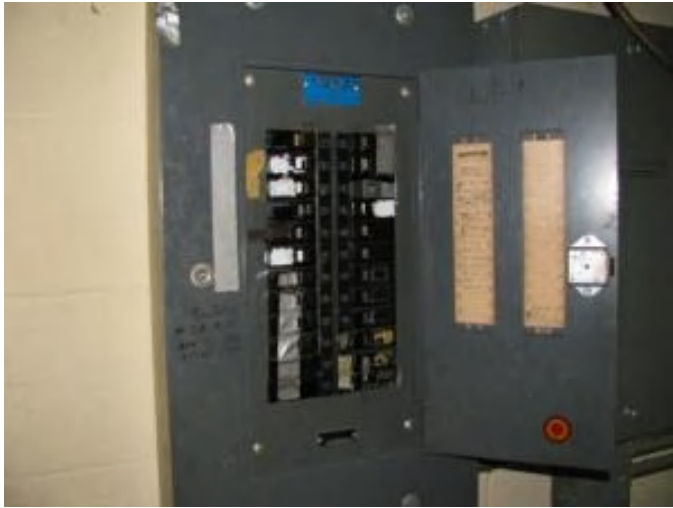
**Location:** Entire Building

**System: D5010 - Electrical Service/Distribution**

**Distress:** Beyond Service Life

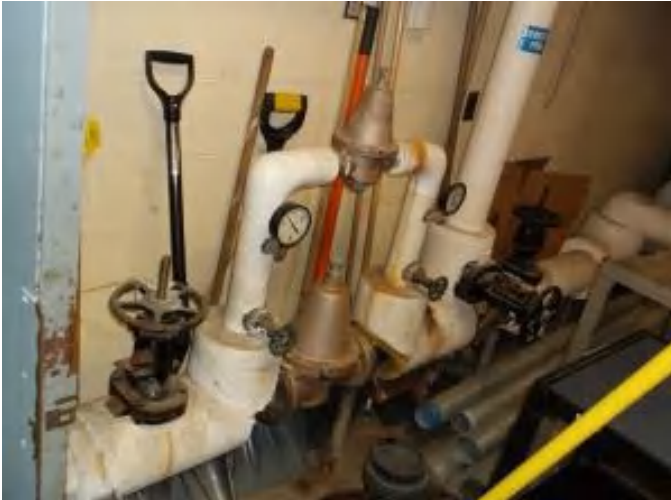
**Location:** Throughout the building

**System: D2020 - Domestic Water Distribution**

**Distress:** Beyond Service Life

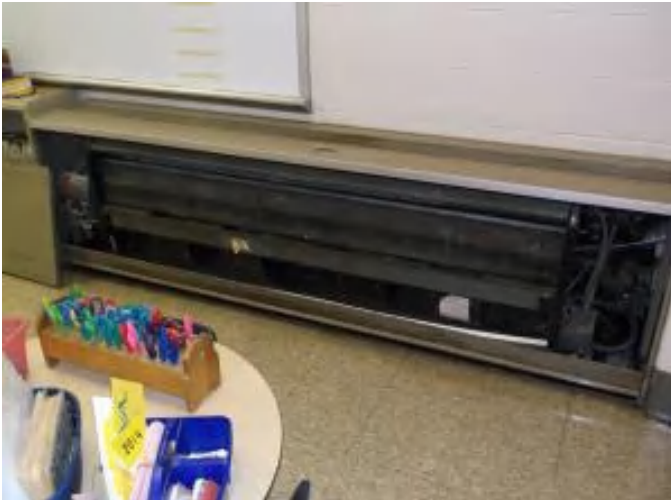
**Location:** Throughout the building

**System: D3040 - Distribution Systems**

**Distress:** Beyond Service Life

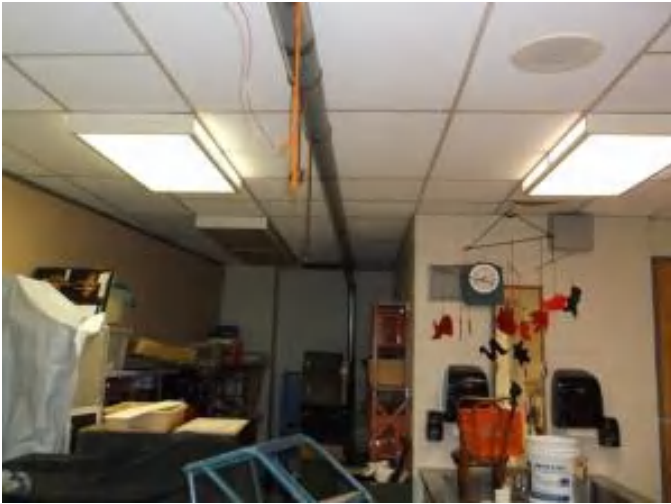
**Location:** Throughout the building

**System: D4010 - Sprinklers**

**Distress:** Life Safety / NFPA / PFD

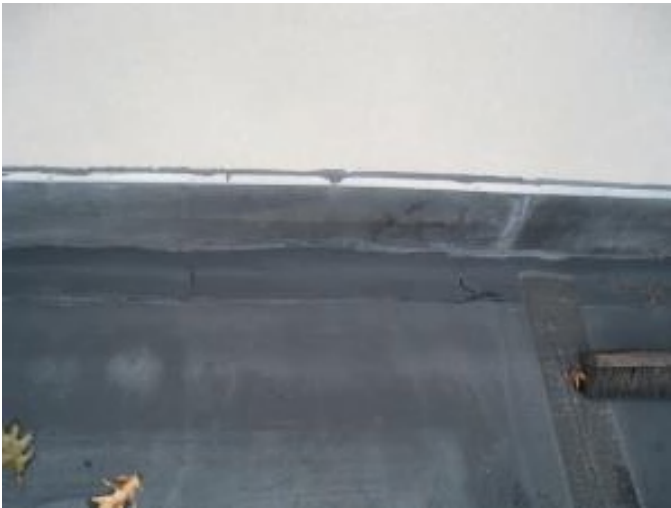
**Location:** Roof

**System: B3010120 - Single Ply Membrane**

**Distress:** Beyond Service Life

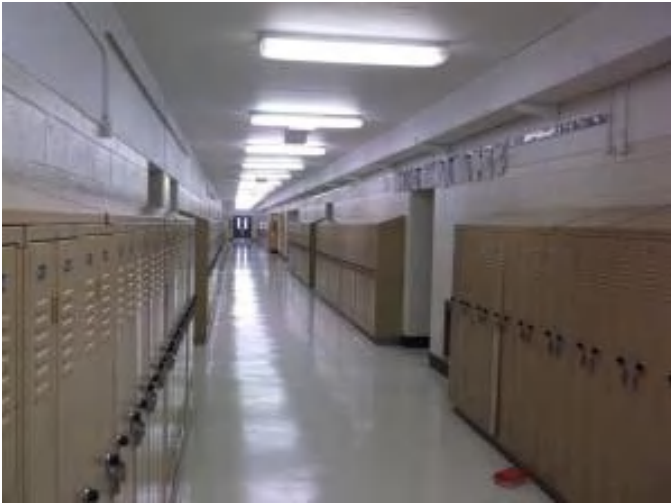
**Location:** Corridors

**System: D3040 - Distribution Systems**

**Distress:** Building / MEP Codes

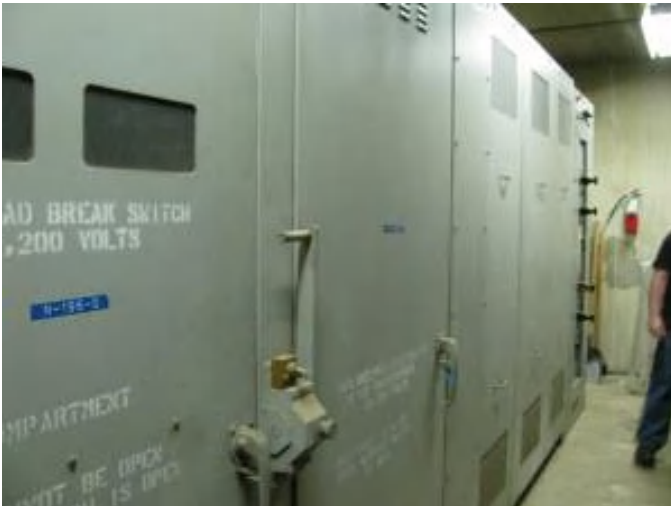
**Location:** Main Electrical Room

**System: D5010 - Electrical Service/Distribution**

**Distress:** Beyond Service Life

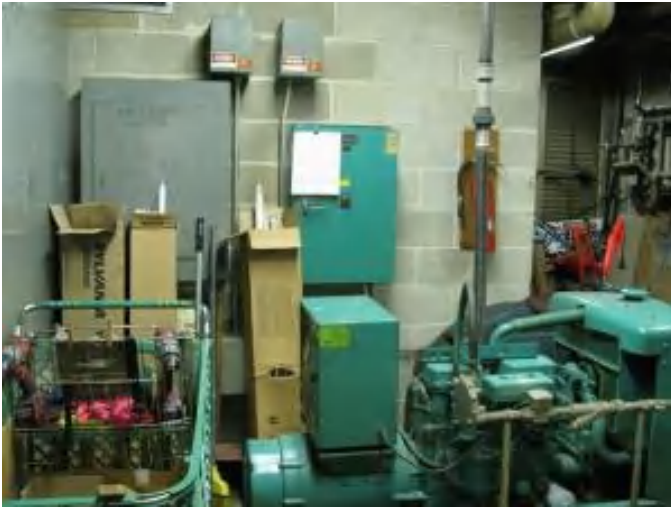
**Location:** Entire building

**System: D5010 - Electrical Service/Distribution**

**Distress:** Beyond Service Life

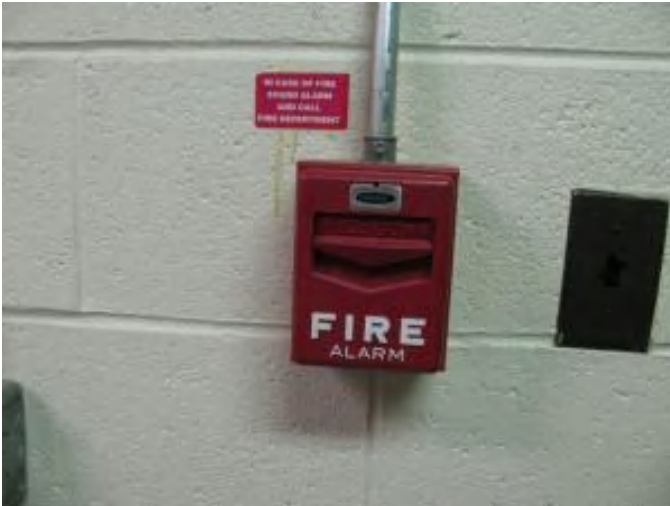
**Location:** Entire Building

**System: D5030 - Communications and Security**

**Distress:** Beyond Service Life

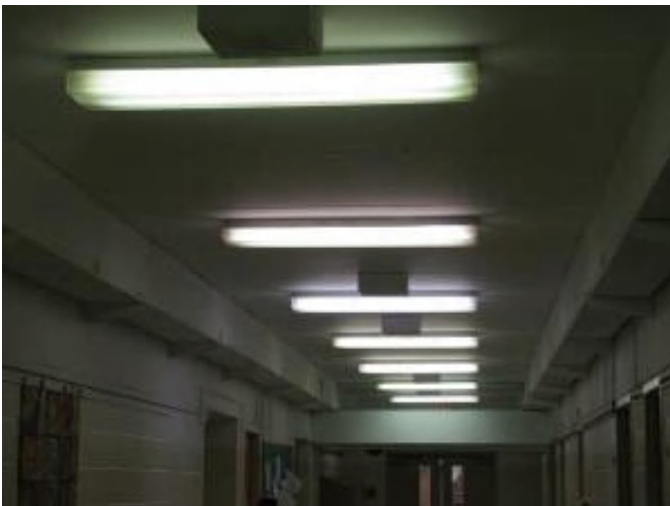
**Location:** Entire Building

**System: D5030 - Communications and Security**

**Distress:** Security Issue

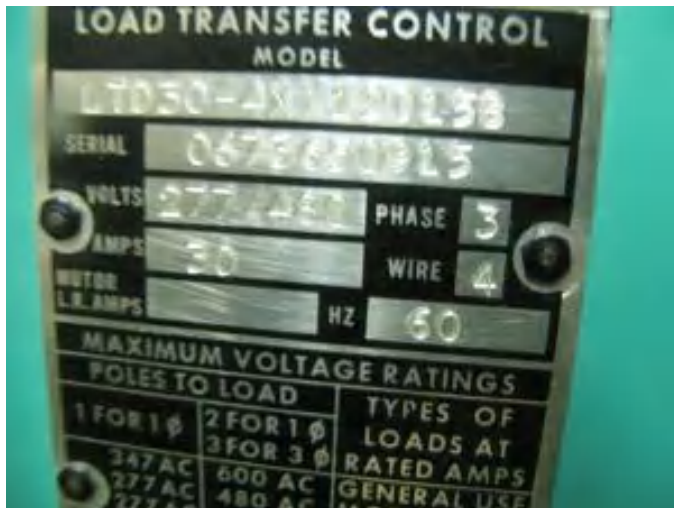
**Location:** Boiler Room

**System: D5090 - Other Electrical Systems**

**Distress:** Beyond Service Life

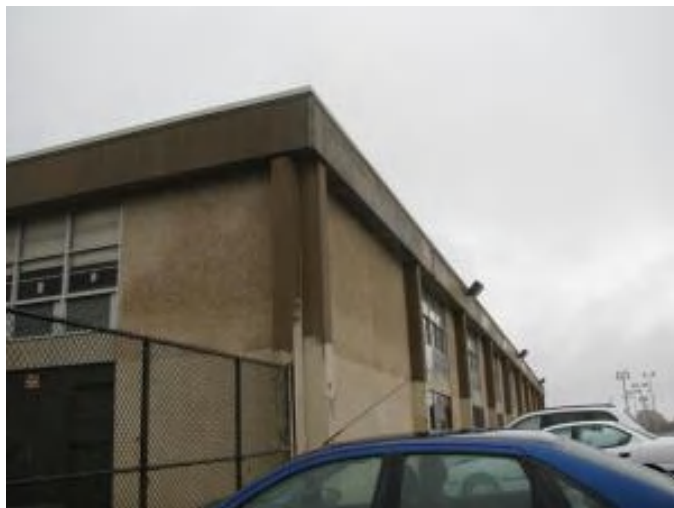
**Location:** Roof

**System: D5090 - Other Electrical Systems**

**Distress:** Life Safety / NFPA / PFD

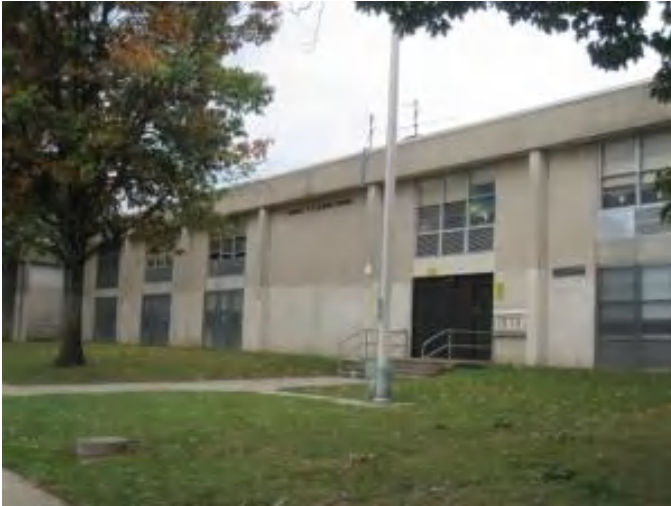
**Location:** Soffit

**System: B2010 - Exterior Walls**

**Distress:** Appearance

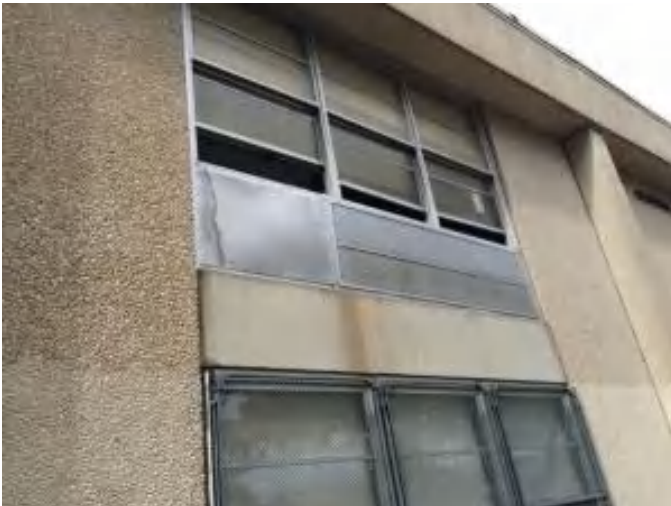
**Location:** All exterior windows

**System: B2020 - Exterior Windows**

**Distress:** Beyond Service Life

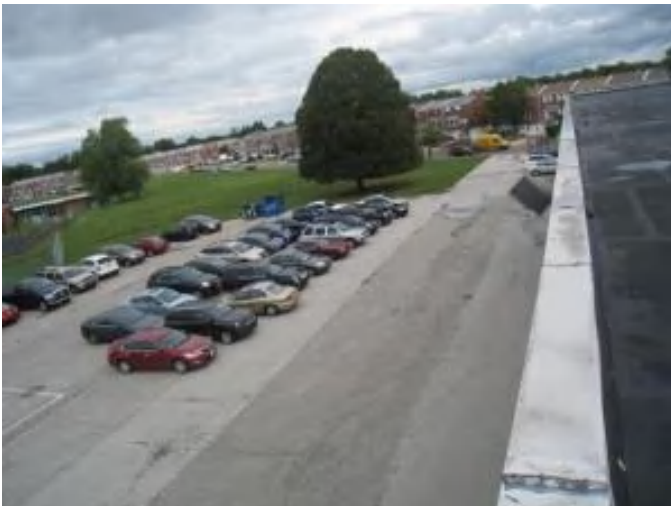
**Location:** Roof coping

**System: B3010120 - Single Ply Membrane**

**Distress:** Beyond Service Life

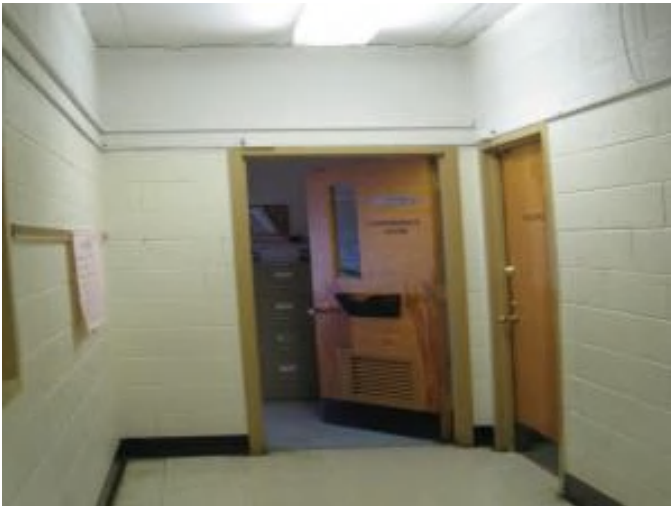
**Location:** Interior doors

**System: C1020 - Interior Doors**

**Distress:** Appearance

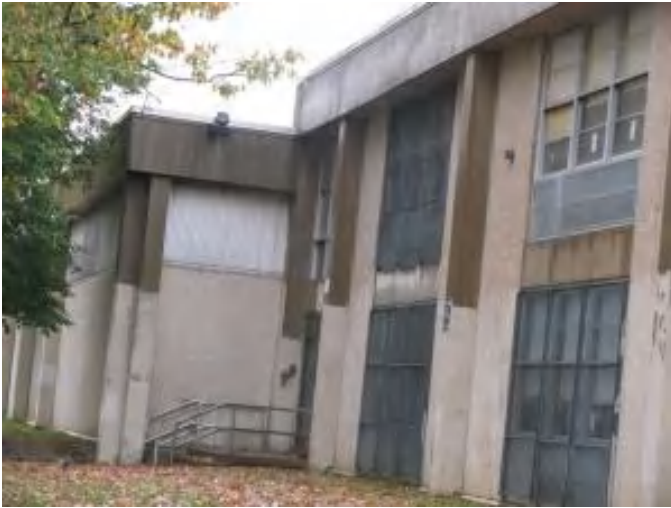
**Location:** first 10ft of exterior concrete panels

**System: C3010230 - Paint & Covering**

**Distress:** Appearance

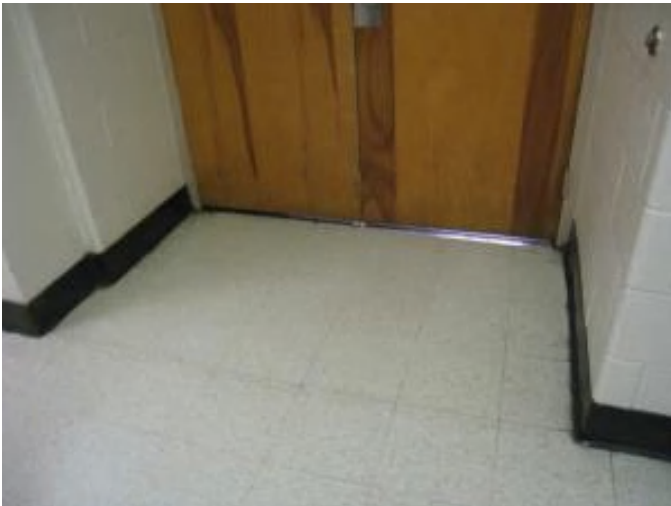
**Location:** Interior walls

**System: C3010230 - Paint & Covering**

**Distress:** Appearance

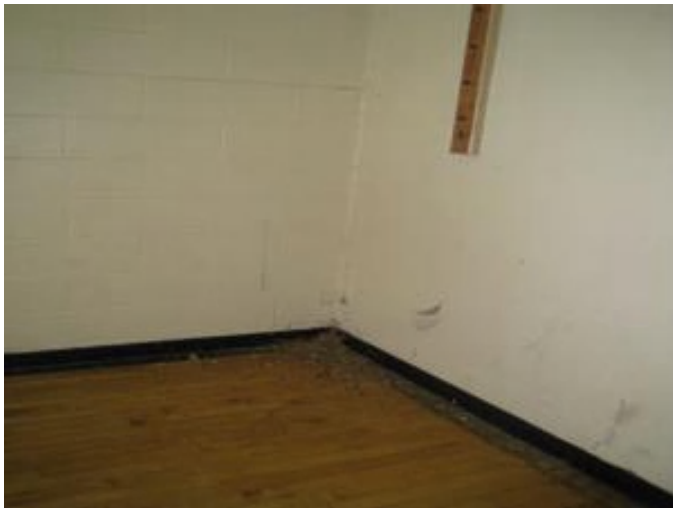
**Location:** Gymnasium

**System: C3020414 - Wood Flooring**

**Distress:** Appearance

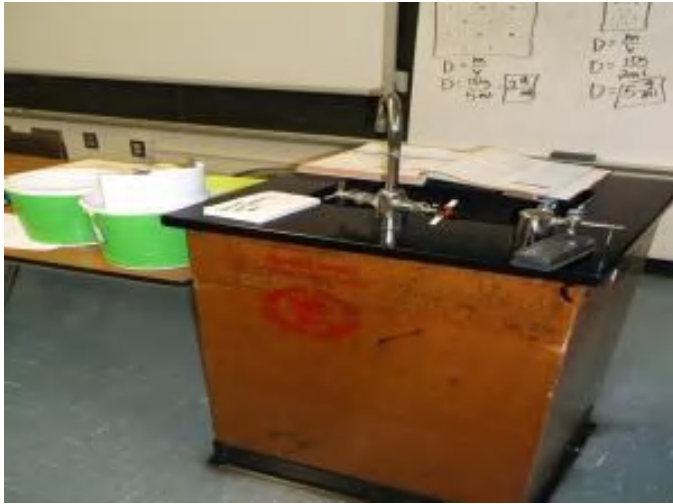
**Location:** Science

**System: E1020 - Institutional Equipment**

**Distress:** Beyond Service Life

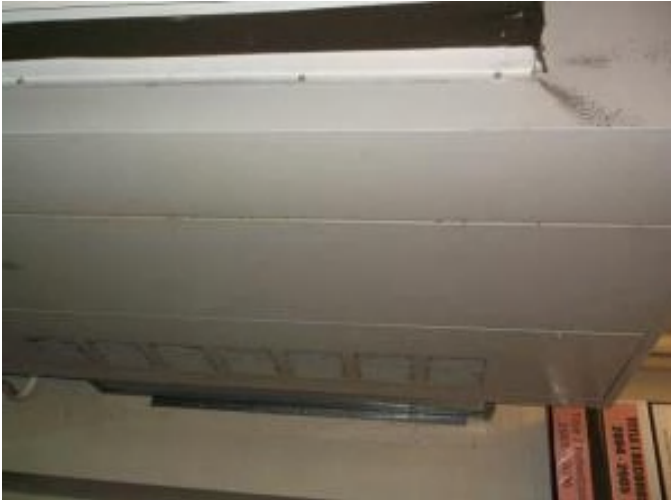
**Location:** Administration

**System: D3040 - Distribution Systems**

**Distress:** Beyond Service Life

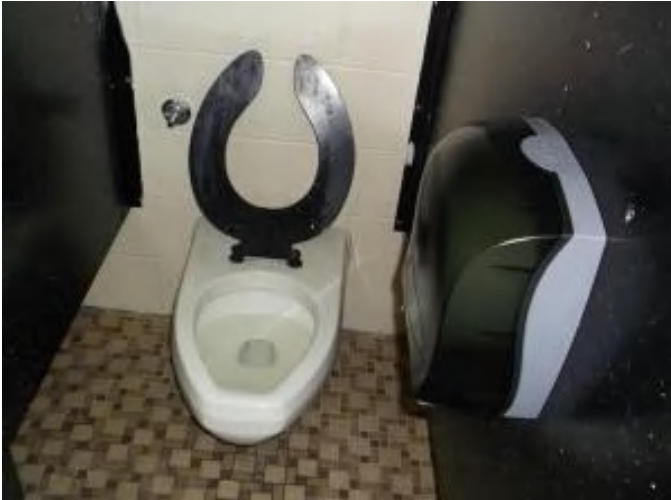
**Location:** Restrooms

**System: D2010 - Plumbing Fixtures**

**Distress:** Beyond Service Life

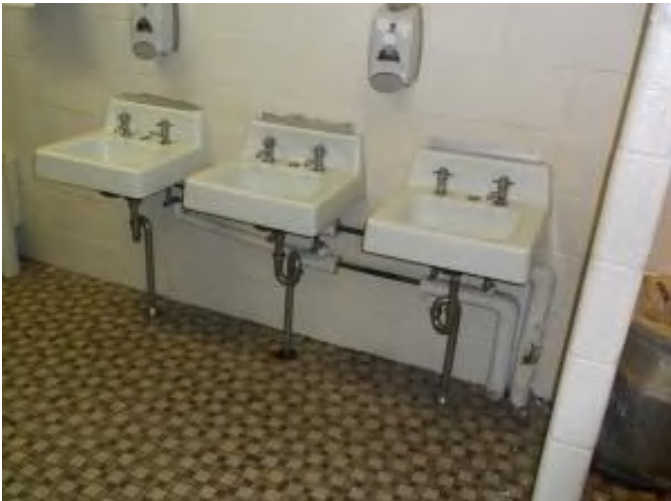
**Location:** Restrooms

**System: D2010 - Plumbing Fixtures**

**Distress:** Beyond Service Life

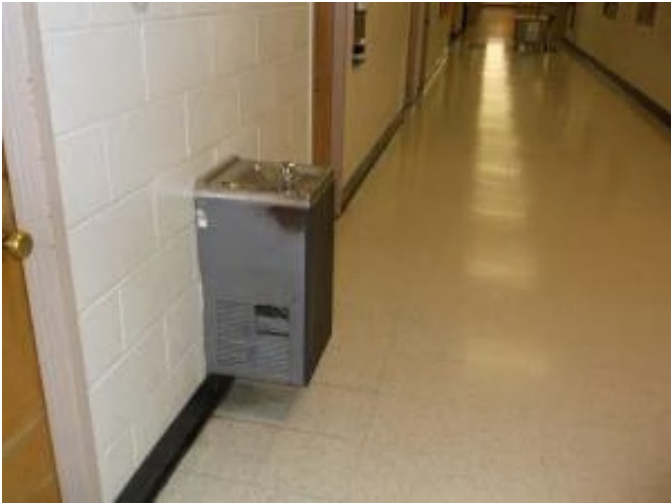
**Location:** Corridors

**System: D2010 - Plumbing Fixtures**

**Distress:** Accessibility

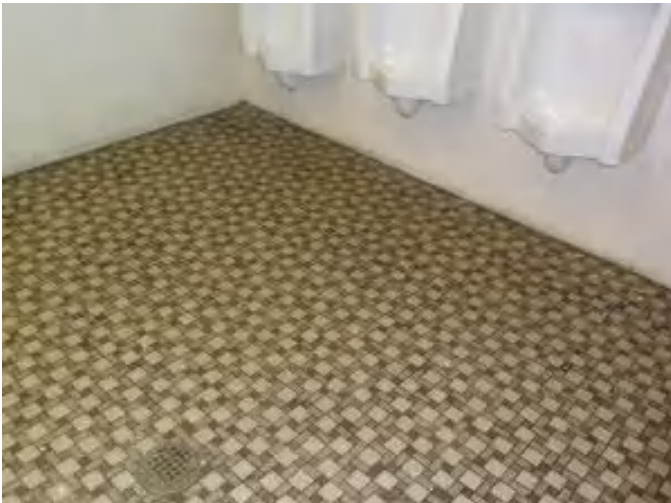
**Location:** Restrooms

**System: D2010 - Plumbing Fixtures**

**Distress:** Beyond Service Life

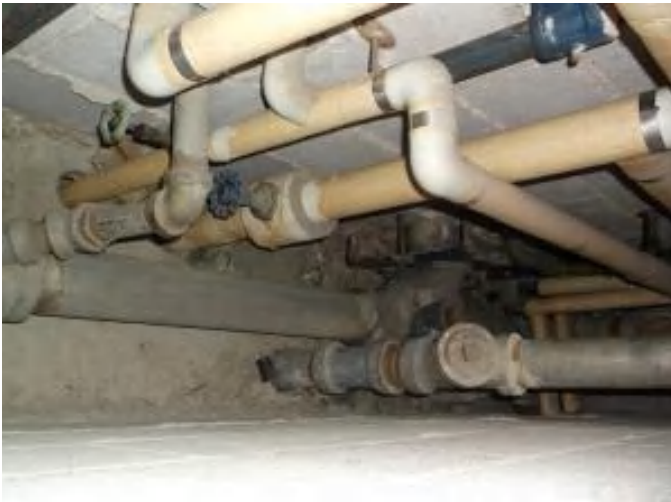
**Location:** Throughout Building

**System: D2020 - Domestic Water Distribution**

**Distress:** Beyond Service Life

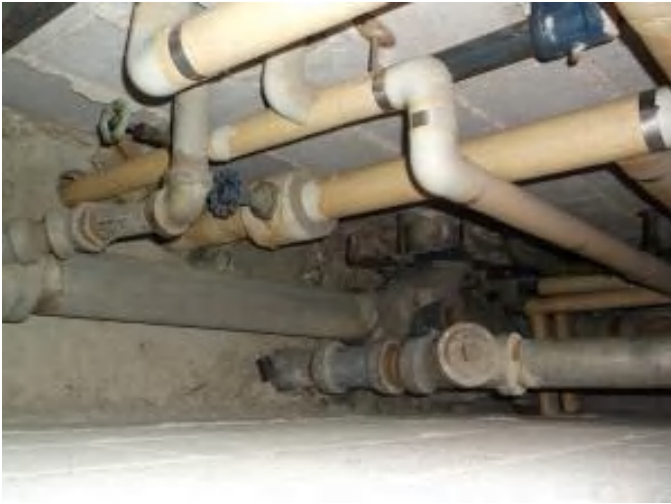
**Location:** Throughout Building

**System: D2030 - Sanitary Waste**

**Distress:** Beyond Service Life

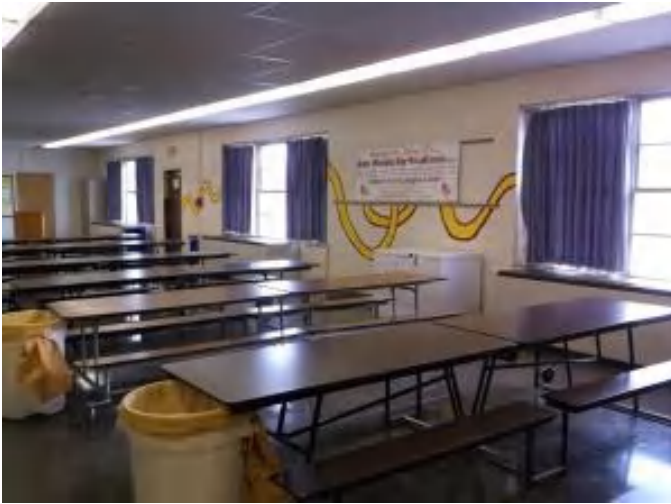
**Location:** Throughout Building

**System: D3040 - Distribution Systems**

**Distress:** Building / MEP Codes

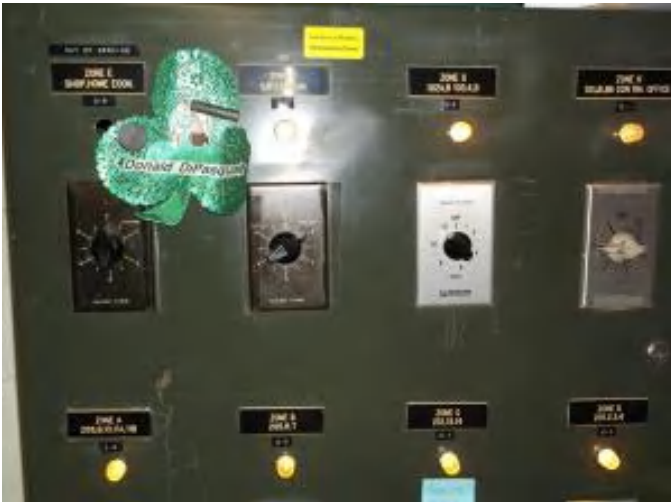
**System: D3060 - Controls & Instrumentation**

**Location:** Throughout Building

**Distress:** Energy Efficiency

**Correction:** Replace pneumatic controls with DDC (75KSF)

**Notes:** Replace the electric and electronic controls for the HVAC systems with modern DDC modules and actuators to improve reliability and energy efficiency. Provide a new building automation system (BAS) with communication interface to the preferred system in use throughout the District.

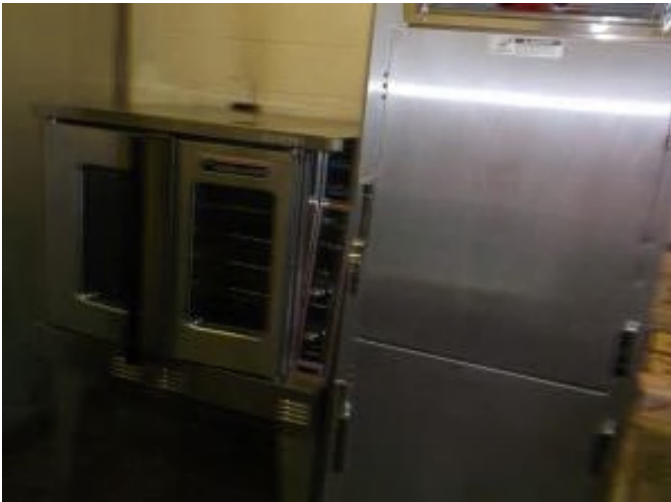
**System: E1090 - Other Equipment**

**Location:** Kitchen

**Distress:** Building / MEP Codes

**Correction:** Replace kitchen exhaust hood (10 ft)

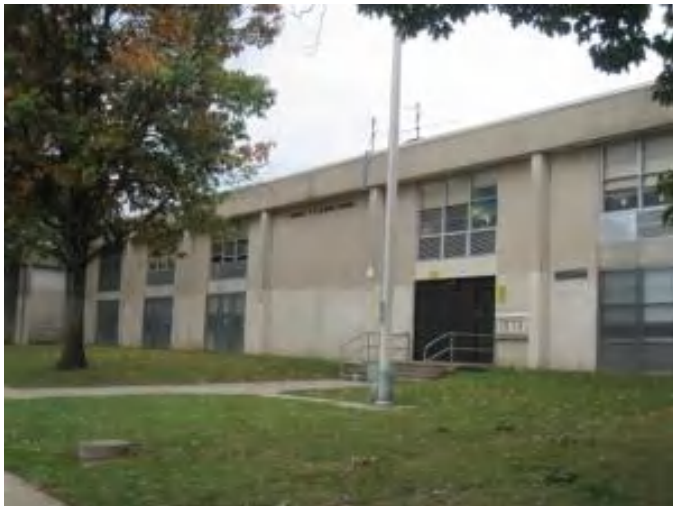
#### System: G2030 - Pedestrian Paving

**Location:** front entrance

**Distress:** Accessibility
