Facility Condition Assessment Summary Report

Hopkinson School

School District of Philadelphia

January 31, 2017

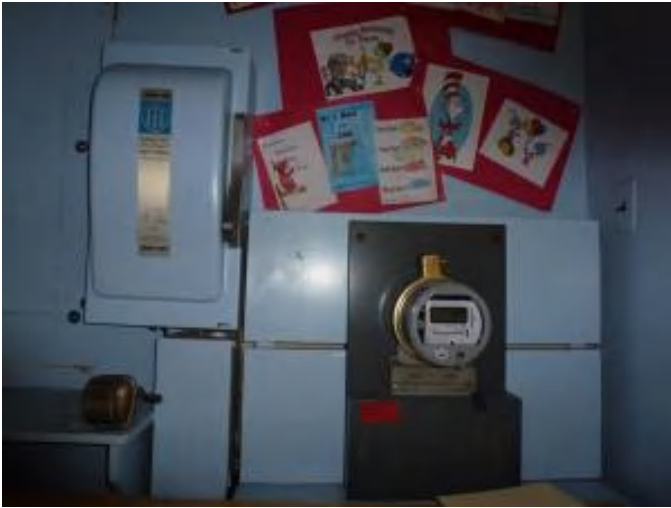
Location: main building - electrical room

System: D5010 - Electrical Service/Distribution

Distress: Beyond Service Life

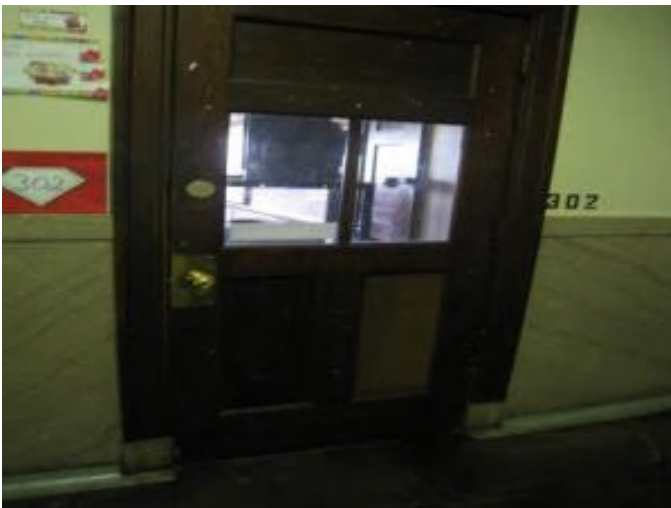
Location: main building - interior doors

System: C1020 - Interior Doors

Distress: Building / MEP Codes

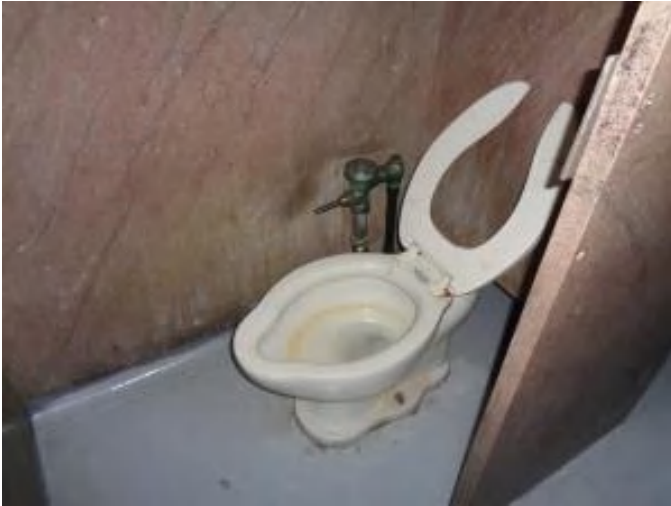
Location: main building - toilet rooms

System: D2010 - Plumbing Fixtures

Distress: Beyond Service Life

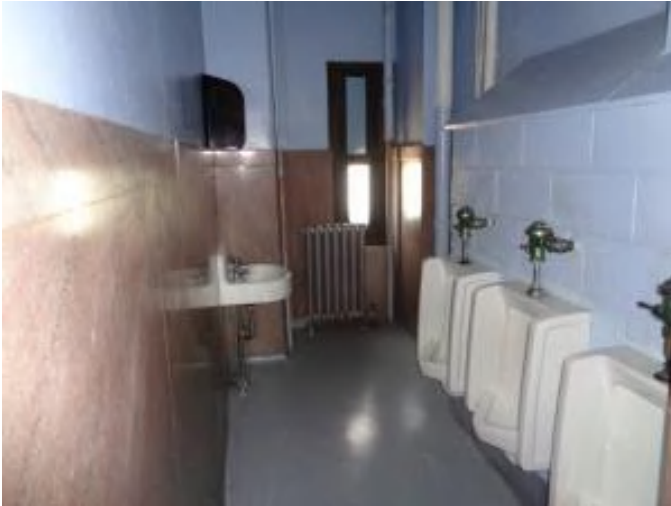
Location: main building - toilet rooms

System: D2010 - Plumbing Fixtures

Distress: Beyond Service Life

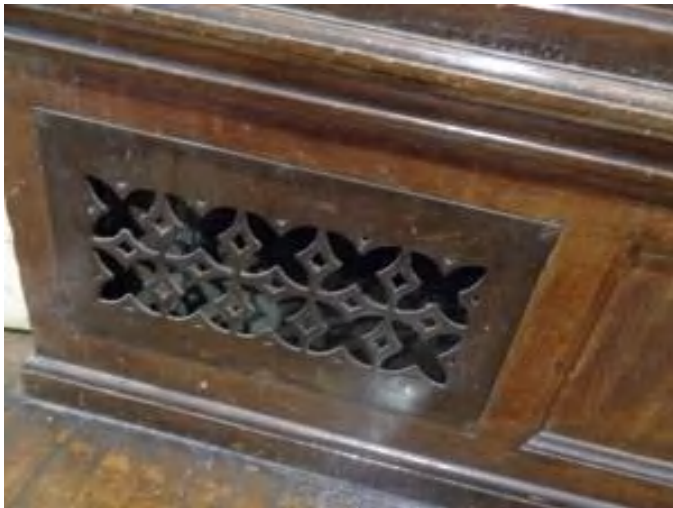
Location: main building - auditorium

System: D3040 - Distribution Systems

Distress: Beyond Service Life

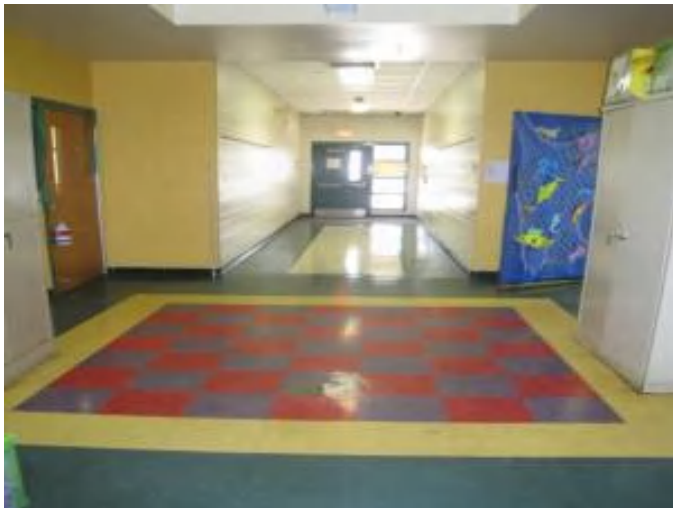
Location: LSH - classrooms and offices

System: C1020 - Interior Doors

Distress: Security Issue

Notes: Provide security hardware for classrooms and offices, locking from inside classroom/office

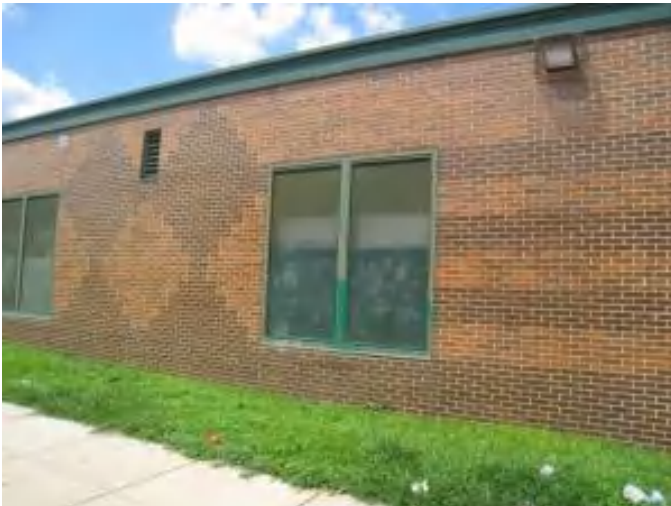
Location: LSH - exterior walls

System: B2020 - Exterior Windows

Distress: Appearance
