Facility Condition Assessment Summary Report

Solis-Cohen School

School District of Philadelphia
S834001;Solis-Cohen
Final
Site Assessment Report
January 31, 2017

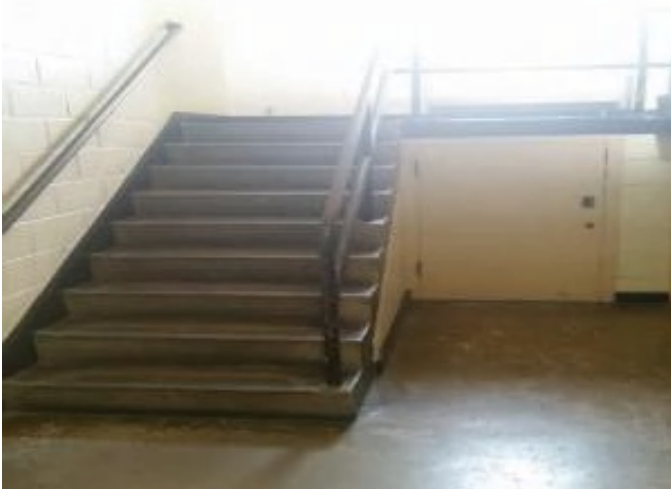
Location: interior stairways

System: C2010 - Stair Construction

Distress: Building / MEP Codes

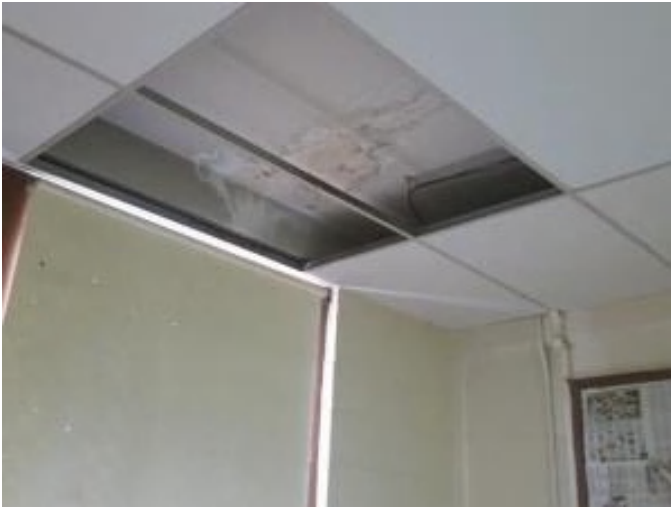
Location: all suspended 2x4 clgs

System: C3030 - Ceiling Finishes

Distress: Beyond Service Life

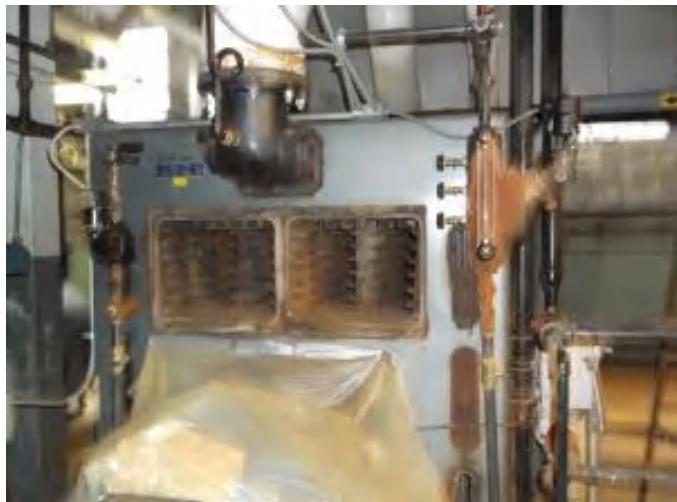
Location: Boiler Mechanical Equipment Room

System: D3020 - Heat Generating Systems

Distress: Beyond Service Life

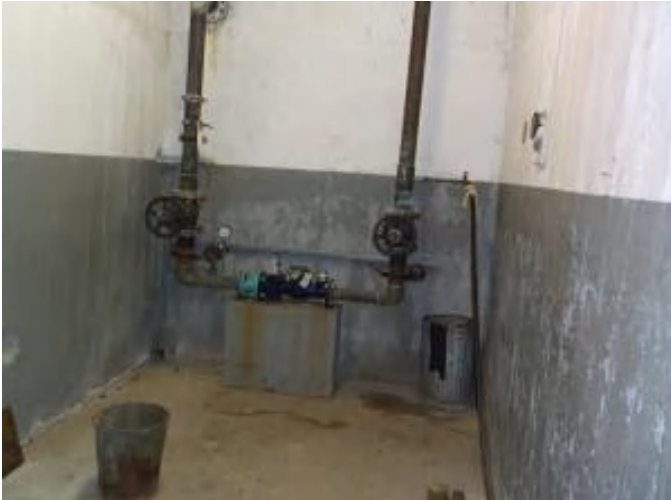
Location: Throughout the building

System: D2020 - Domestic Water Distribution

Distress: Beyond Service Life

Notes: Inspect and replace the original as needed the domestic water piping in the building

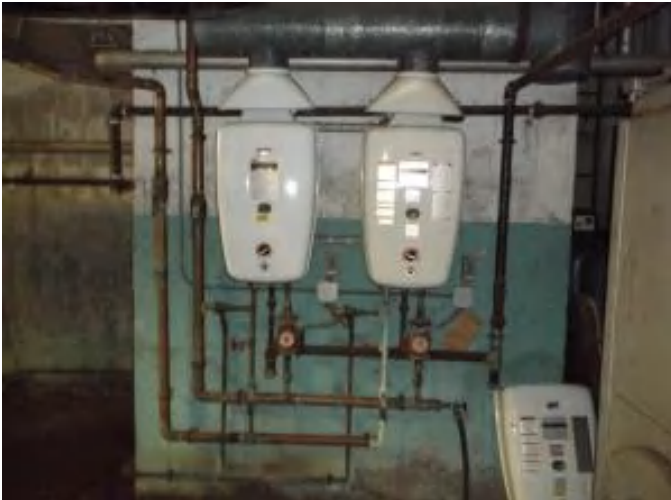
Location: Boiler Mechanical Equipment Room

System: D2020 - Domestic Water Distribution

Distress: Beyond Service Life

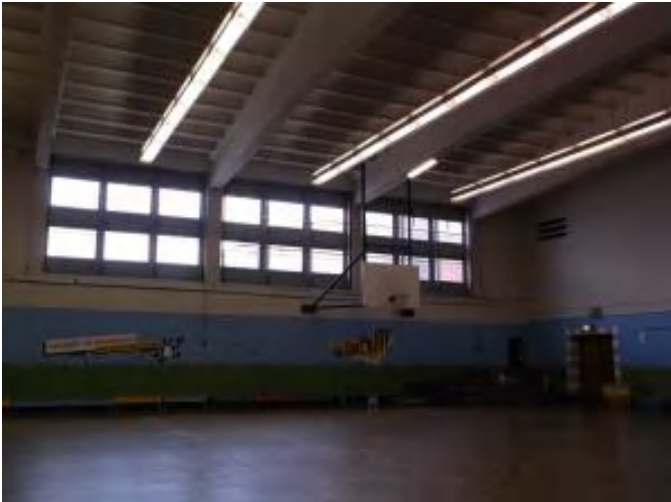
System: D3040 - Distribution Systems

Location: Gymnasium
Distress: Building / MEP Codes
Category: 2 - Code Compliance
Priority: 5 - Response Time (> 5 yrs)
Correction: Install HVAC unit for Gymnasium (single station).
Qty: 6,000.00
Unit of Measure: Ea.
Estimate: \$308,301.04
Assessor Name: System
Date Created: 09/21/2015

Notes: Provide ventilation, heating and cooling for the gymnasium by installing a packaged roof top unit.

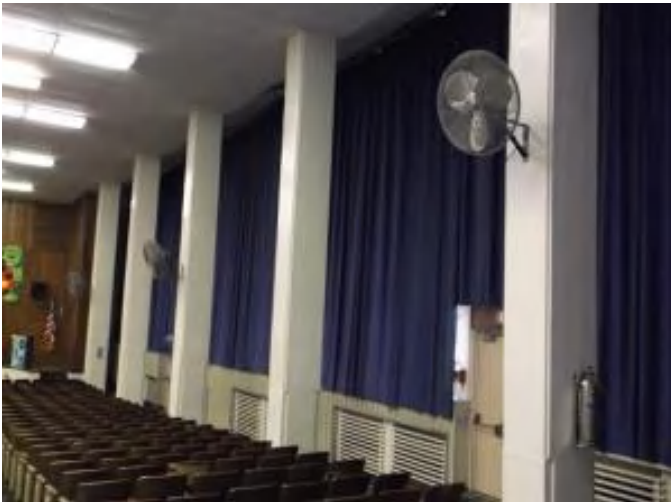
System: D3040 - Distribution Systems

Location: Auditorium
Distress: Building / MEP Codes
Category: 2 - Code Compliance
Priority: 5 - Response Time (> 5 yrs)
Correction: Install HVAC unit for Auditorium (200 seat).
Qty: 200.00
Unit of Measure: Seat
Estimate: \$285,085.41
Assessor Name: System
Date Created: 09/21/2015

Notes: Provide ventilation, heating and cooling for the Auditorium by removing the existing steam convectors and electric convection heaters and installing a package rooftop constant volume air handling unit with distribution ductwork and registers.

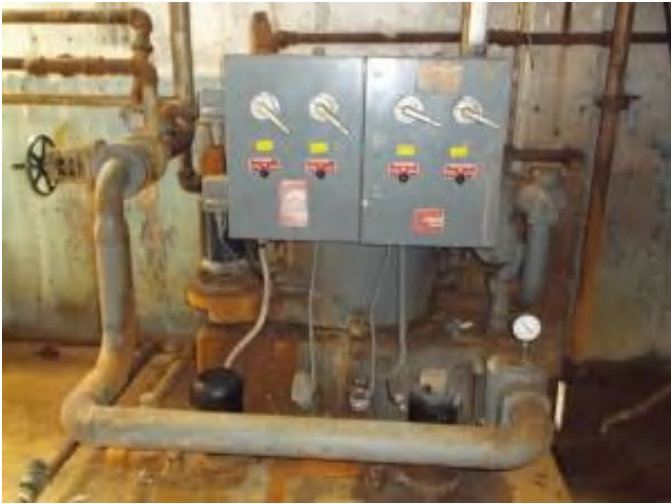
Location: Boiler Mechanical Equipment Room

System: D3040 - Distribution Systems

Distress: Beyond Service Life

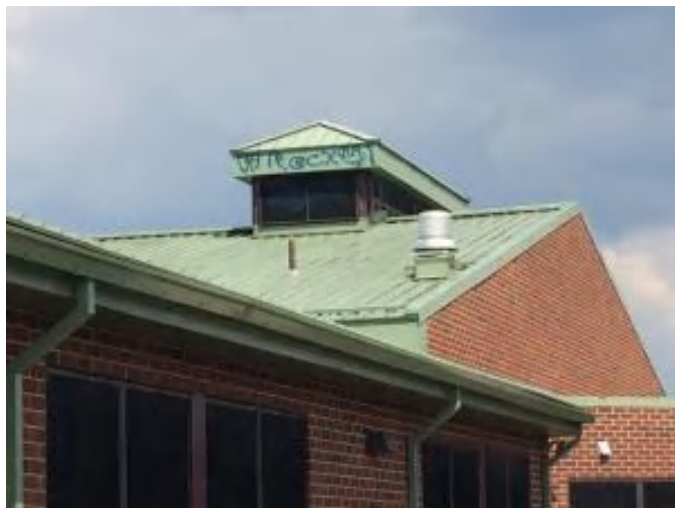
Location: PEC clerestory unit on roof

System: B2010 - Exterior Walls

Distress: Appearance
