Facility Condition Assessment Summary Report

Thomas School

School District of Philadelphia
S219001;Fell and Thomas
Final
Site Assessment Report
February 1, 2017

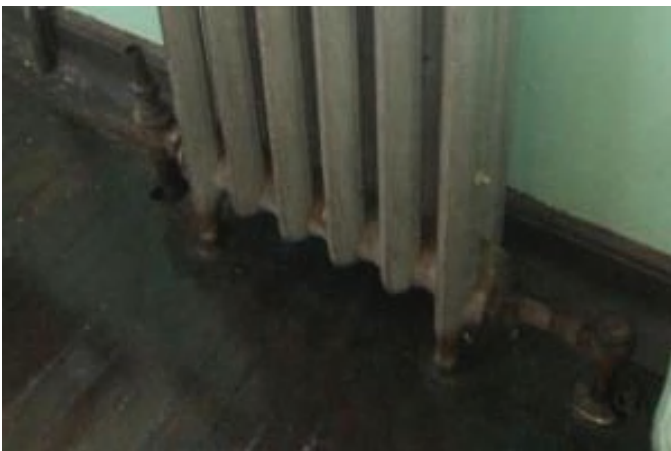
System: D3040 - Distribution Systems

Location: Entire building

Distress: Maintenance Required

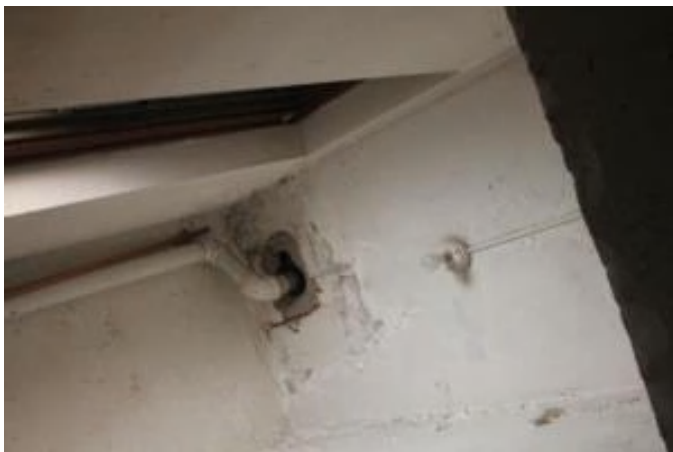
System: D2040 - Rain Water Drainage

Location: Entire building

Distress: Beyond Service Life

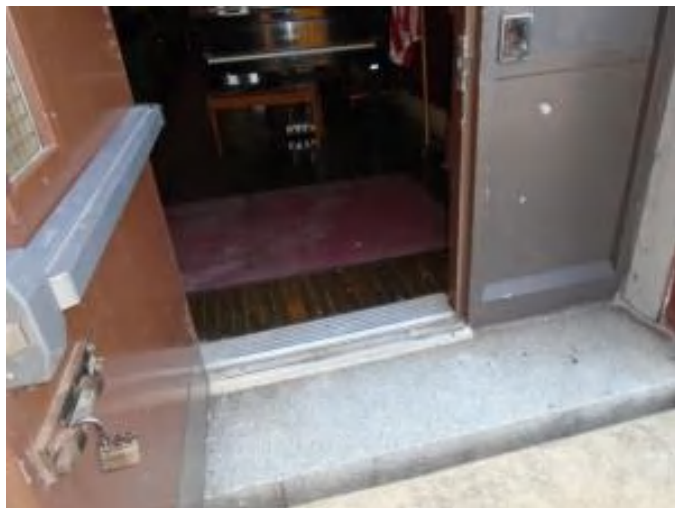
System: G2030 - Pedestrian Paving

Location: Auditorium Entrance

Distress: Accessibility

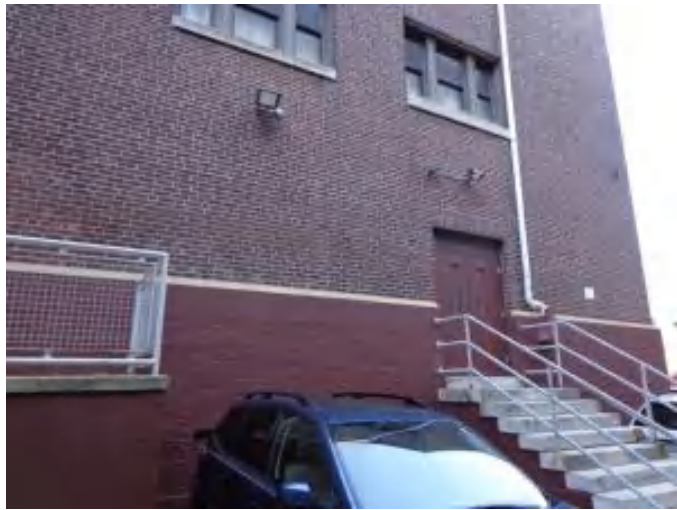
Location: Site exterior at Thomas

Distress: Beyond Service Life

Correction: Replace video surveillance camera

Notes: Provide an allowance for the replacement of 6 exterior video surveillance cameras.
