Facility Condition Assessment Summary Report

Washington, Martha School

S142001; Washington, Martha

Site Assessment Report

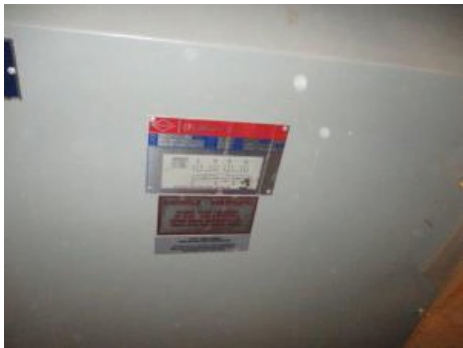
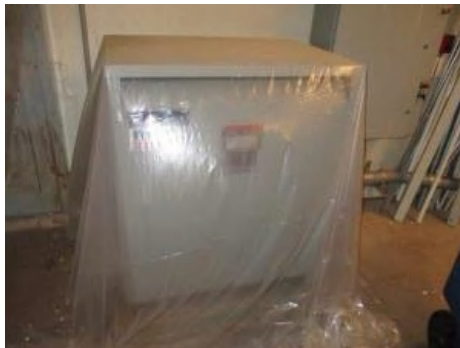
System: D5010 - Electrical Service/Distribution

Note: Phase converter 100KVA, manufactured by OLSUN

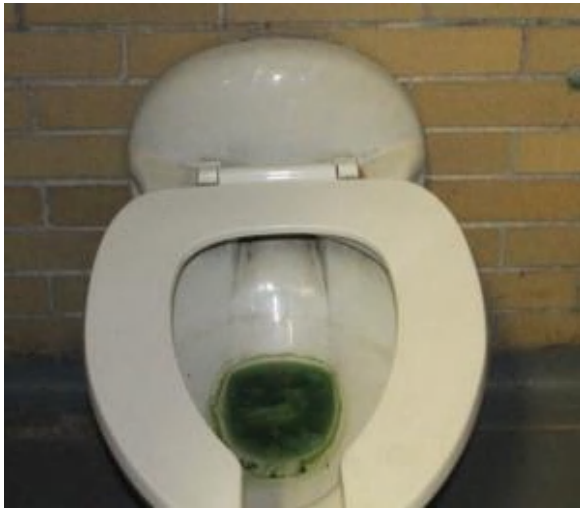
Location: Toilet rooms

Toilet room plumbing fixtures are a mixture of various ages and styles, including some original fixtures still in service and also modern low flow pieces as well. The basement boys' toilet still has floor level urinals. Fixtures are cracked, clogged, stained, out of service, etc. The district should budget to replace 50% of toilet room fixtures. The cafeteria kitchen area has a service sink for food service personnel use. There is an original all-in-one kitchenette with sink, range, and icebox in the 1955 addition. It has surpassed its useful

System: D2010 - Plumbing Fixtures

Distress: Beyond Service Life

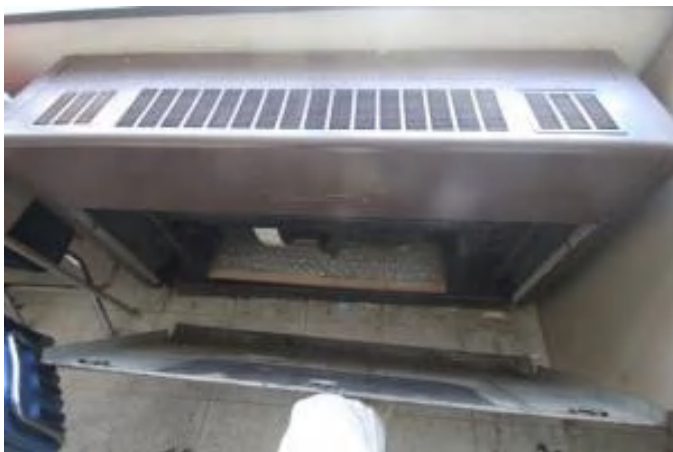
Location: Classroom addition

System: D3040 - Distribution Systems

Distress: Beyond Service Life
