## Facility Condition Assessment Summary Report

### Widener School

Final

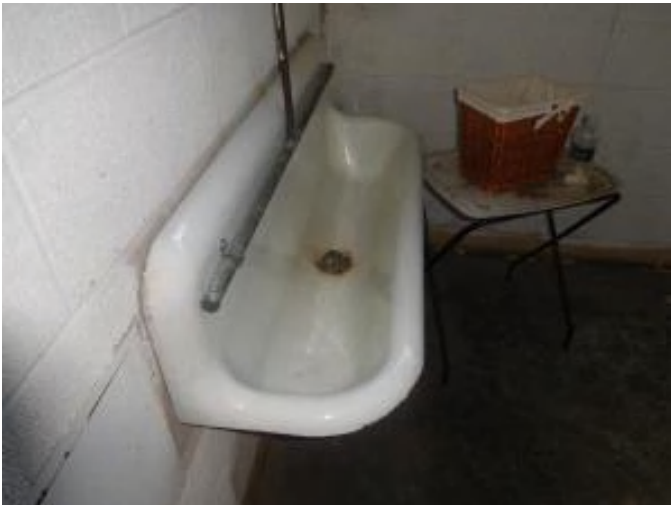
**Location:** toilet room

### **System: D2010 - Plumbing Fixtures**

**Distress:** Beyond Service Life

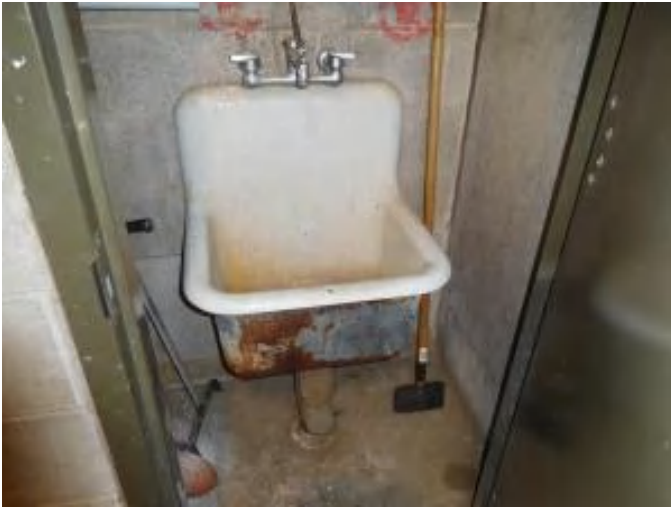
**Location:** entire building

**System: D2030 - Sanitary Waste**

**Distress:** Beyond Service Life

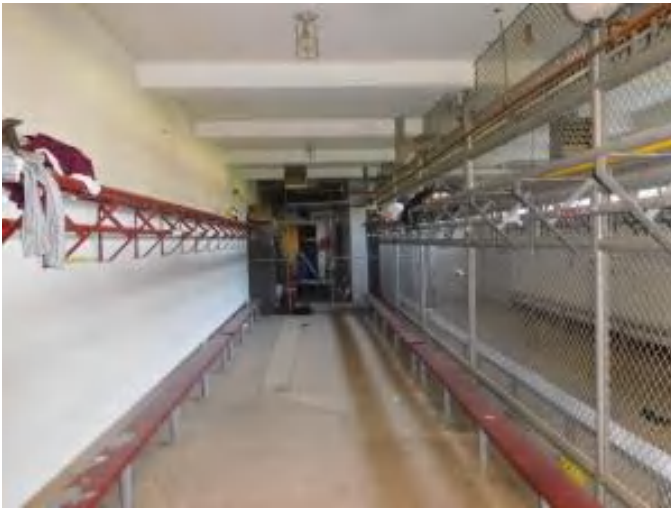
**Location:** entire building

**System: D4010 - Sprinklers**

**Distress:** Life Safety / NFPA / PFD

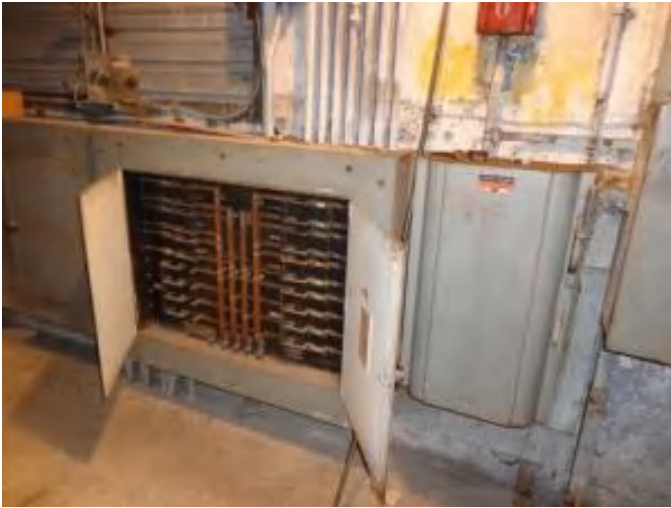
**Location:** Mechanical Room

**System: D5010 - Electrical Service/Distribution**

**Distress:** Beyond Service Life

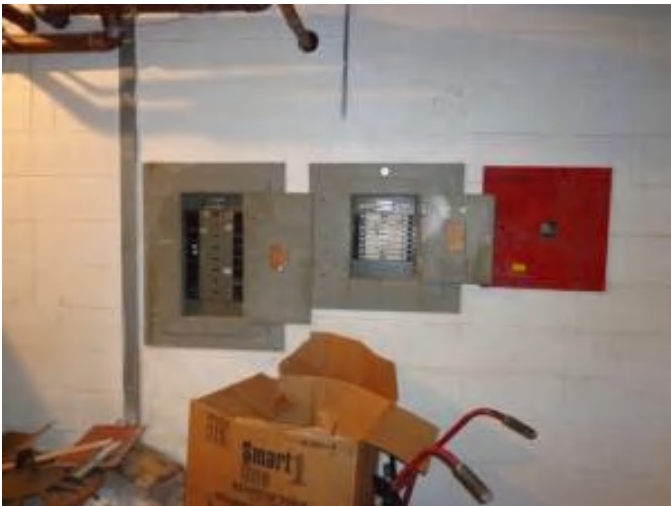
**Location:** Floors 1 and 2

There are four (4) flush mounted 100A panelboards in the field house that were also installed in the original 1956 construction project and need to be replaced, three (3) on the First Floor and one (1) on the Second Floor.

**System: D5010 - Electrical Service/Distribution**

**Distress:** Beyond Service Life

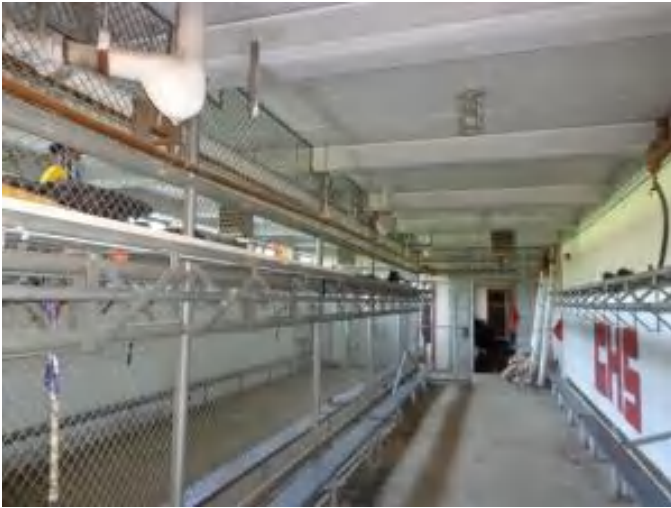
**Location:** Entire Building

**System: D5020 - Lighting and Branch Wiring**

**Distress:** Beyond Service Life

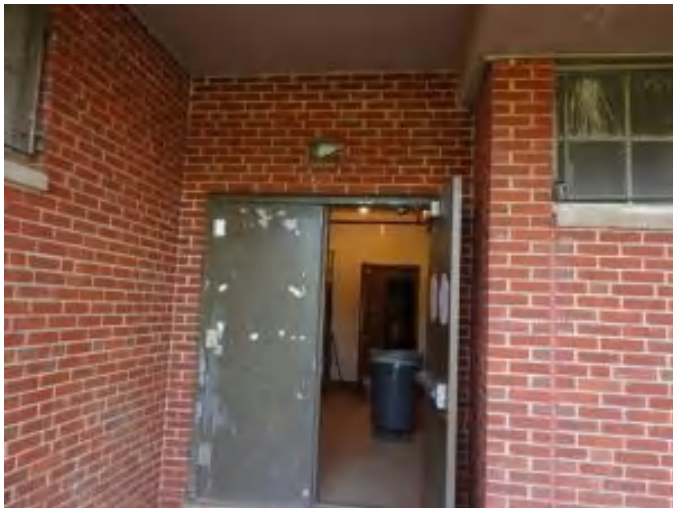
**Location:** Building Exterior

There are lighting fixtures located at the exit discharge on both the First and Second Floors. Most of these fixtures are damaged and not operational. All exterior lighting fixtures above the exit doors need to be replaced. Exterior lighting is controlled by a time clock.

**System: D5020 - Lighting and Branch Wiring**

**Distress:** Beyond Service Life

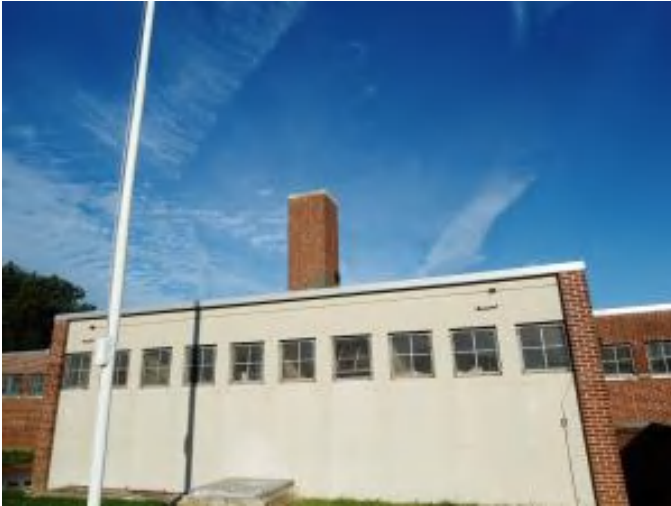
**Location:** Exterior Elevation

The exterior windows are a mix of the original industrial metal framed single pane applications. Some of the windows are operable while others no longer function. The exterior windows have exceeded the expected life cycle for this type of application. It is recommended that the exterior window system be replaced with units that retain their dimensions and profiles, but that incorporate updated energy-efficient features.

**System: B2020 - Exterior Windows**

**Distress:** Damaged

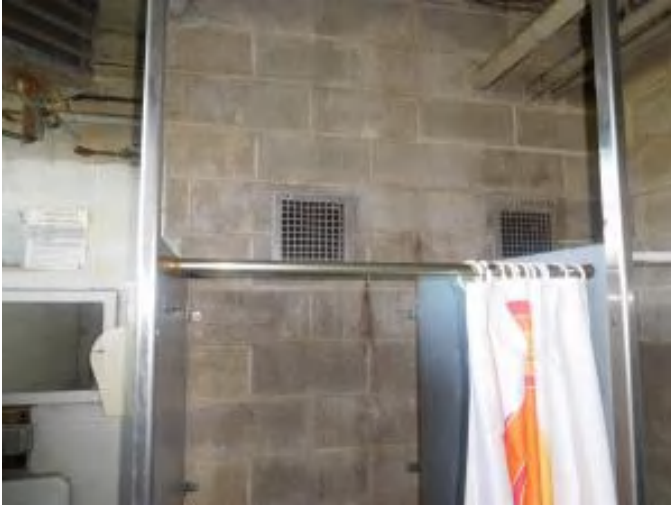
**Location:** locker rooms

Serious consideration should be given to the current condition of the locker rooms and restrooms. This problem should be a top priority for the facility as undesirable biological growth was noted at drain covers and urinals. Thorough cleaning and decontamination of the facility is recommended to ensure safe conditions for students and staff.

**System: D2010 - Plumbing Fixtures**

**Distress:** Beyond Service Life

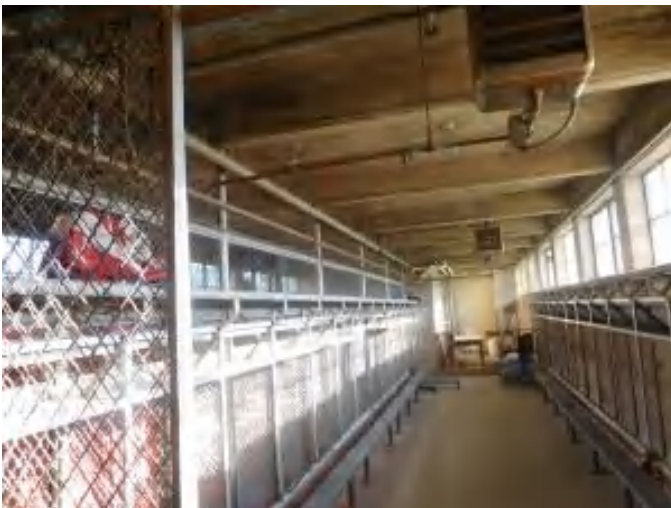
**Location:** entire building

**System: D3040 - Distribution Systems**

**Distress:** Building / MEP Codes

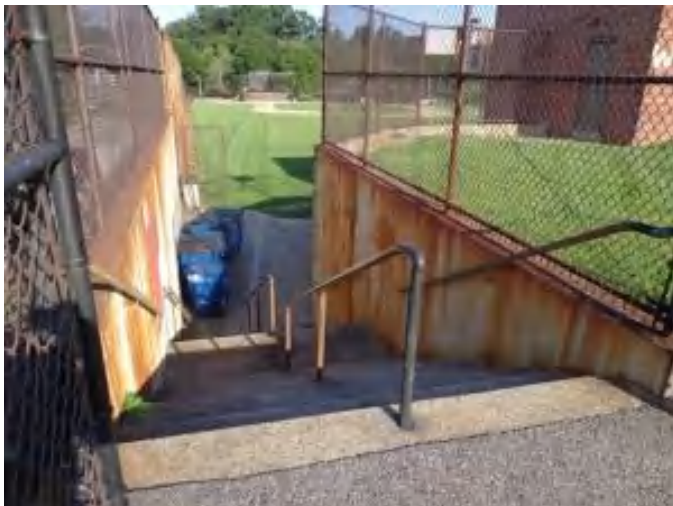
**Location:** Exterior Stairs south side

**System: D5020 - Lighting and Branch Wiring**

**Distress:** Life Safety / NFPA / PFD

Site Lighting-- Other than the lighting fixtures above the exit doors, there is no site lighting for the fields. For safety considerations, it is recommended that the exterior stairs on the south side of the building be illuminated from a building mounted floodlight.

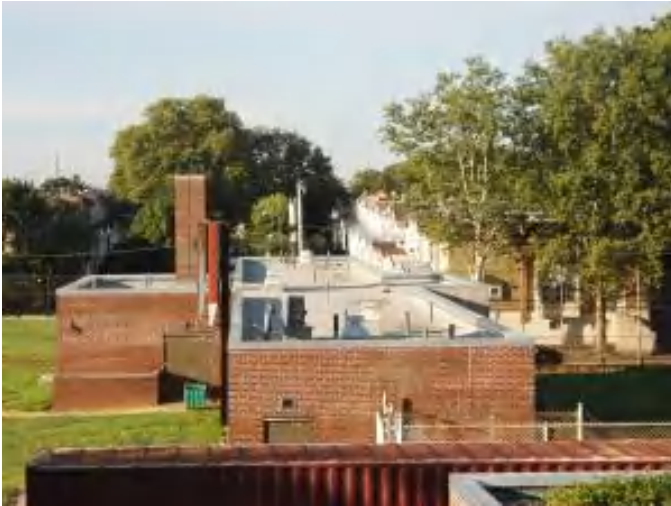
**Location:** Roof

The built up roof was reported to have been installed within the past twenty years. The roof is in very good condition with few exceptions. Currently there is an active leak that if not repaired soon will start to deteriorate the insulation and the integrity of this facility. This deficiency provides a budgetary consideration for built up roof repair for this section. Special consideration to coordinate the exterior projects in this report is recommended in order not to duplicate efforts.

**System: B3010105 - Built-Up**

**Distress:** Beyond Service Life

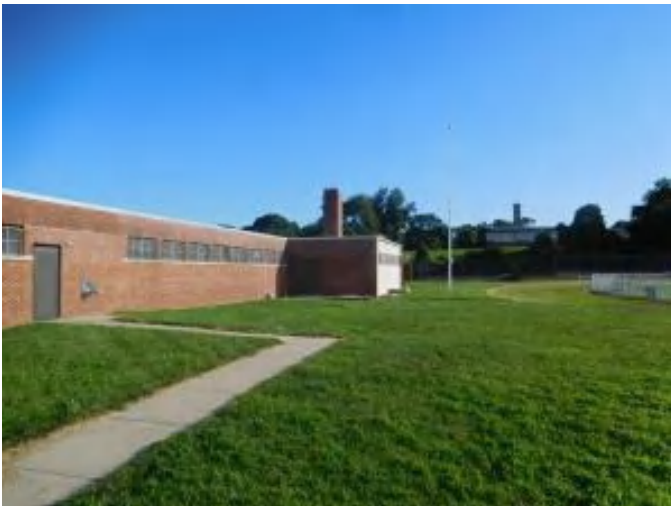
**Location:** exterior, mechanical room

**System: D3030 - Cooling Generating Systems**

**Distress:** Inadequate

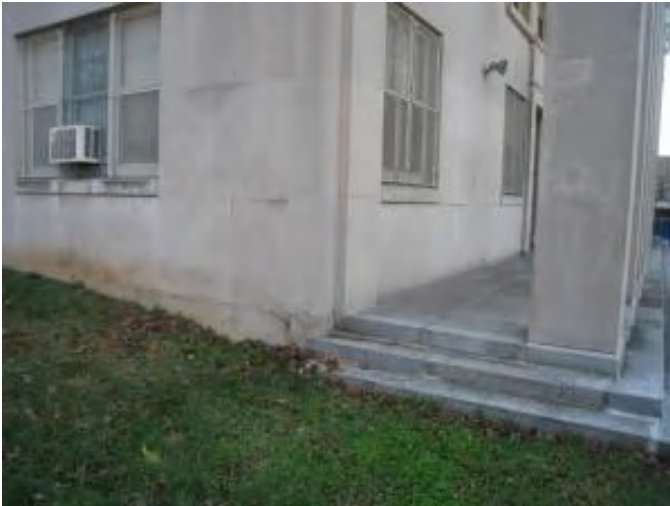
**Location:** Girls HS - foundation

#### System: A1010 - Standard Foundations

**Distress:** Building Envelope Integrity

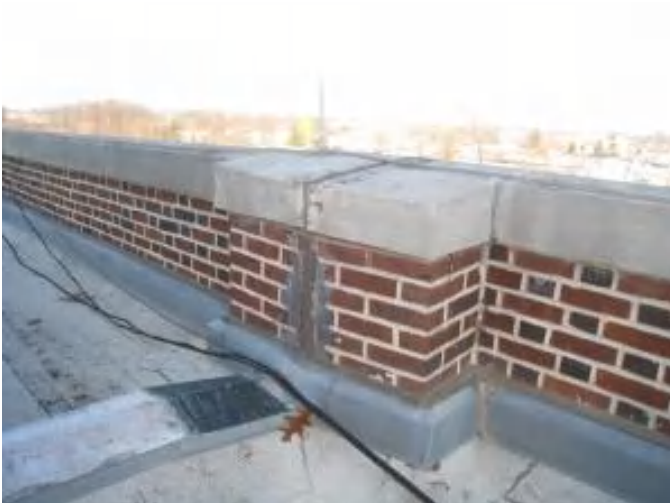
**Location:** Girls HS - roof

#### System: B2010 - Exterior Walls

**Distress:** Failing

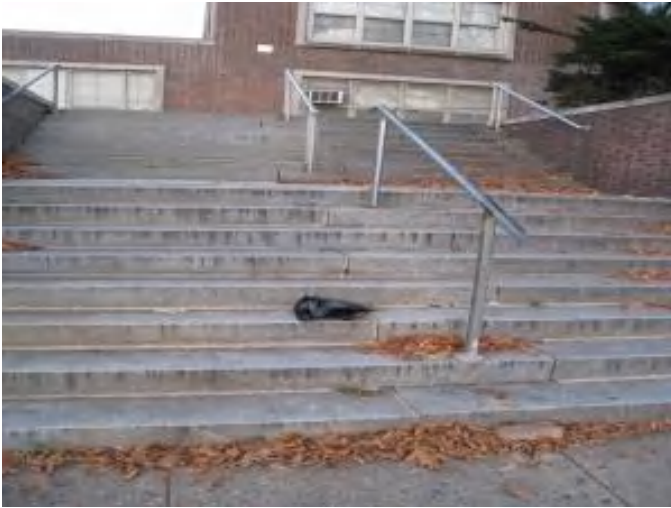
**Location:** Girls HS - exterior stairs

**System: C2010 - Stair Construction**

**Distress:** Building / MEP Codes

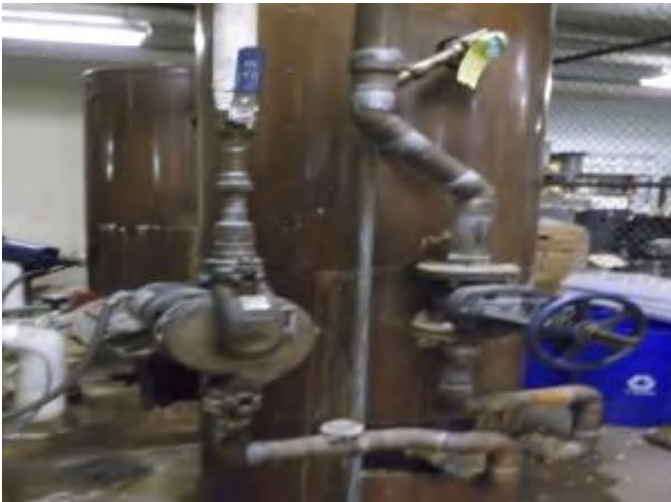
**Location:** Mezzanine Mechanical

**System: D2020 - Domestic Water Distribution**

**Distress:** Building / MEP Codes

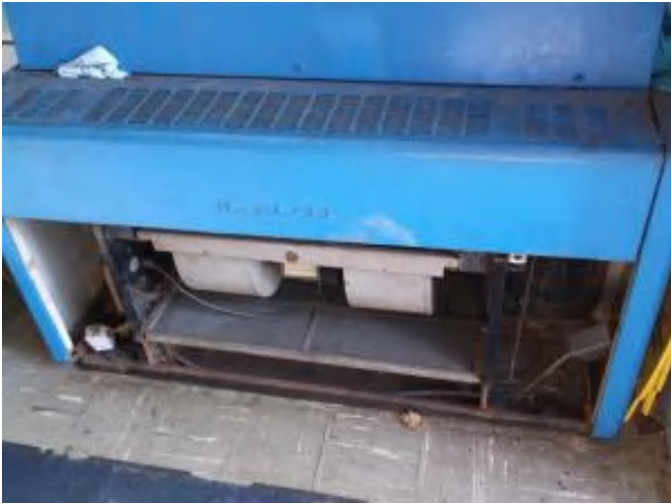
**Location:** Classrooms

**System: D3040 - Distribution Systems**

**Distress:** Health Hazard / Risk

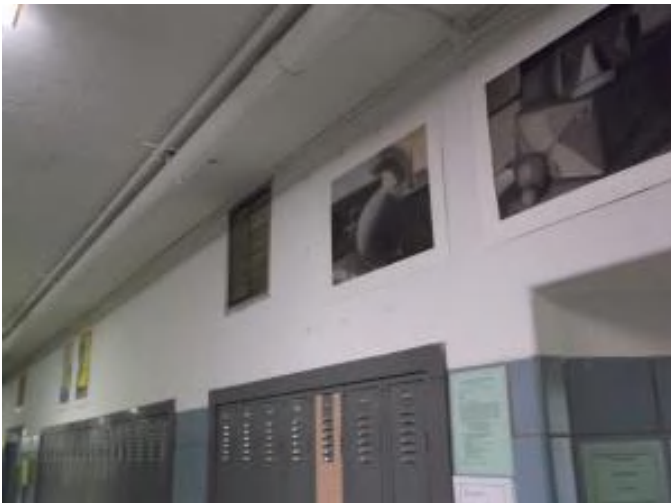
**Location:** Corridors

**System: D3040 - Distribution Systems**

**Distress:** Health Hazard / Risk

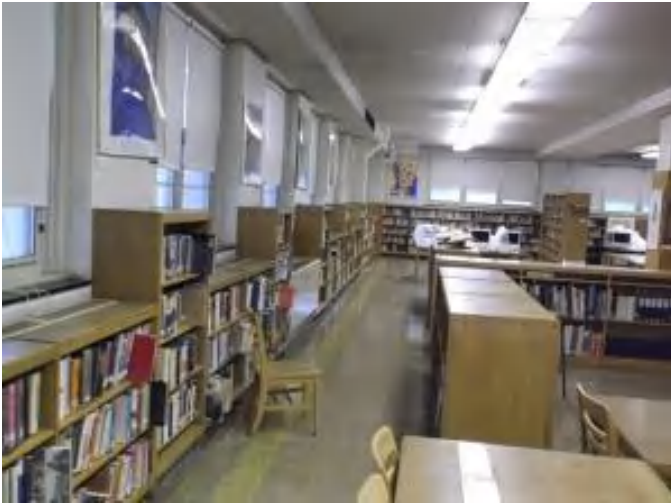
**Location:** IMC

**System: D3040 - Distribution Systems**

**Distress:** Health Hazard / Risk

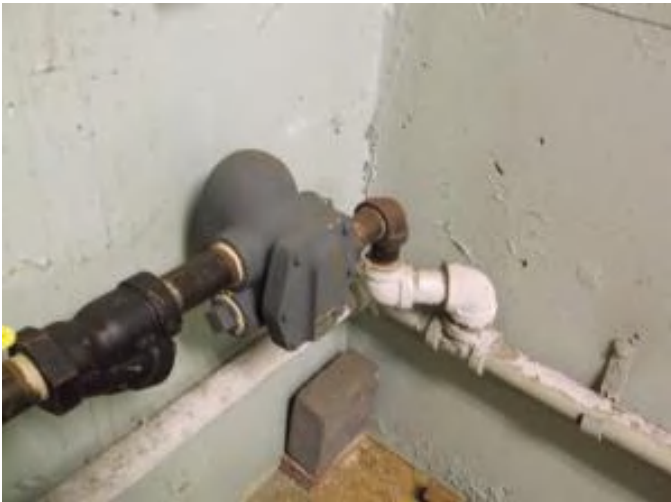
**Location:** Throughout Building

**System: D3040 - Distribution Systems**

**Distress:** Beyond Service Life

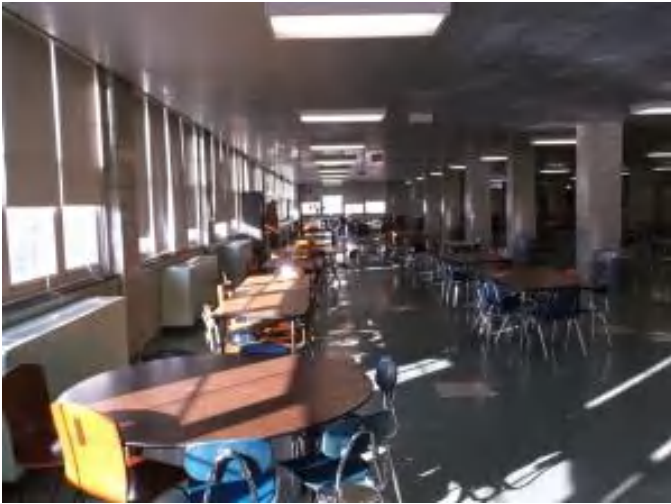
**Location:** Cafeteria

**System: D3040 - Distribution Systems**

**Distress:** Health Hazard / Risk

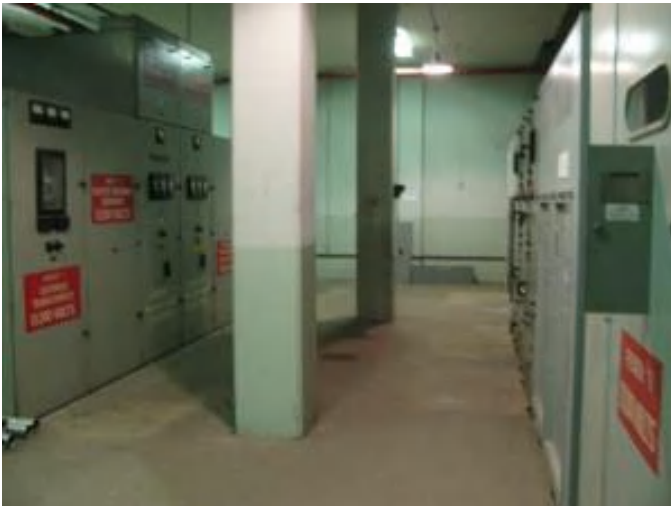
**Location:** Girls HS- Electrical Room

**Distress:** Beyond Service Life

**Correction:** Replace Substation

**Notes:** Replace the existing switchgear with new 1200A, 13200V switchgear consisting consist of two 600A incoming breaker switches and two 600A, 13200V outgoing interrupting switches, one tie breaker and metering sections. Provide two Substations each consist of two 600A interrupter switches, one 3000A double ended low voltage switchboards. Use existing transformers.

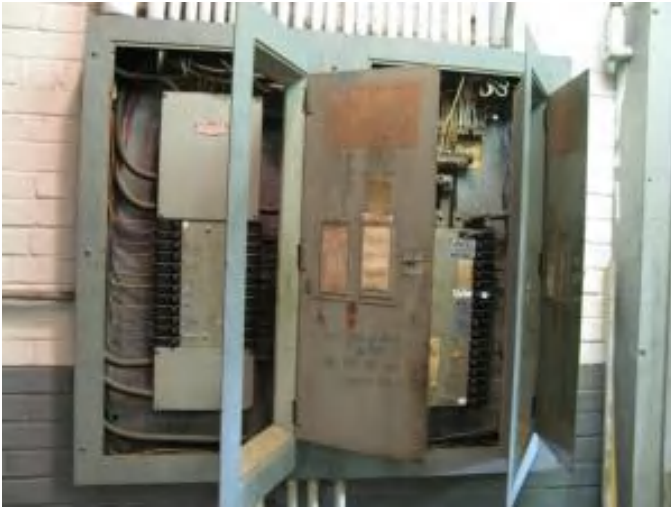
**Location:** Grils HS- Entire Building

**Distress:** Beyond Service Life

**Correction:** Replace Electrical Distribution System (U)

**Notes:** Replace the entire distribution system with new panels and new wiring /conduits. Our recommendation is to replace existing conduits and wiring to new Junction boxes, receptacles, and lighting. Provide arc flash label on the electrical equipment. Estimated (15)225A + (8)400A power panel and 23 lighting/receptacle panels. panels.

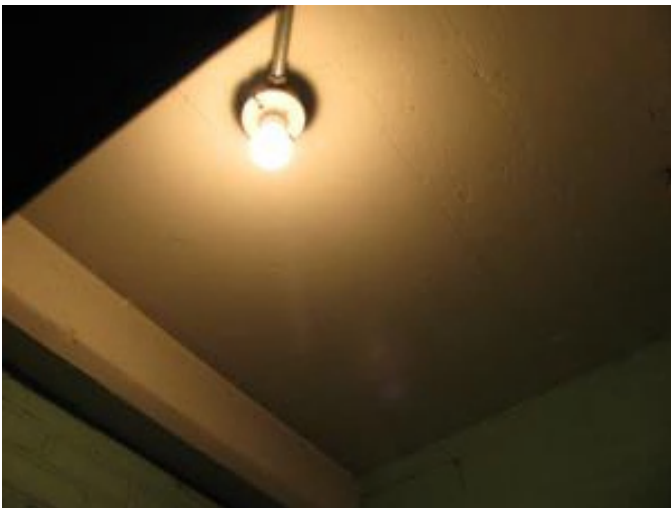
**Location:** Girls HS- Entire Building

**Distress:** Beyond Service Life

**Correction:** Replace Lighting Fixtures (SF)

**Notes:** Replace all the lighting fixtures in classrooms, offices and cafeteria with new fluorescent lighting fixtures with T8 lamp. Replace gymnasium illuminates with LED high bay. Estimated 25 total.

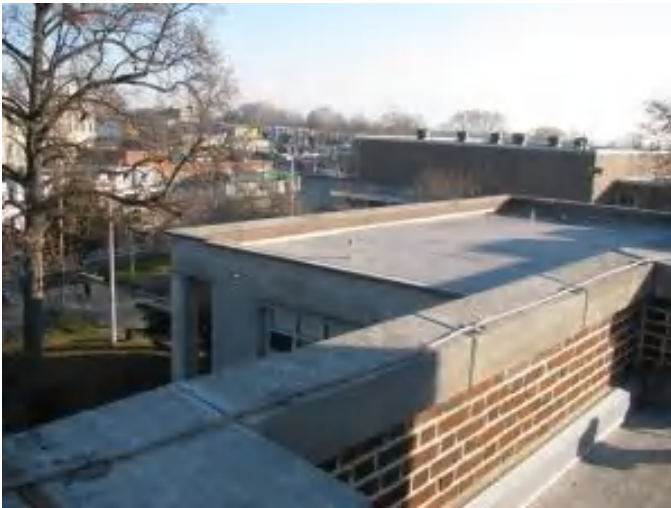
**Location:** Girls Hs- Exterior Building

**Distress:** Security Issue

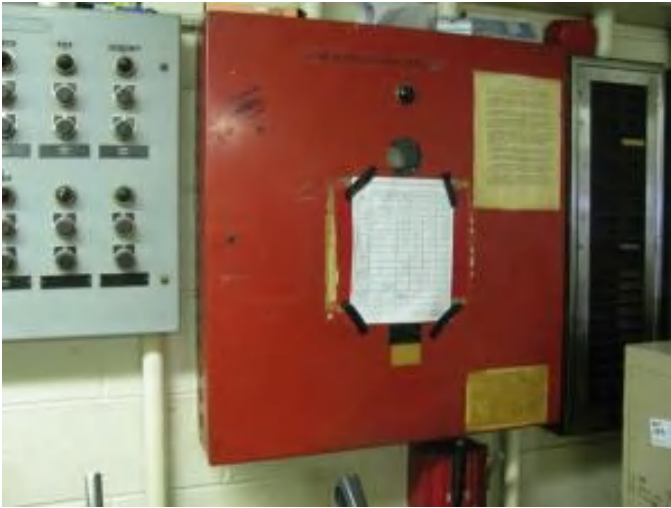
**Location:** Girls HS- Entire Building

**Distress:** Life Safety / NFPA / PFD

**Correction:** Replace fire alarm system

**Notes:** Replace existing fire alarm system with an automatic fire alarm system including smoke detectors in corridors and other recommended areas per NEC. Install horn/strobes in class rooms, corridors, offices, toilets, library and other recommended areas per codes.

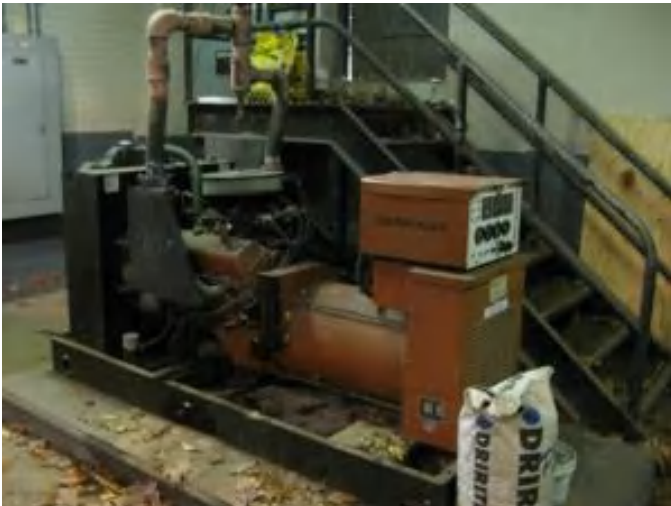
**Location:** Girls HS- Boiler Room

**Distress:** Life Safety / NFPA / PFD

**Correction:** Replace standby generator system

**Notes:** Replace existing generator with new 100KW generator. Provide new Automatic Transfer Switch and emergency distribution panel board.

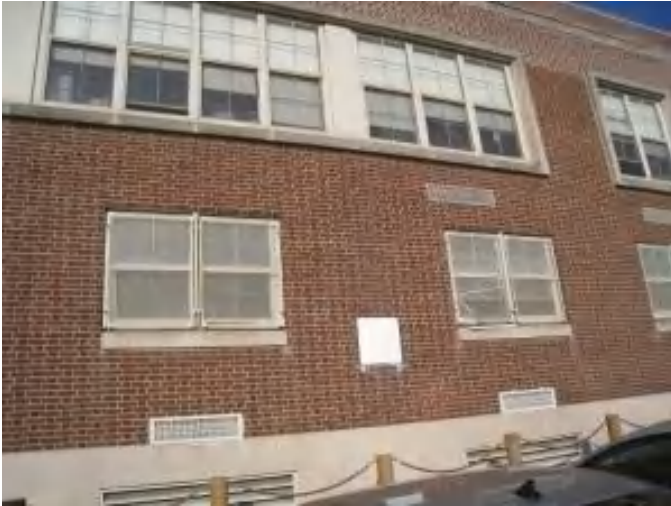
**Location:** Girls HS - exterior walls

**Distress:** Failing

- horizontal joint crack on the back auditorium wall facing Broad Street
- vertical crack running up the side of the building at the northeast corner near Olney
- lintels above the windows repoint
- The top of the furnace flue cracks - repoint

**Correction:** Repair cracks in masonry - replace missing mortar and repoint - SF of wall area

**Notes:** Repoint cracked masonry (2,000sf):

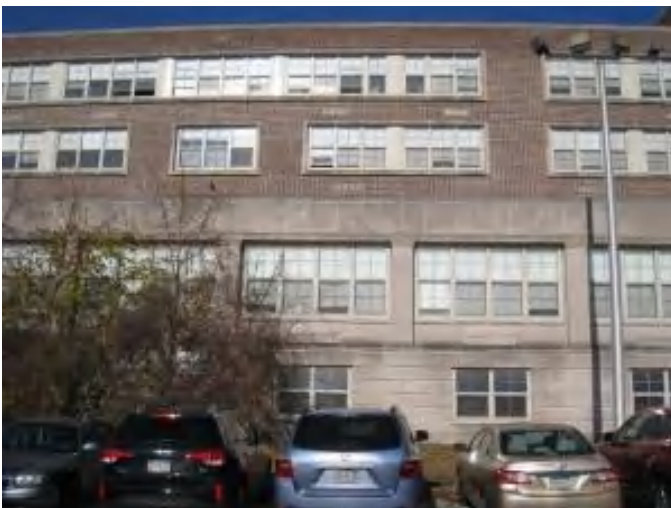
**Location:** Girls HS - exterior

**Distress:** Appearance

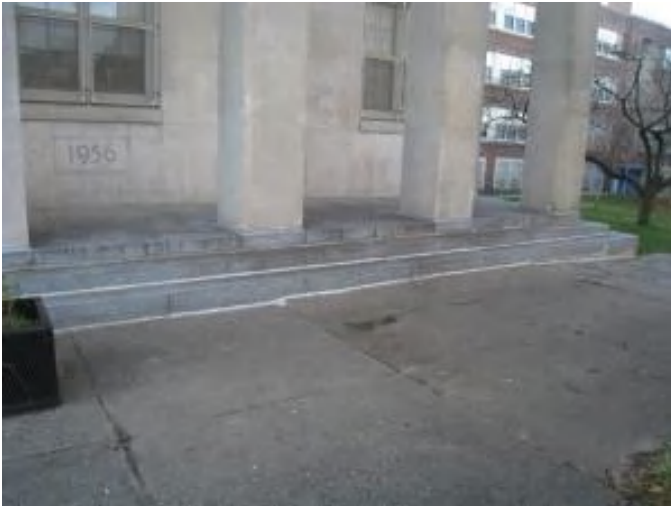
**Location:** Girls HS - exterior

**Distress:** Damaged

**Correction:** Repair spalled concrete wall structure

**Notes:** Repair chipped limestone panels (100sf)

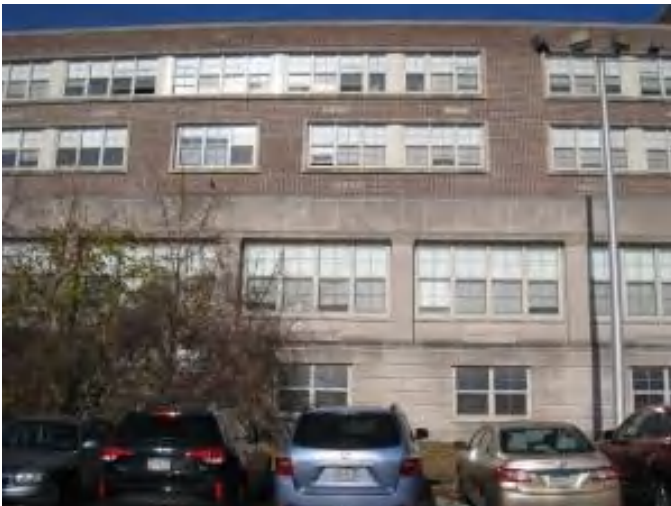
**Location:** Girls HS - windows

**Distress:** Inadequate

**Correction:** Replace security screens

**Notes:** Replace broken or missing window screens (200each)

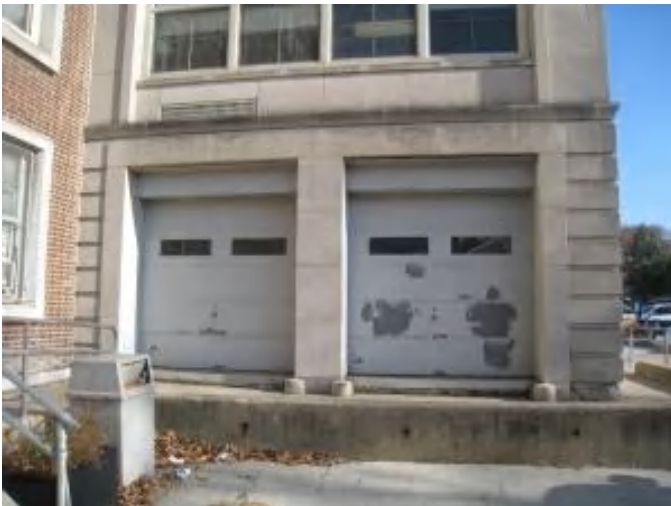
**Location:** Girls HS - loading dock

**Distress:** Damaged

**Correction:** Remove and replace overhead door - pick the closest type and size and add for the operator if required

**Notes:** Replace overhead or rollup doors into loading area (3 12x12)

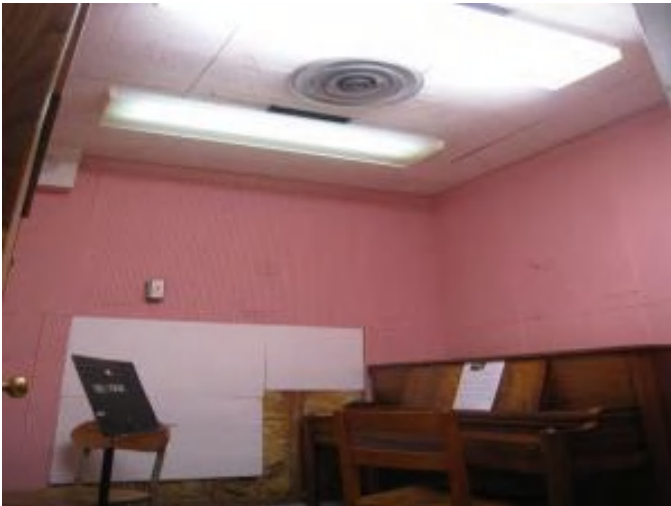
**Location:** Girls HS - music practice booths

**Distress:** Damaged

**Correction:** Remove non-rated interior glass panels and replace with studs, gypsum board, paint (E) wall

**Notes:** Replace interior walls of sound proof practice booths (2000sf)

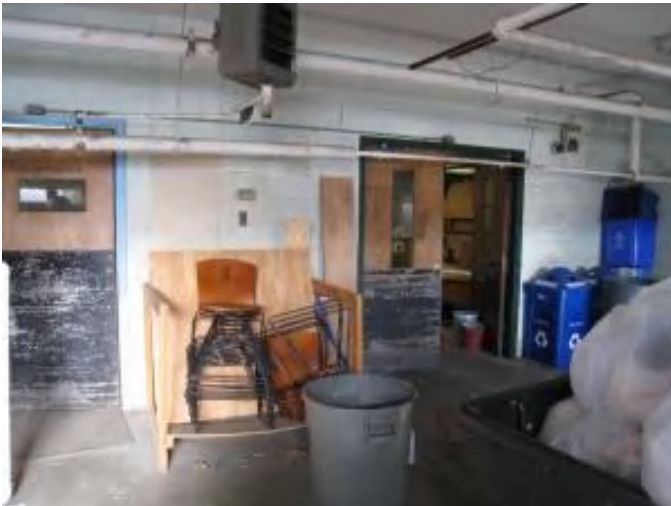
**Location:** Girls HS - basement

**Distress:** Building / MEP Codes

**Correction:** Remove and replace hollow metal frames and doors

**Notes:** Remove and replace all basement steel doors, frames, and hardware in mechanical rooms; fire rated doors with panic hardware for stairs (100) 3x7 doors

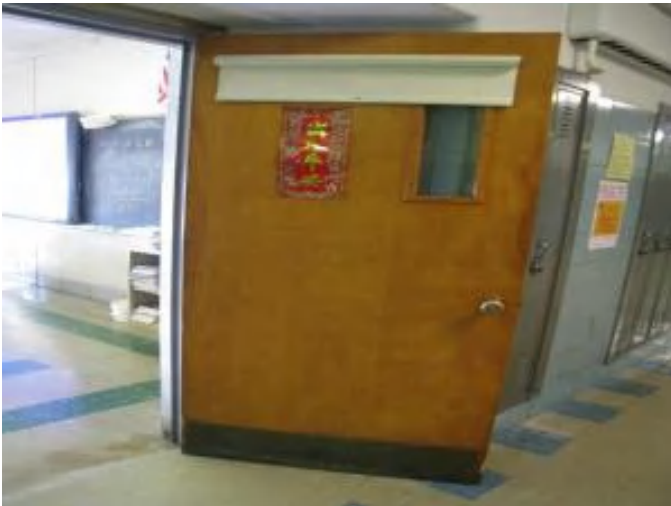
**Location:** Girls HS - corridor doors

**Distress:** Security Issue

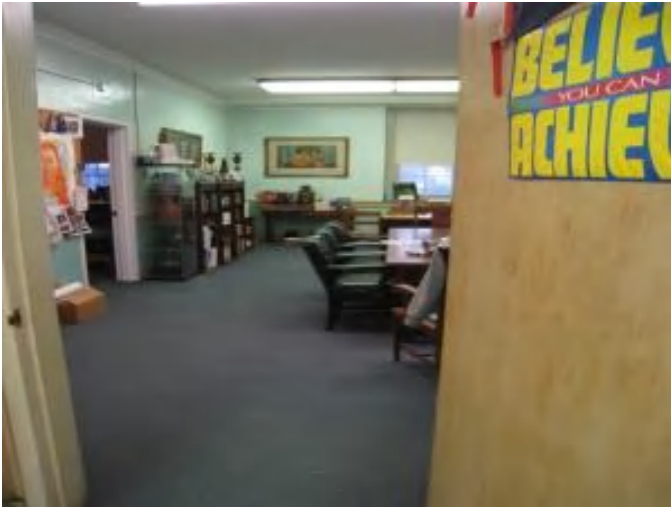
**Location:** Girls HS - floors

**Distress:** Beyond Service Life

**Correction:** Remove and replace carpet

**Notes:** Replace carpet (1,000sf)

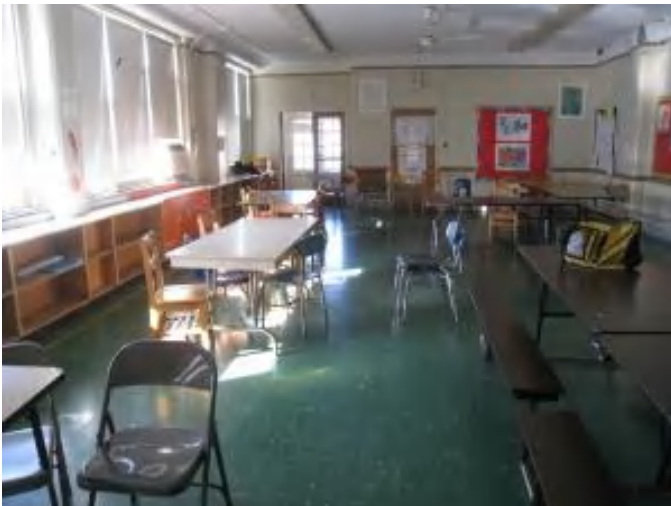
**Location:** Girls HS - floors

**Distress:** Damaged

**Correction:** Remove VAT and replace with VCT - SF of area

**Notes:** Replace VAT floors using proper asbestos abatement procedures if determined asbestos is present. (158,372sf)

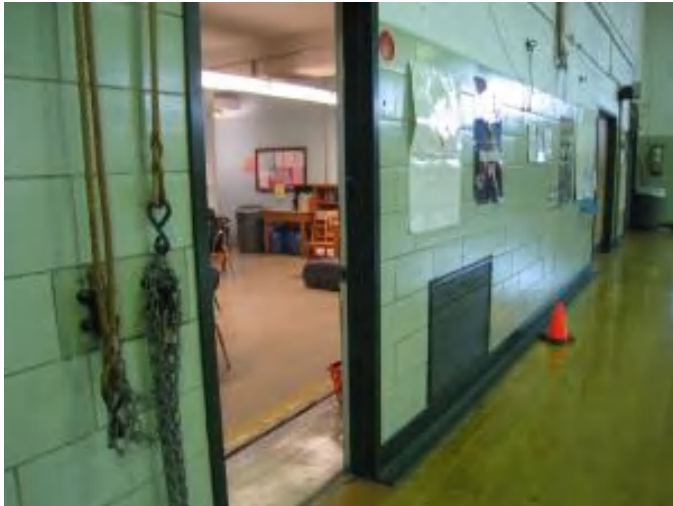
**Location:** Girls HS - gymnasium

**Distress:** Appearance

**Notes:** Strip, sand, repair and refinish all wood floors in gymnasium (10,000sf)

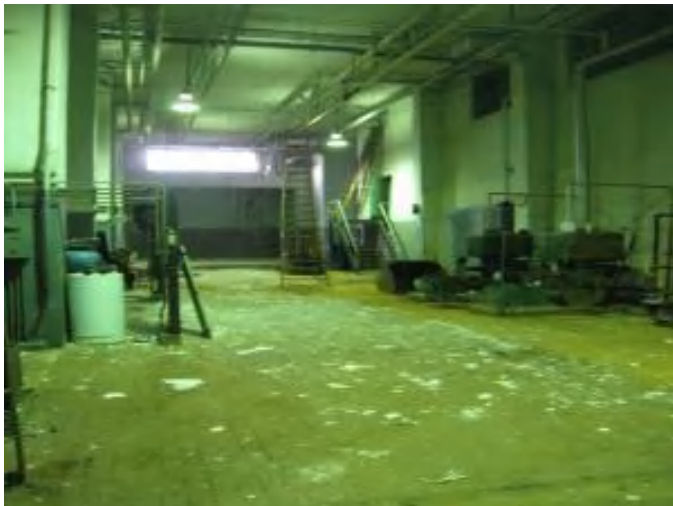
**Location:** Girls HS - concrete slabs

**Distress:** Appearance

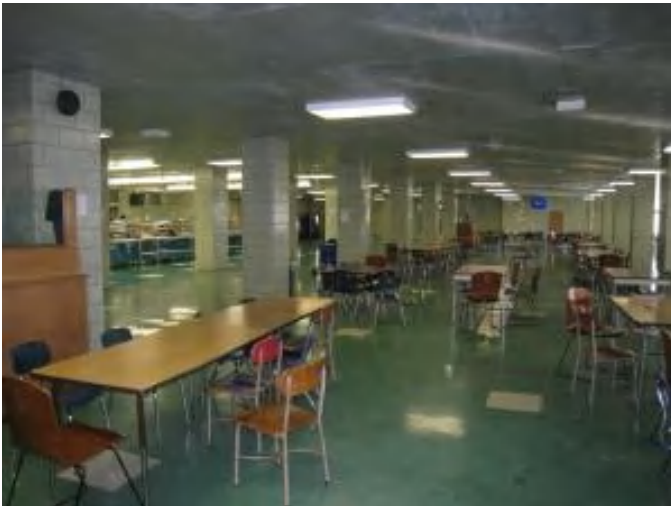
**Location:** Girls HS - ceilings

**Distress:** Damaged

**Correction:** Remove and replace suspended acoustic ceilings - lighting not included

**Notes:** Replace 1'x2' metal ceiling tiles in cafeteria and replace with 2x4 acoustical tile ceiling (11,000)

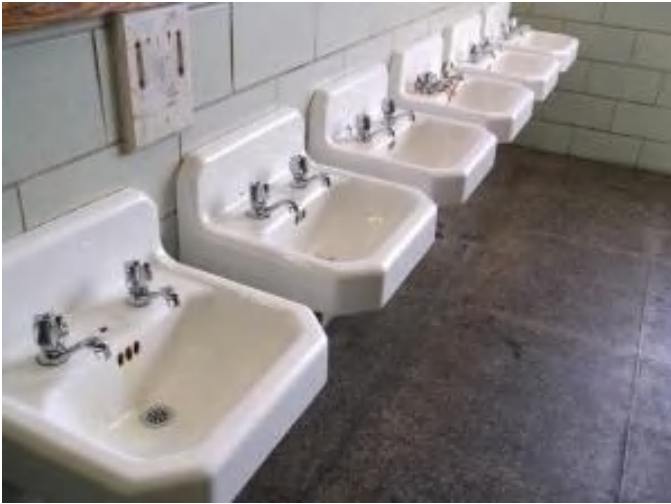
**Location:** Restrooms

**Distress:** Beyond Service Life

**Correction:** Remove and replace or replace lavatory - quantify accessible if required

**Notes:** Replace sixty (60) original lavatories in the restrooms on the Basement thru 3rd Floors with low flow fixtures.

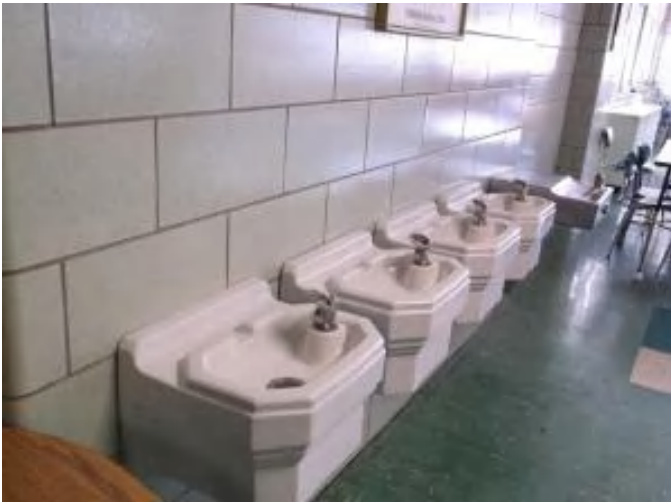
**Location:** Corridors

**Distress:** Accessibility

**Correction:** Remove and Replace Water Fountains - without ADA new recessed alcove

**Notes:** Replace the twenty (20) wall hung drinking fountains with new stainless steel units equipped with integral refrigerated coolers in the corridors and at the restrooms. These units are well beyond their service life and most are NOT accessible type.

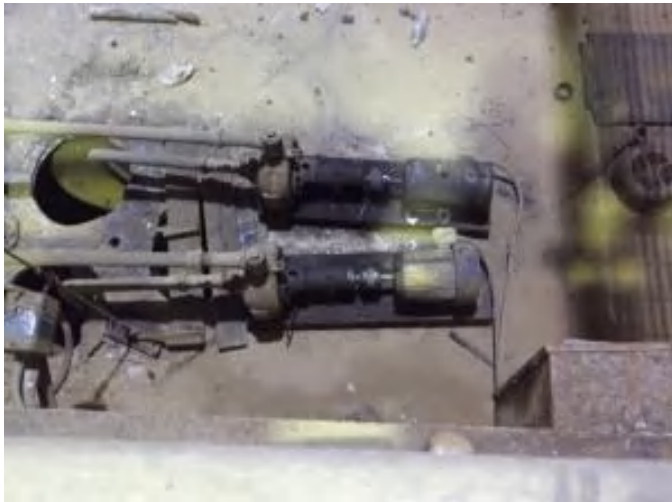
**Location:** subbasement mechanical room

**Distress:** Beyond Service Life

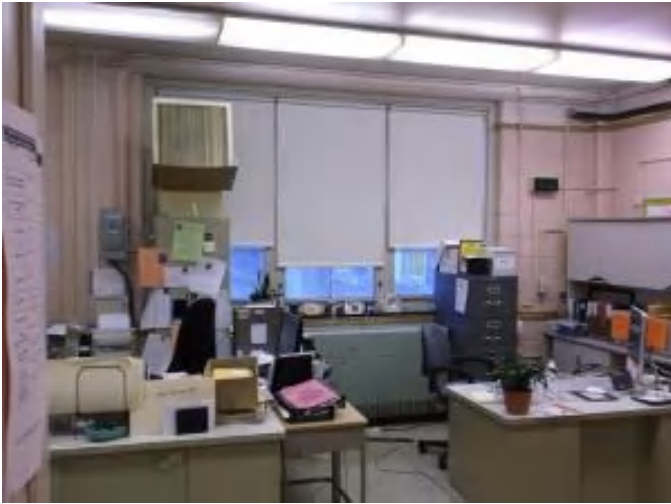
**Location:** Main Offices

**Distress:** Inadequate

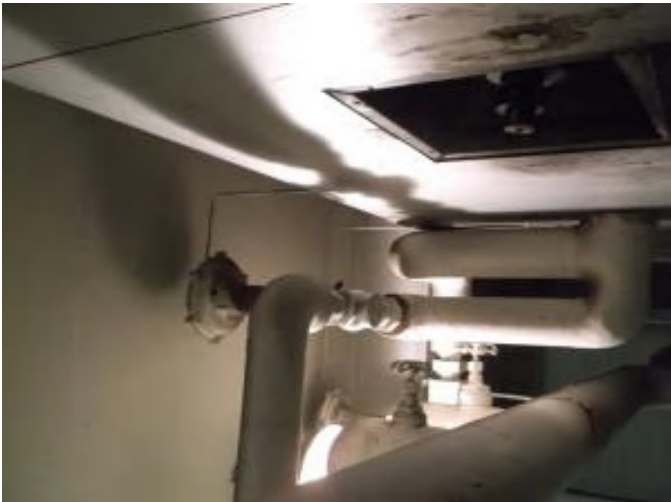
**Location:** Basement Mechanical Room

**Distress:** OSHA

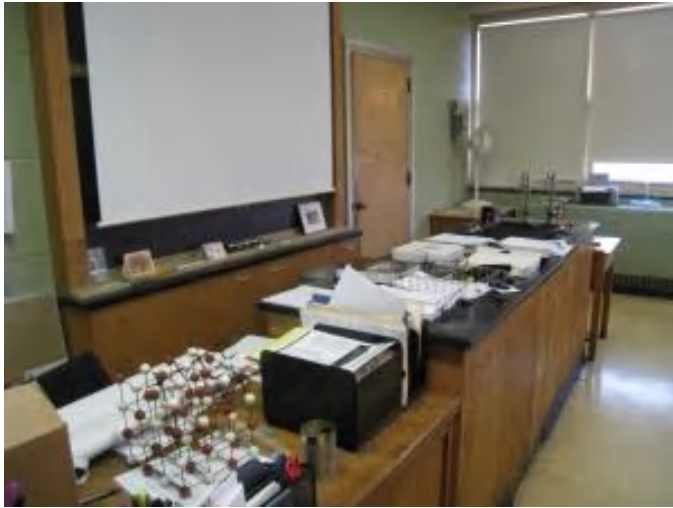
**Location:** Girls HS - science labs

**Distress:** Beyond Service Life

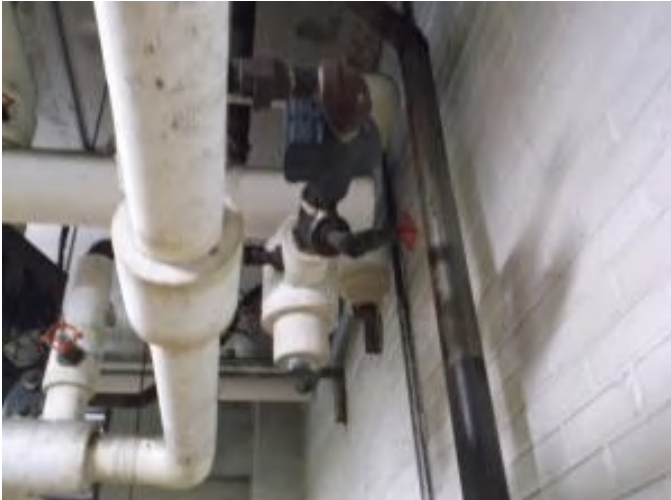
**Location:** Throughout Building

**Distress:** Beyond Service Life

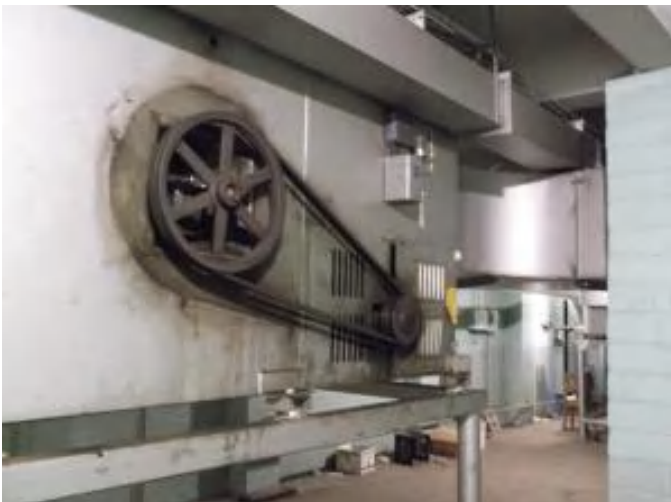
**Location:** Basement Mechanical Room

**Distress:** Failing

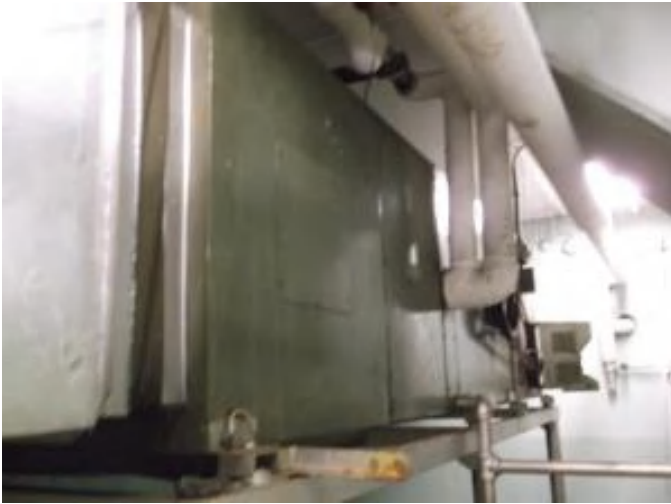
**Location:** Gym

**Distress:** OSHA

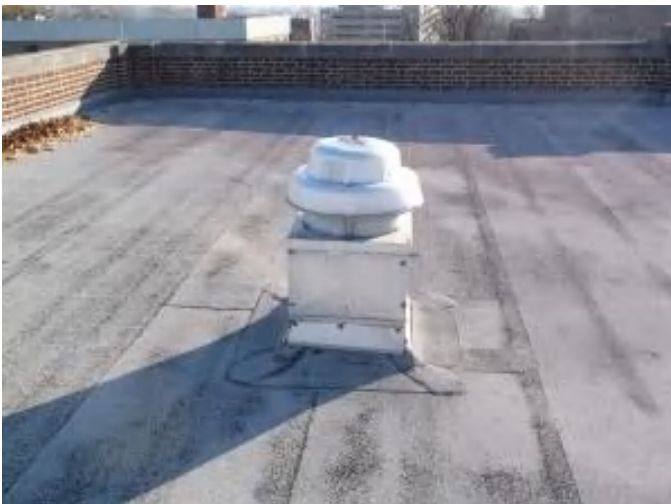
**Location:** Roof

**Distress:** Beyond Service Life

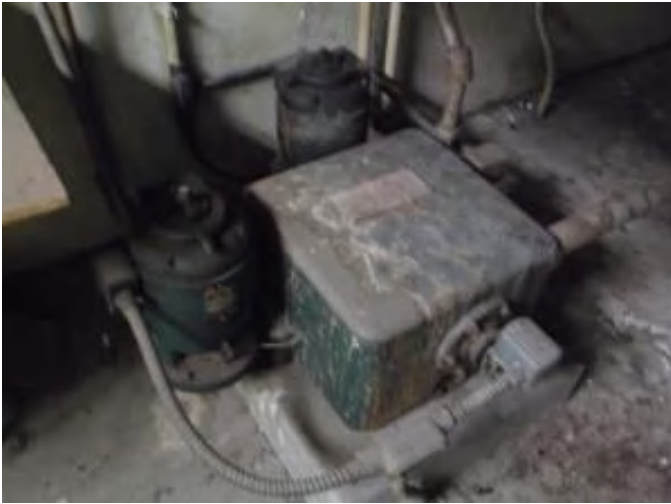
**Location:** mechanical room

**Distress:** Beyond Service Life

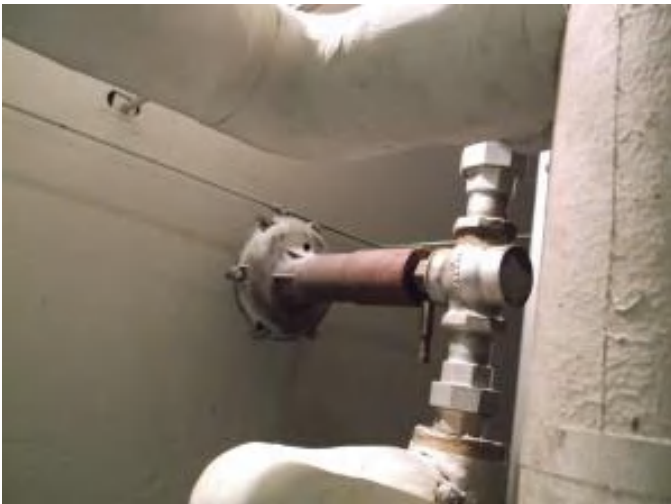
**Location:** Throughout Building

**Distress:** Energy Efficiency

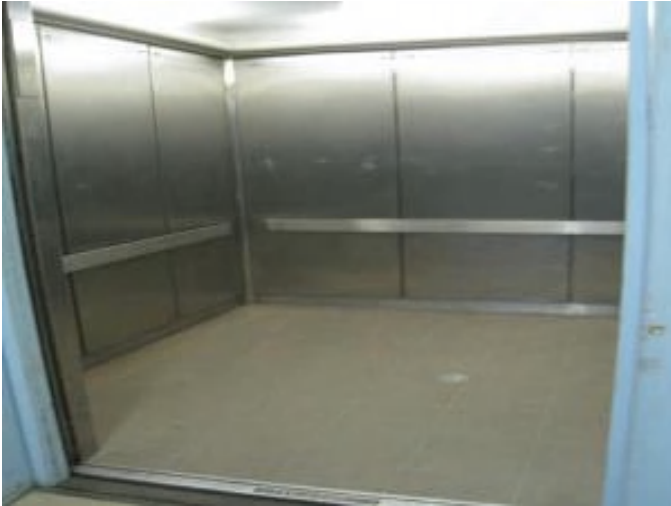
**Location:** Girls HS - elevators

**Distress:** Accessibility

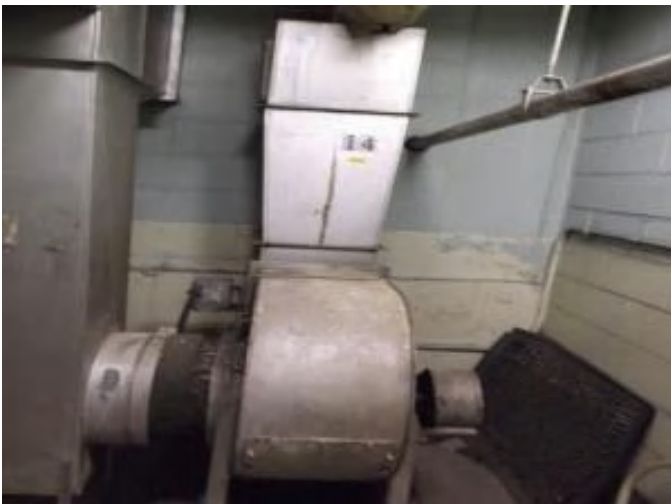
**Location:** Basement Mechanical Room

**Distress:** Beyond Service Life

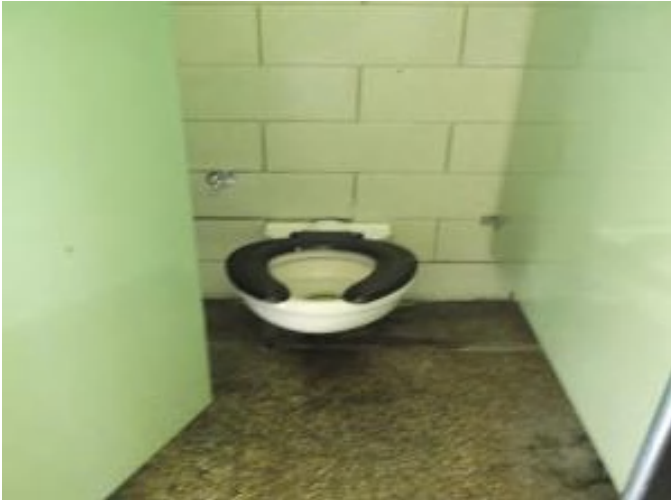
**Location:** Restrooms

**Distress:** Beyond Service Life

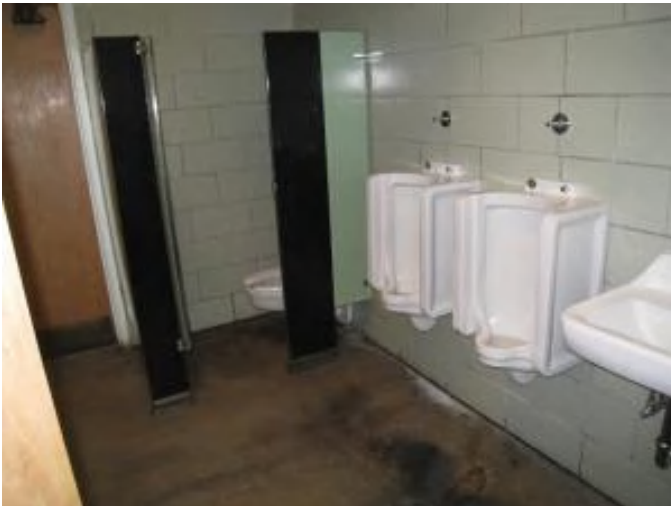
**Location:** Restrooms

**Distress:** Beyond Service Life

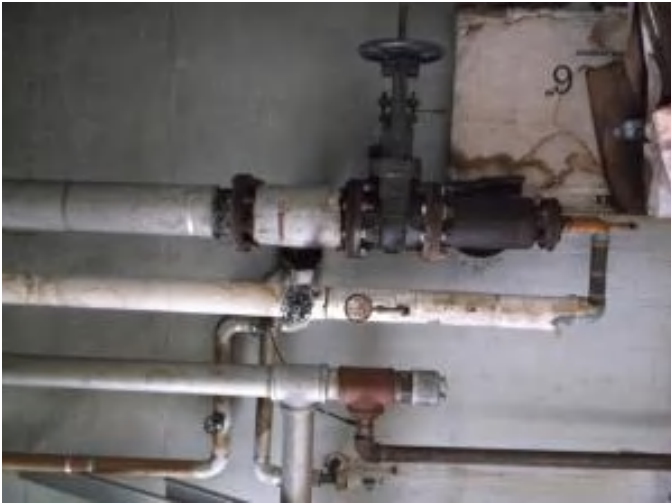
**Location:** Throughout Building

**Distress:** Beyond Service Life

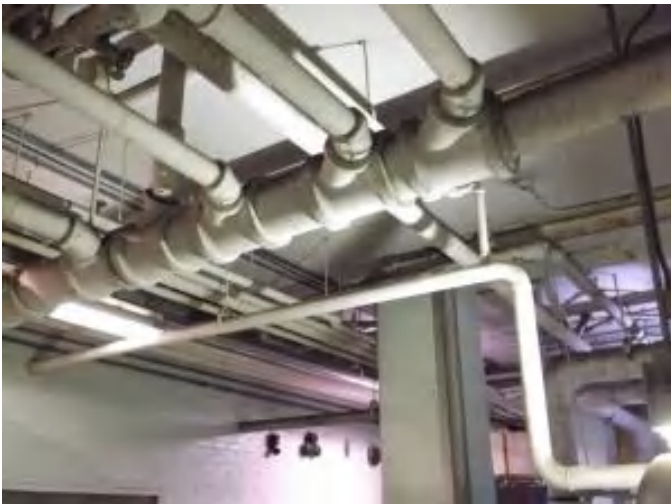
**Location:** Throughout Building

**Distress:** Beyond Service Life
