## Facility Condition Assessment Summary Report

### Widener School

Final

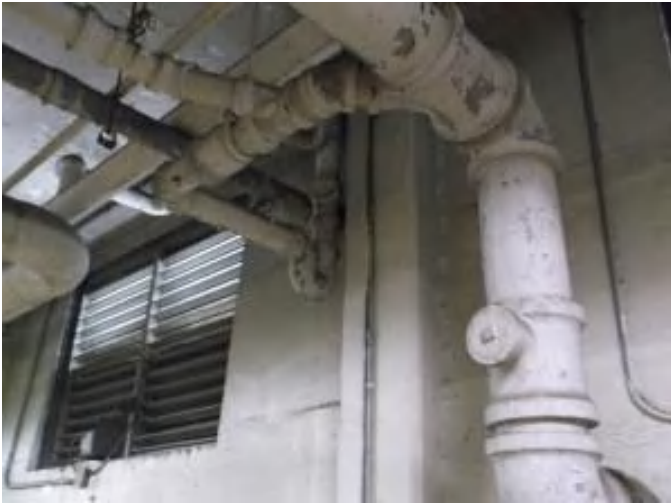
**Location:** Throughout Building

**Distress:** Beyond Service Life

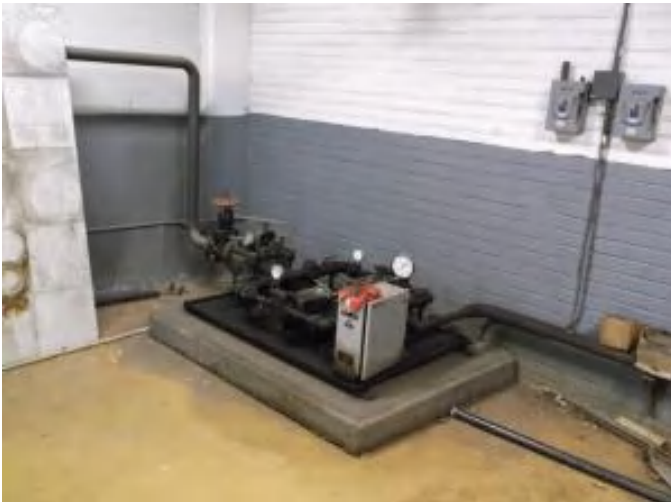
**Location:** Coal/Ash Room

**Distress:** Beyond Service Life

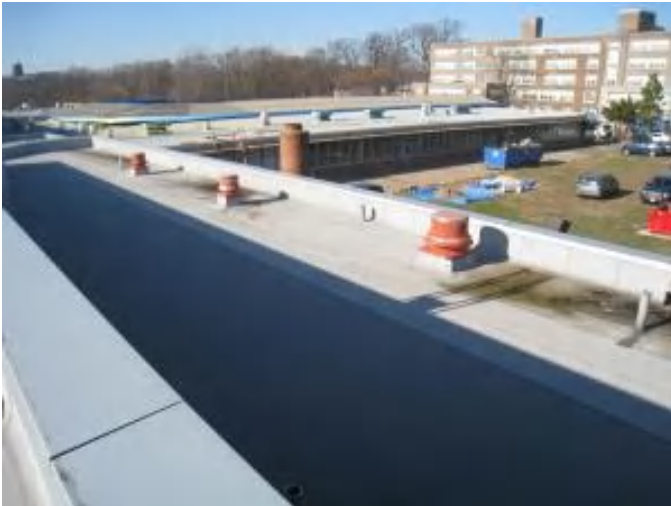
**Location:** Widener - roof

#### System: B3010105 - Built-Up

**Distress:** Inadequate

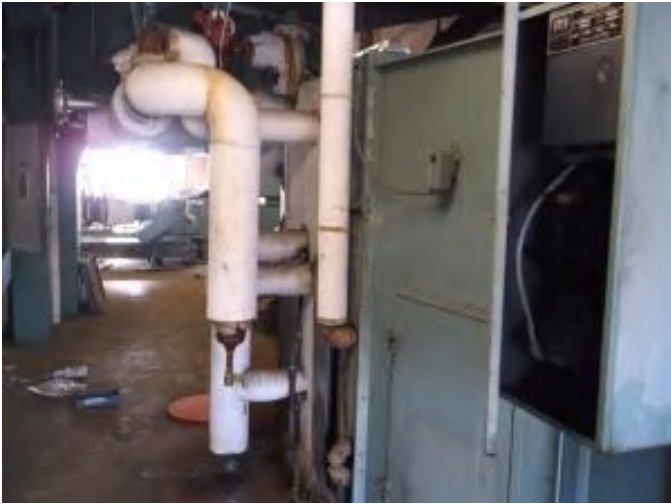
**Location:** Penthouse

**System: D3040 - Distribution Systems**

**Distress:** Health Hazard / Risk

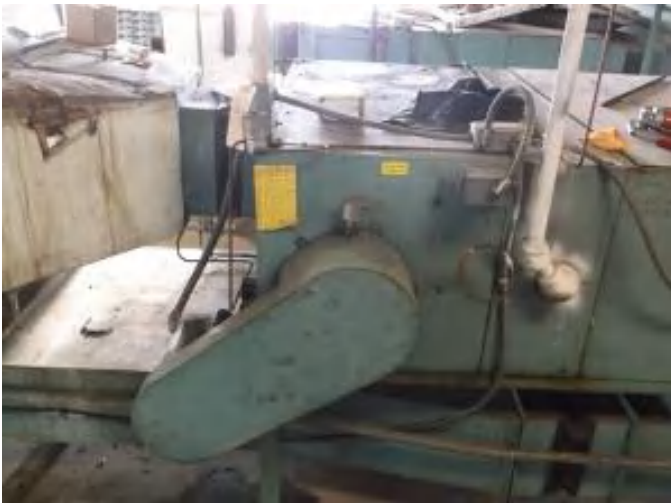
**Location:** Penthouse

**System: D3040 - Distribution Systems**

**Distress:** Health Hazard / Risk

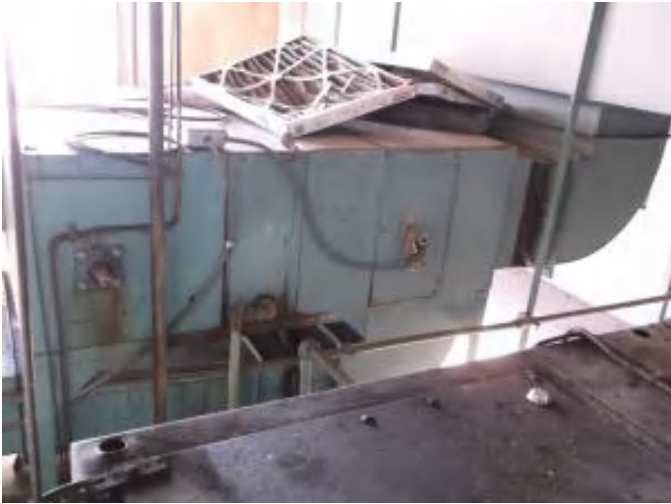
**Location:** Penthouse

**System: D3040 - Distribution Systems**

**Distress:** Health Hazard / Risk

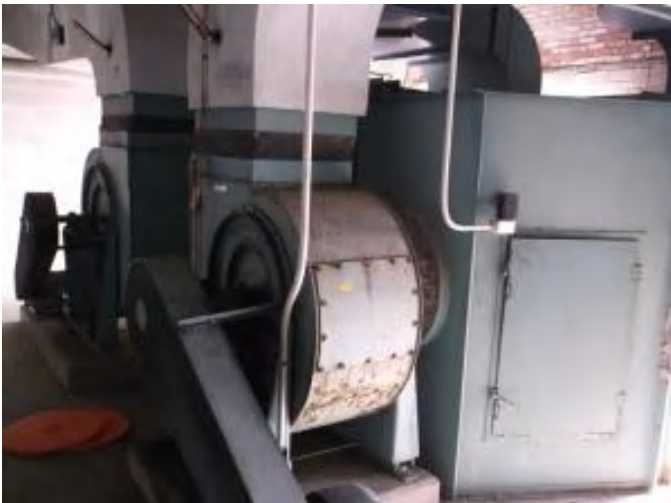
**Location:** Penthouse

**System: D3040 - Distribution Systems**

**Distress:** Health Hazard / Risk

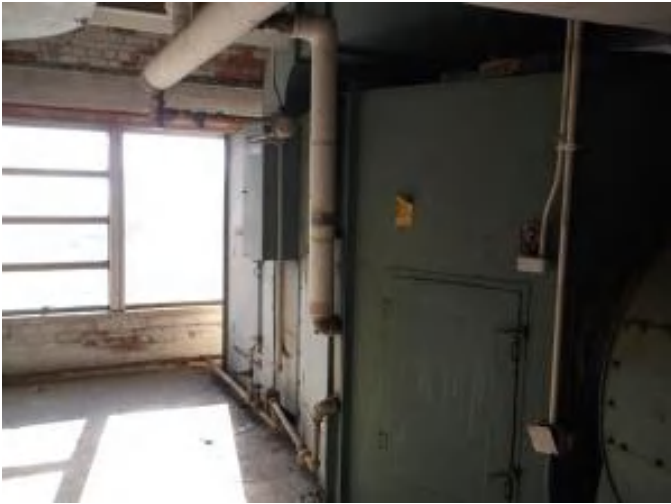
**Location:** Penthouse

**System: D3040 - Distribution Systems**

**Distress:** Health Hazard / Risk

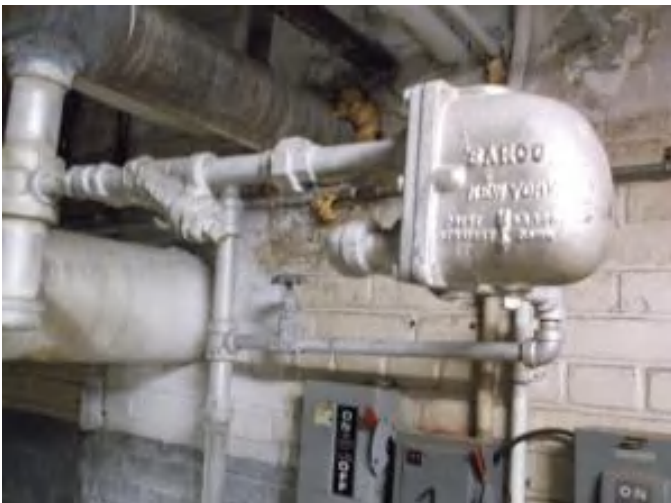
**Location:** Throughout Building

**System: D3040 - Distribution Systems**

**Distress:** Beyond Service Life

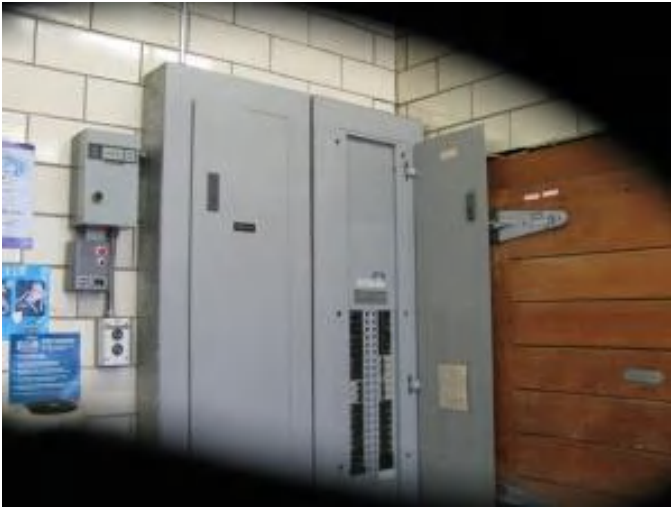
**Location:** Windener-Entire Building

**System: D5010 - Electrical Service/Distribution**

**Distress:** Beyond Service Life

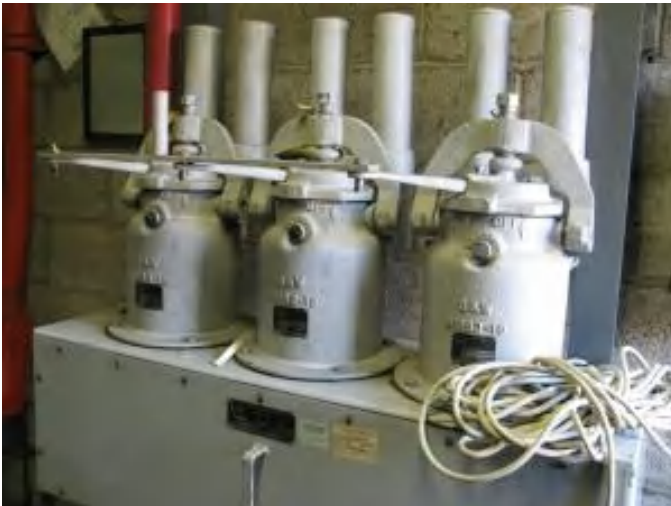
**Location:** Windener-Switchgear room and Electrical Room

**System: D5010 - Electrical Service/Distribution**

**Distress:** Beyond Service Life

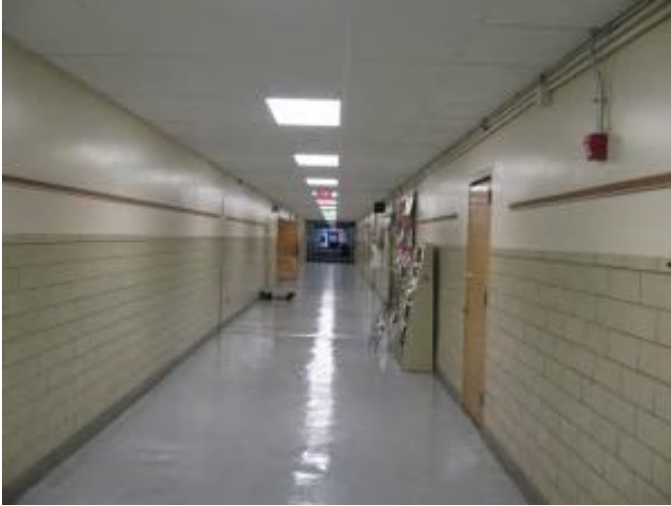
**Location:** Windener-Entire Building

**System: D5030 - Communications and Security**

**Distress:** Security Issue

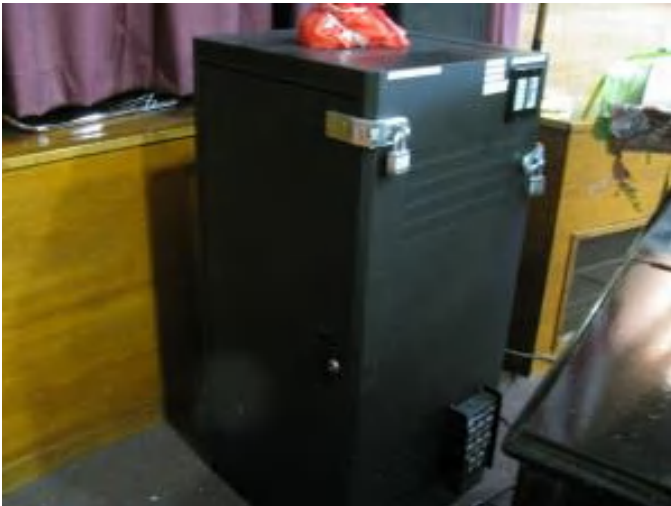
**Location:** Windener-Auditorium

**System: D5030 - Communications and Security**

**Distress:** Inadequate

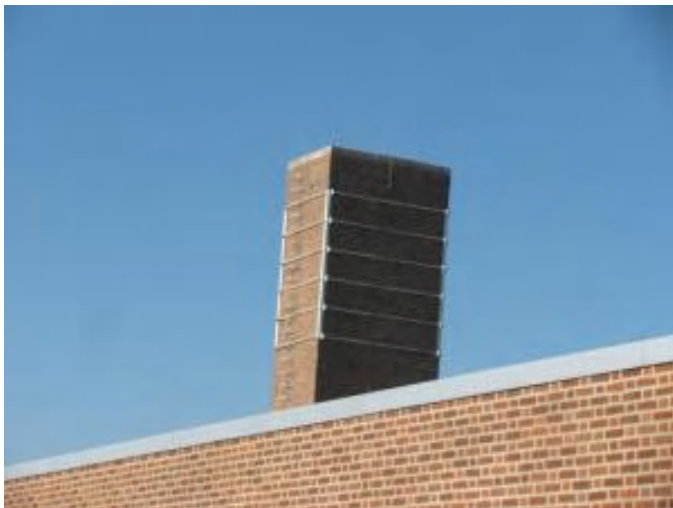
**Location:** Windener-Roof

**System: D5090 - Other Electrical Systems**

**Distress:** Life Safety / NFPA / PFD

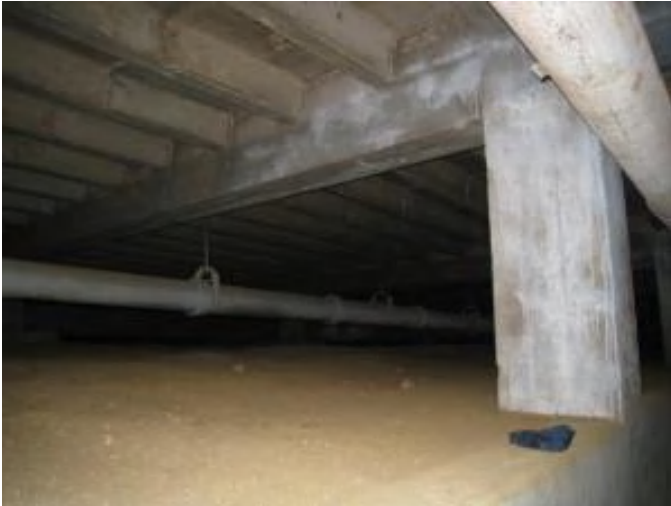
**Location:** Widener - crawl space

**System: B1010 - Floor Construction**

**Distress:** Failing

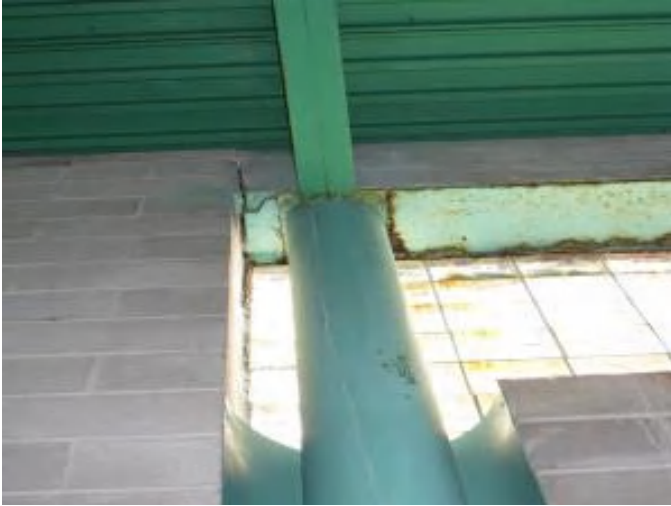
**Location:** Widener - pool house glass block

**System: B2010 - Exterior Walls**

**Distress:** Damaged

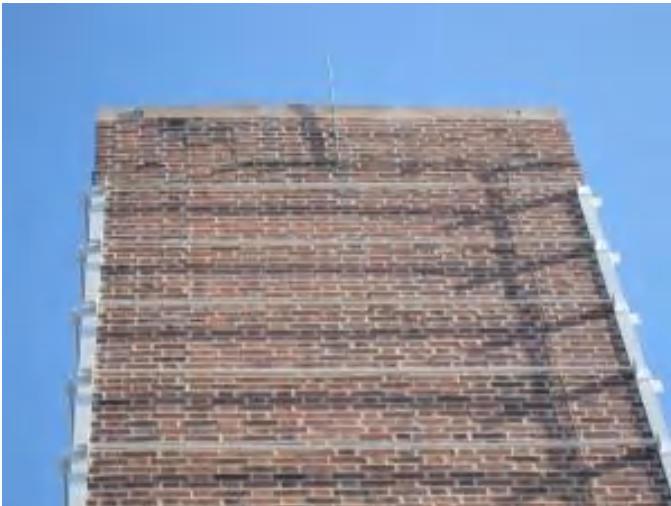
**Location:** Widener - chimney

**System: B2010 - Exterior Walls**

**Distress:** Failing

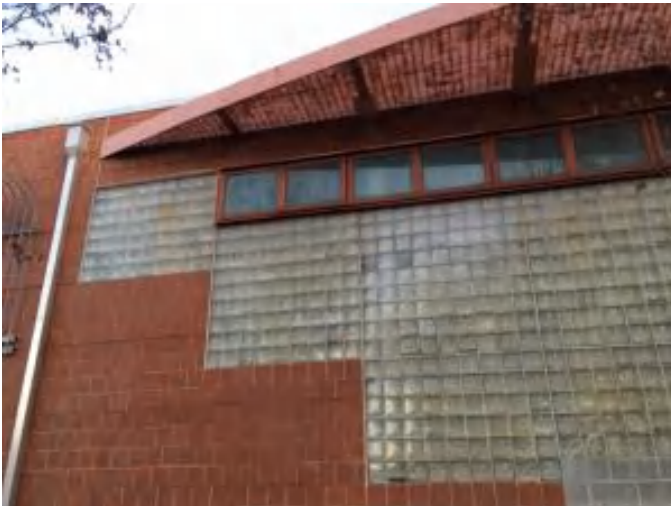
**Location:** Widener - exterior walls

**System: B2010 - Exterior Walls**

**Distress:** Failing

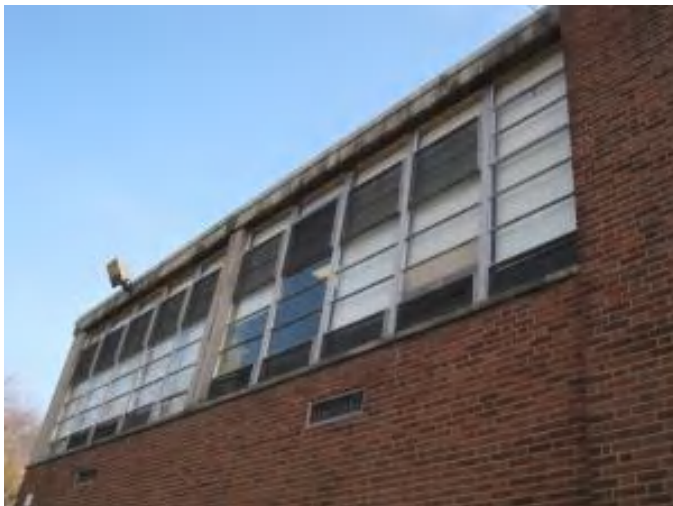
**Location:** Widener - brick and limestone

**System: B2010 - Exterior Walls**

**Distress:** Appearance

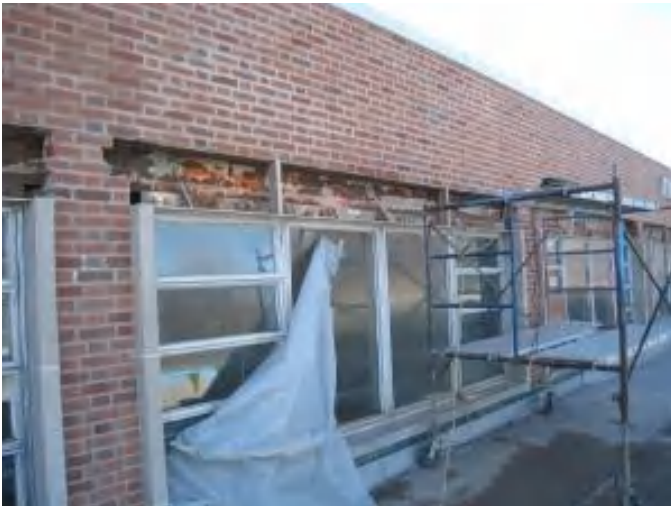
**Location:** Widener - windows

Exterior windows are aluminum frame and single glazed units, that might be original. The frames are corroded, window putty is cracked and failing, and caulking is failing. The Team was told that a full window replacement is underway. Based on the observations made during the field inspection, the existing windows certainly need to be replaced with new insulating high-efficiency glass units as the District has planned.

**System: B2020 - Exterior Windows**

**Distress:** Beyond Service Life

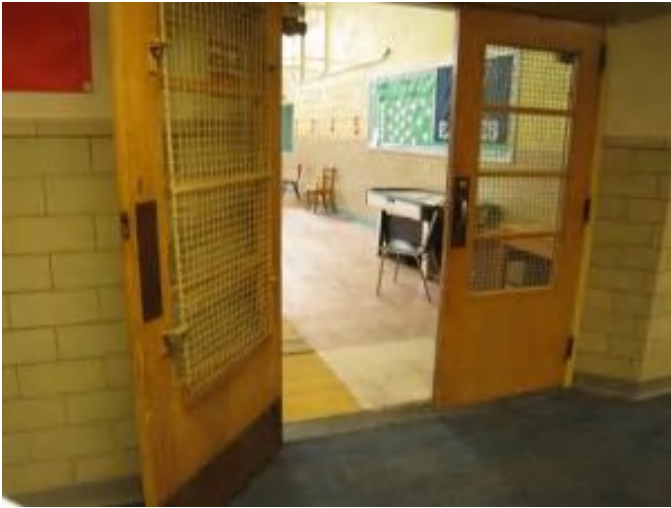
**Location:** Widener - interior doors

**System: C1020 - Interior Doors**

**Distress:** Beyond Service Life

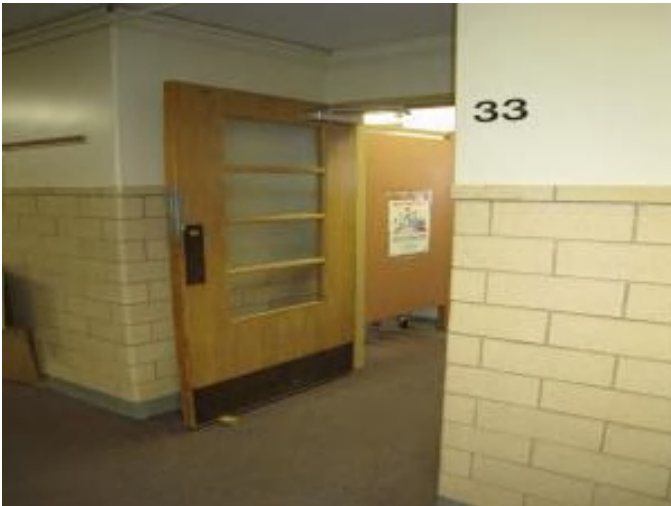
**Location:** Widener - interior doors

**System: C1020 - Interior Doors**

**Distress:** Security Issue

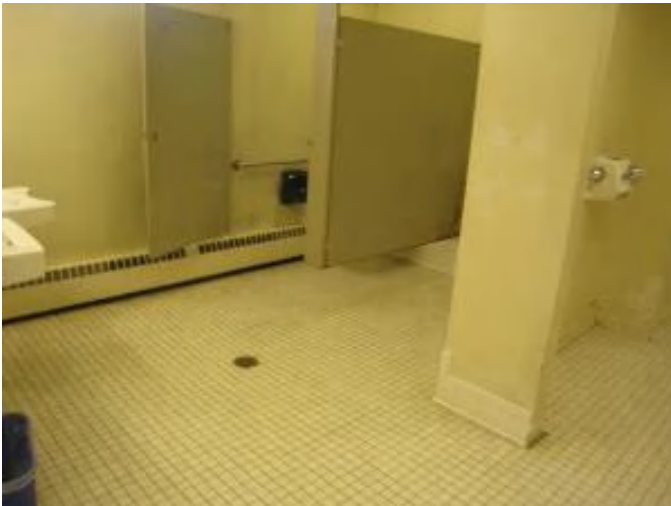
**Location:** Widener - toilet rooms

**System: C1030 - Fittings**

**Distress:** Failing

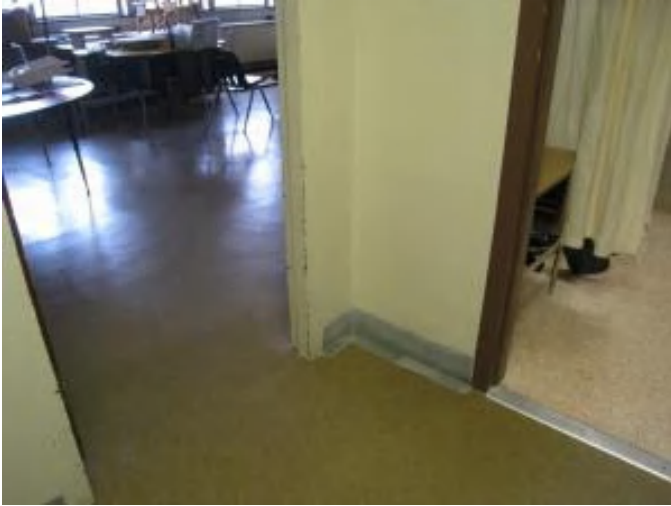
**Location:** Widener - interior walls

**System: C3010230 - Paint & Covering**

**Distress:** Damaged

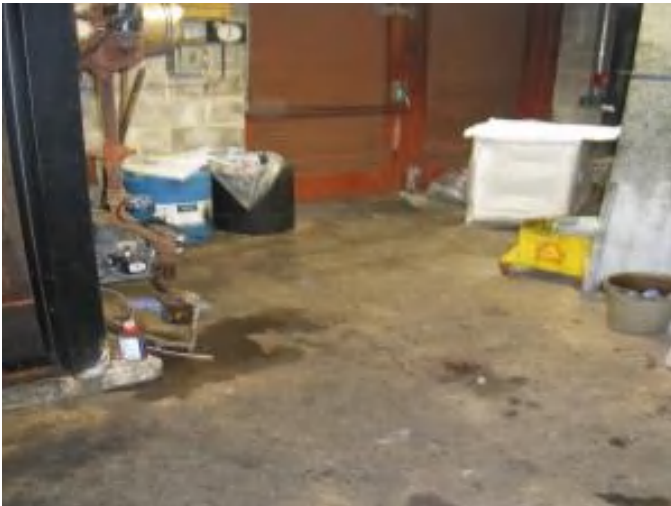
**Location:** Widener - pool house basement

**System: C3010230 - Paint & Covering**

**Distress:** Appearance

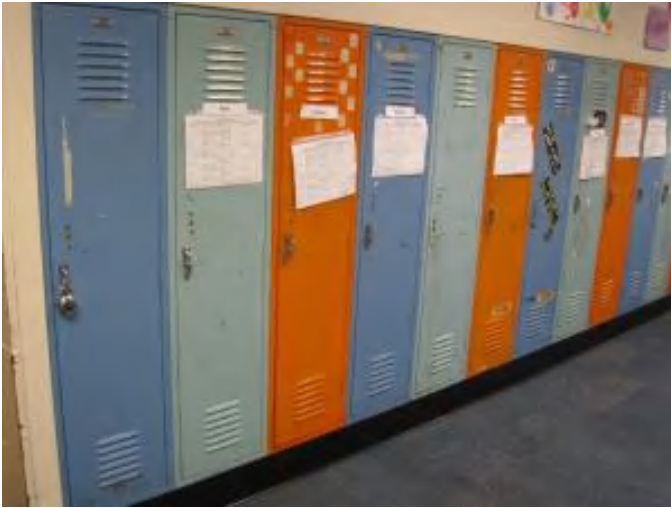
**Location:** Widener - lockers in corridors

**System: C3010230 - Paint & Covering**

**Distress:** Appearance

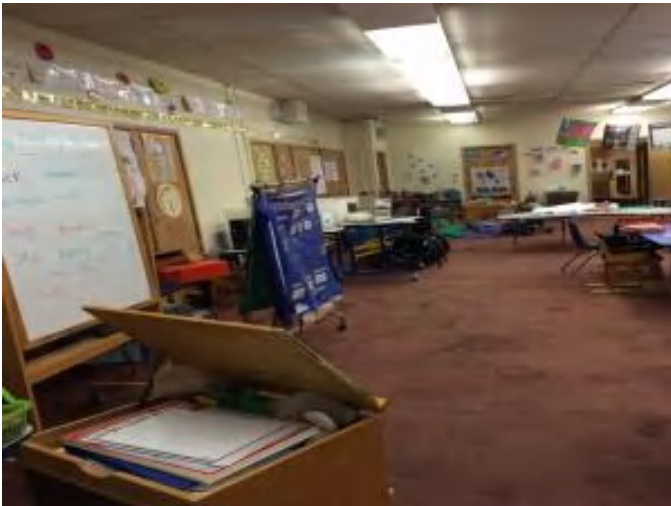
**Location:** Widener - carpet

**System: C3020411 - Carpet**

**Distress:** Damaged

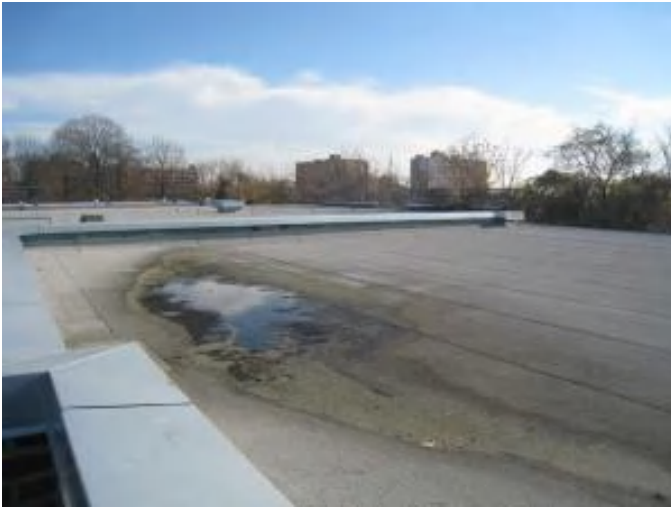
**Location:** Throughout Building

**System: D2040 - Rain Water Drainage**

**Distress:** Beyond Service Life

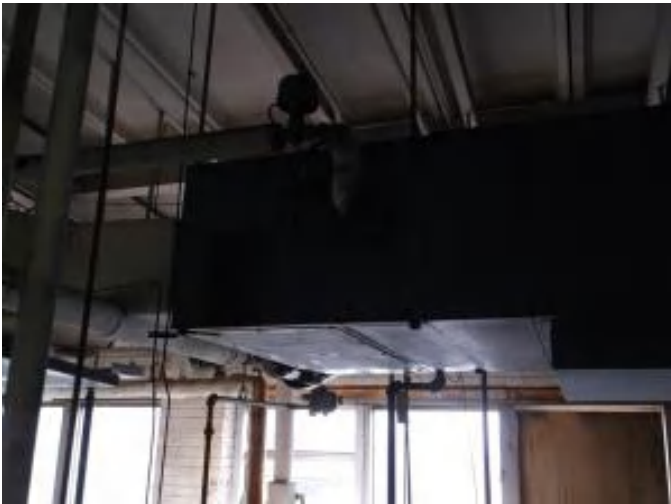
**Location:** Throughout Building

**System: D3060 - Controls & Instrumentation**

**Distress:** Energy Efficiency

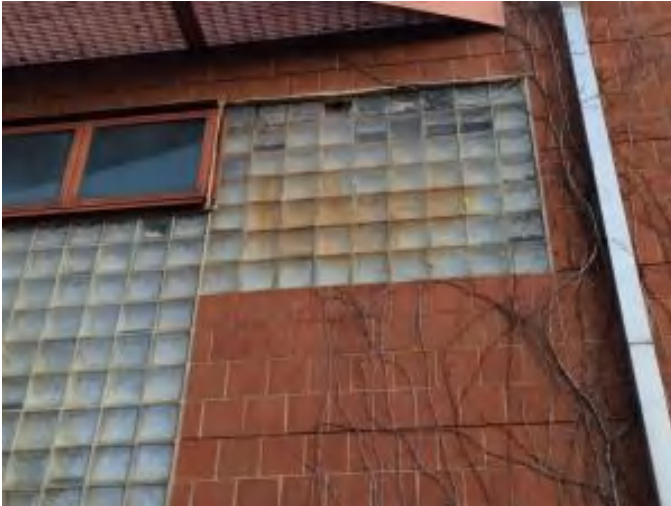
**Location:** Widener - pool house glass block

**System: B2010 - Exterior Walls**

**Distress:** Failing

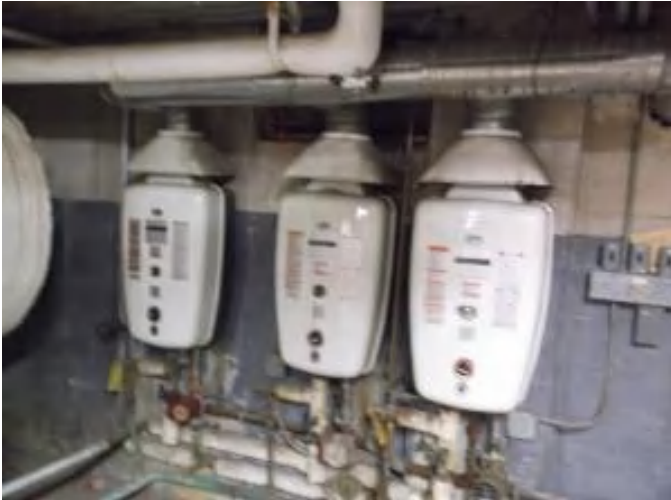
**Location:** Boiler Room

**System: D2020 - Domestic Water Distribution**

**Distress:** Beyond Service Life

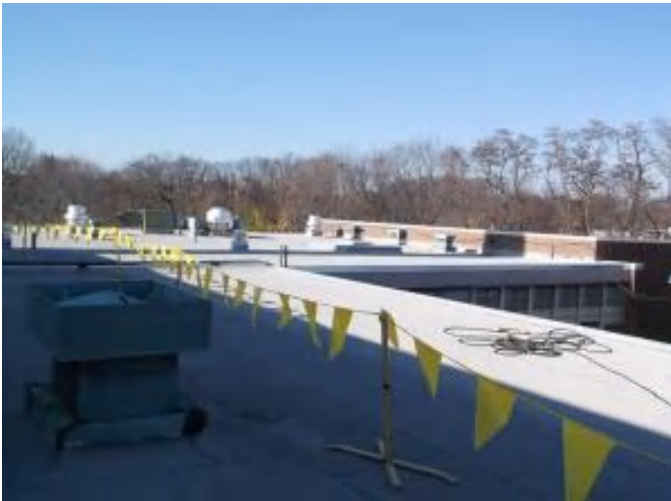
**Location:** Roof

**Distress:** Beyond Service Life

**Notes:** Replace the older power roof ventilators that exhaust air from the restrooms and utility rooms; total of nine (9) fans. These fans should be replaced as they are well beyond their anticipated service life.

**Correction:** Replace power roof ventilator (24" dia.)

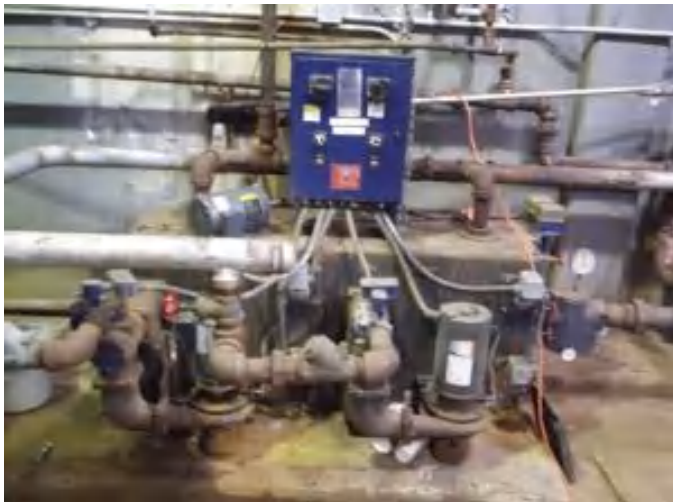
**Location:** mechanical room

**Distress:** Beyond Service Life

**Notes:** Replace the two duplex condensate receivers installed in 1994 as they are beyond the anticipated service life.

**Correction:** Replace Condensate Receiver Pump Set

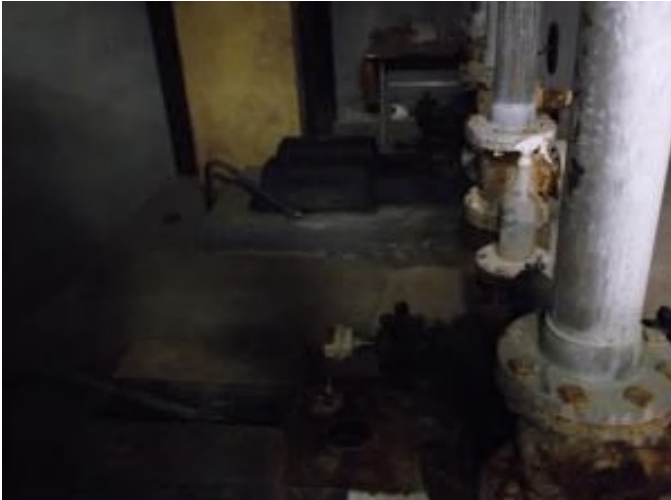
**Location:** Throughout Building

**Distress:** Beyond Service Life

**Notes:** Replace the original galvanized steel domestic water piping in service for more than 60 years.

**Correction:** Replace domestic water piping (75 KSF)

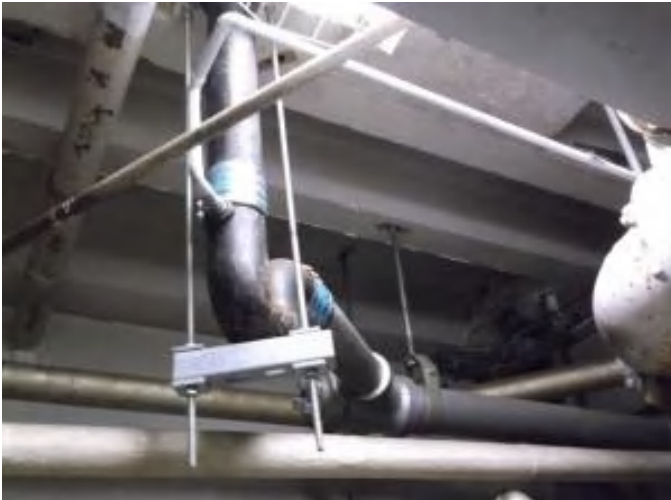
**Location:** Throughout Building

**Distress:** Beyond Service Life

**Notes:** Perform a detailed examination of the original cast iron sanitary waste piping in service in the older section of the building for more than 60 years using visual inspection and video cameras to locate and replace any damaged piping and to further quantify the extent of potential failures.

**Correction:** Inspect sanitary waste piping and replace damaged sections. (+50KSF)

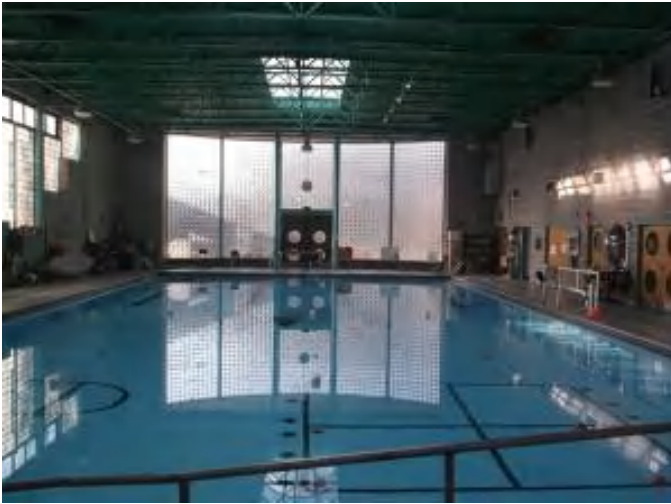
**Location:** Pool

**Distress:** Inadequate

**Notes:** Provide a supplementary dehumidification system for removal of excess moisture from the pool natatorium to protect the building substrates.

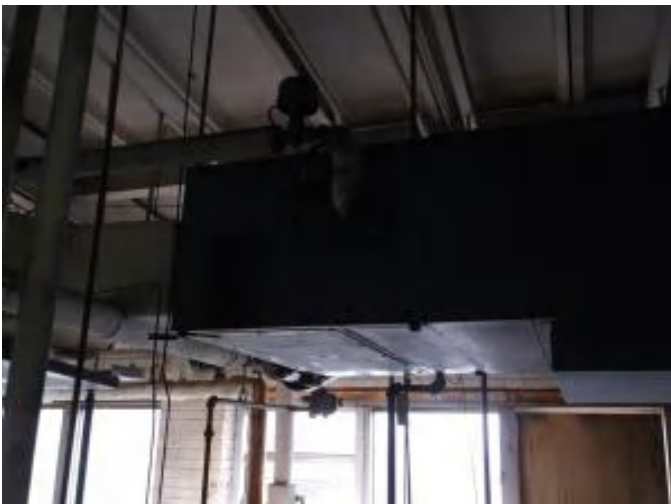
**Location:** Throughout Building

**Distress:** Beyond Service Life

**Notes:** Perform additional testing of the steam and condensate piping in service in the older section of the building for nearly 60 years to locate and replace any damaged sections and to further quantify the extent of potential failures.

**Correction:** Perform testing to identify and replace damaged steam and condensate piping.

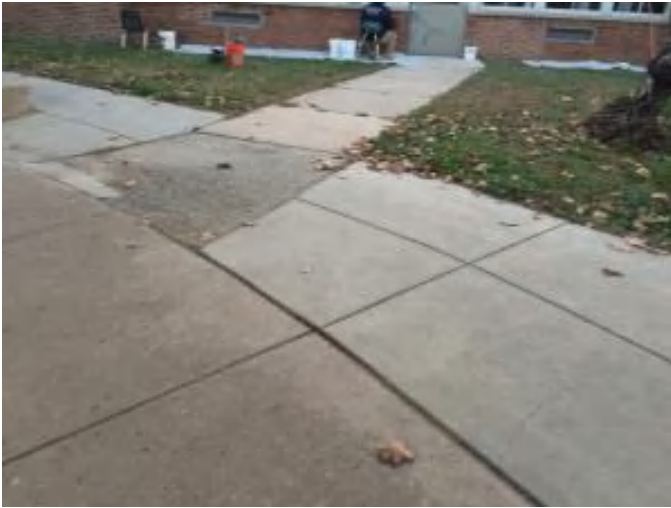
**Location:** Widener - sidewalks

**Distress:** Accessibility

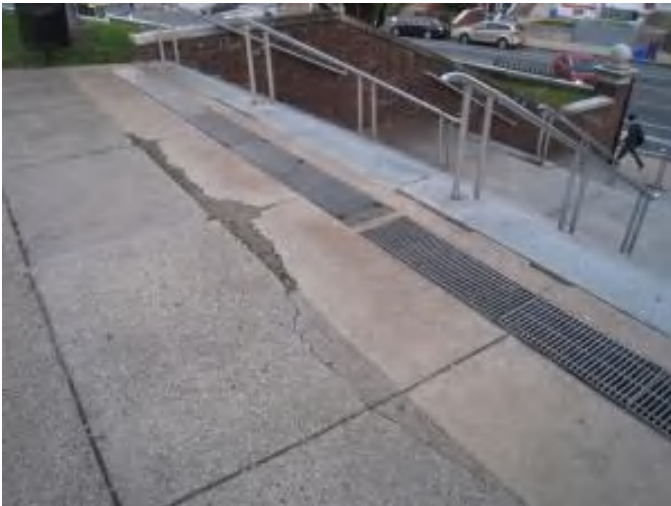
**Location:** Girls HS - sidewalk

**Distress:** Damaged

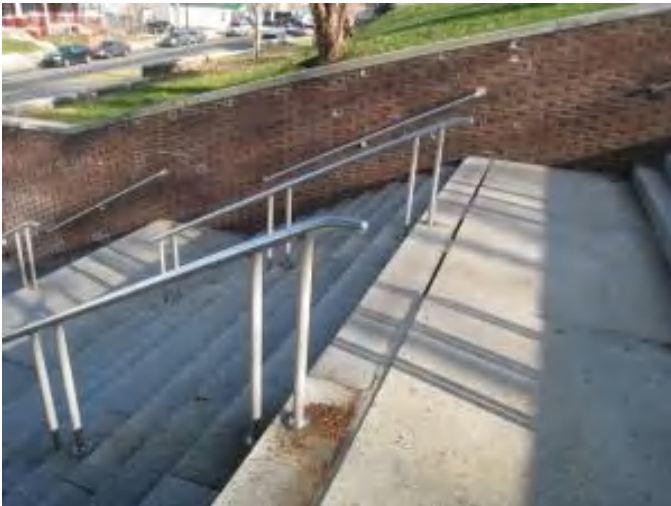
**Location:** Girls HS - exterior stairs

**Distress:** Failing

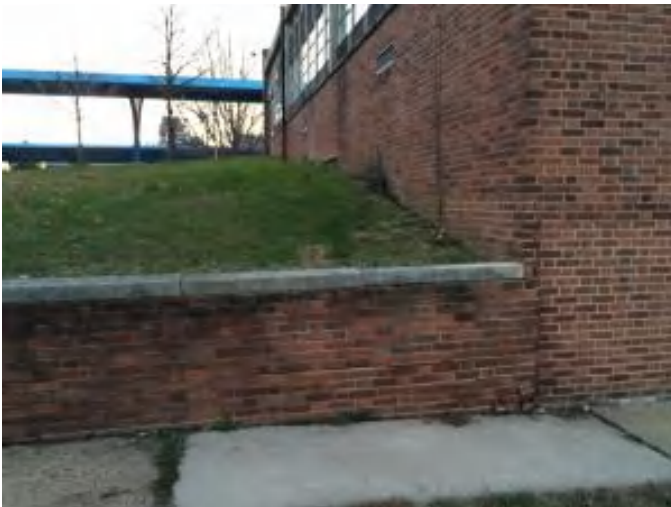
**Location:** Widener - brick retaining walls

**Distress:** Failing

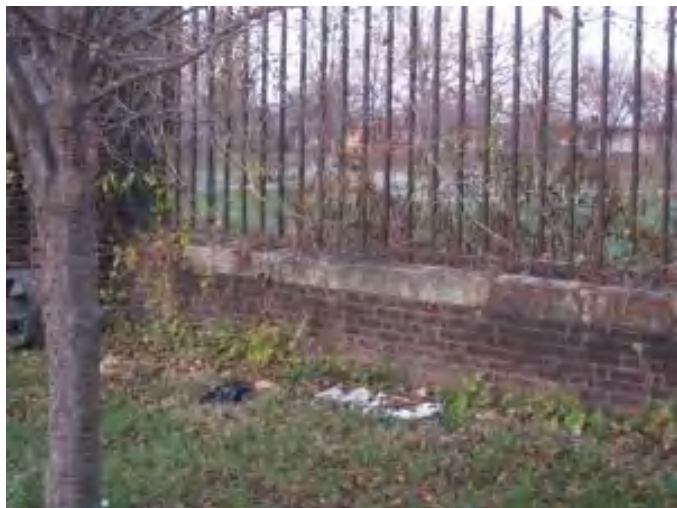
**Location:** Widener - site fence, Broad St.

**Distress:** Appearance

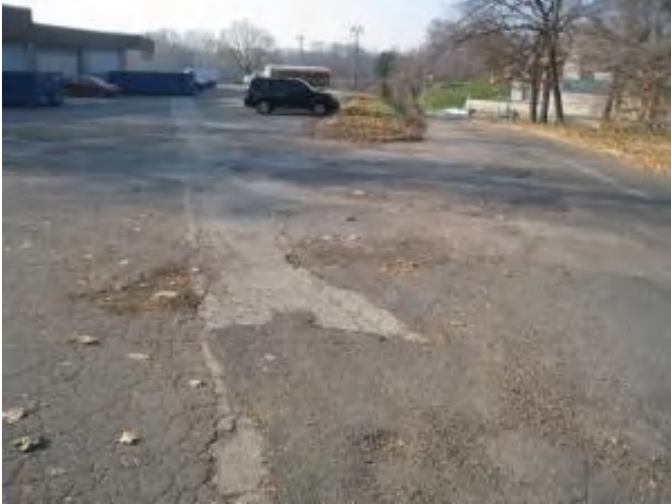
**Location:** Girls HS - access roadways

**Distress:** Damaged

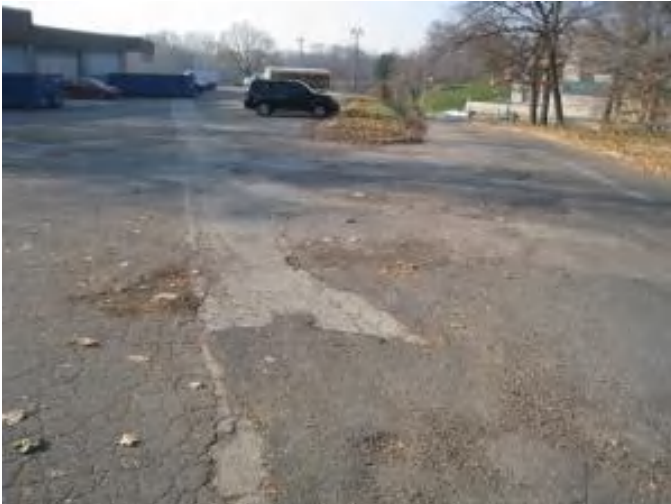
**Location:** Widener - access roadways

**Distress:** Damaged
