Facility Condition Assessment Summary Report

Wilson, W Middle School

School District of Philadelphia
S812001;Wilson, W
Final
Site Assessment Report
January 31, 2017

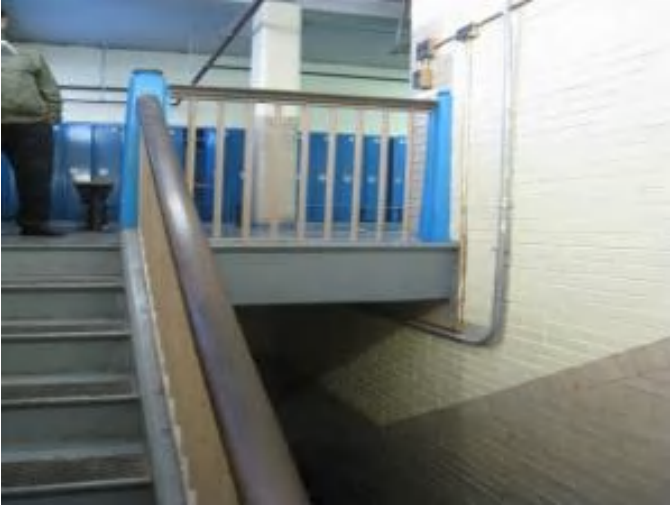
Location: stairways

System: C2010 - Stair Construction

Distress: Building / MEP Codes

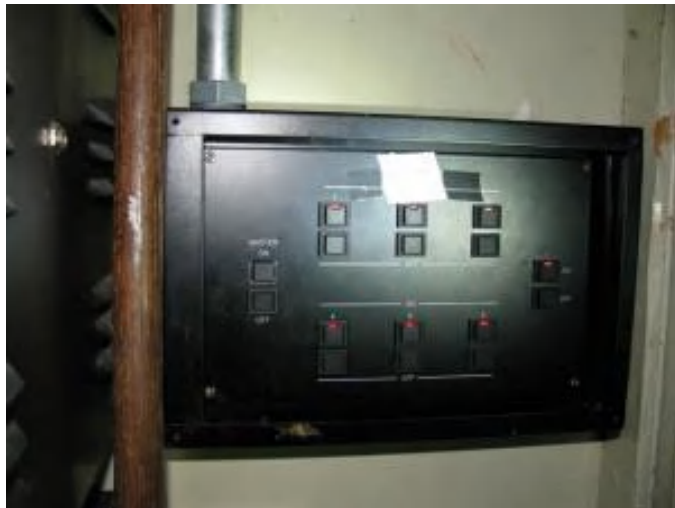
Location: Auditorium

System: E1020 - Institutional Equipment

Distress: Beyond Service Life

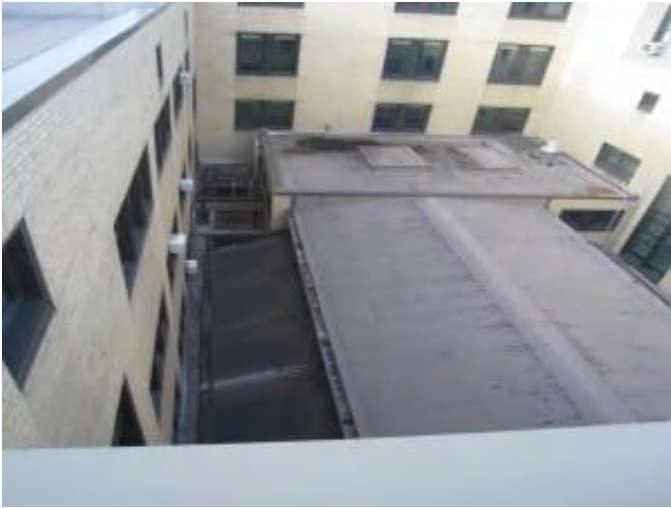
Location: roof gutters

System: B3010140 - Shingle & Tile

Distress: Building Envelope Integrity

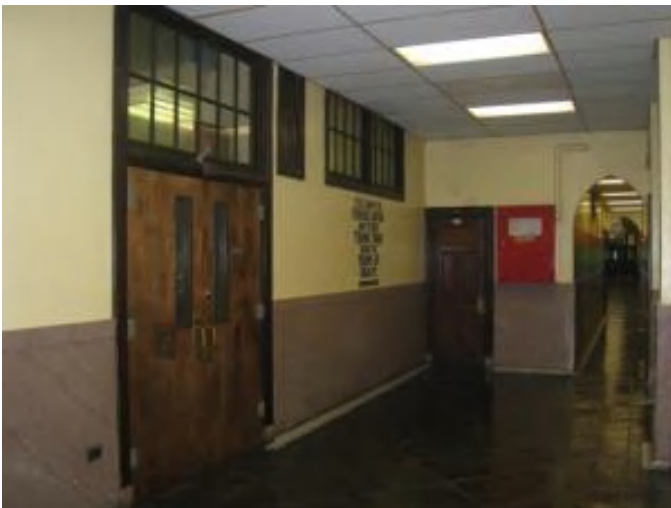
Location: corridor doors

System: C1020 - Interior Doors

Distress: Building / MEP Codes

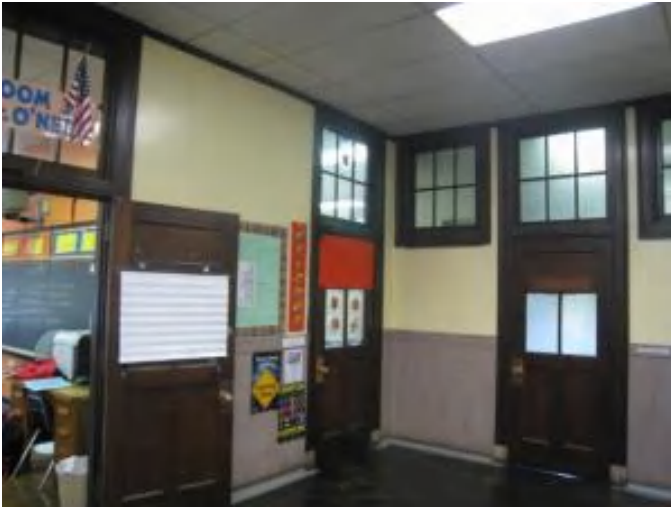
Location: corridor doors

System: C1020 - Interior Doors

Distress: Security Issue

Notes: Provide security hardware for classrooms and offices, locking from inside classroom. (160)

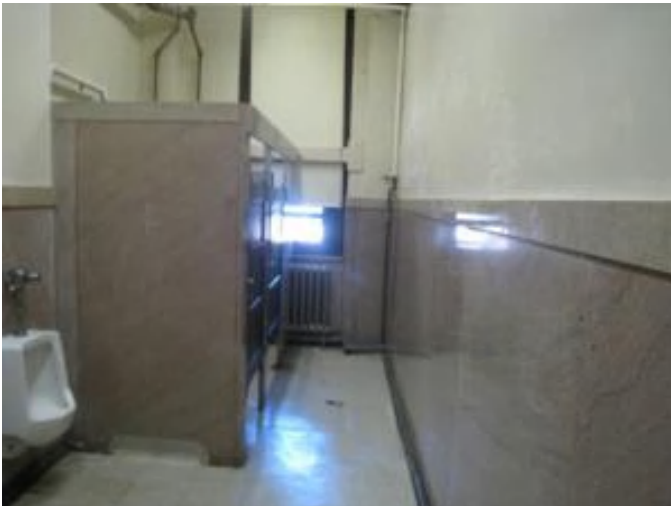
Location: toilet rooms

System: C1030 - Fittings

Distress: Beyond Service Life

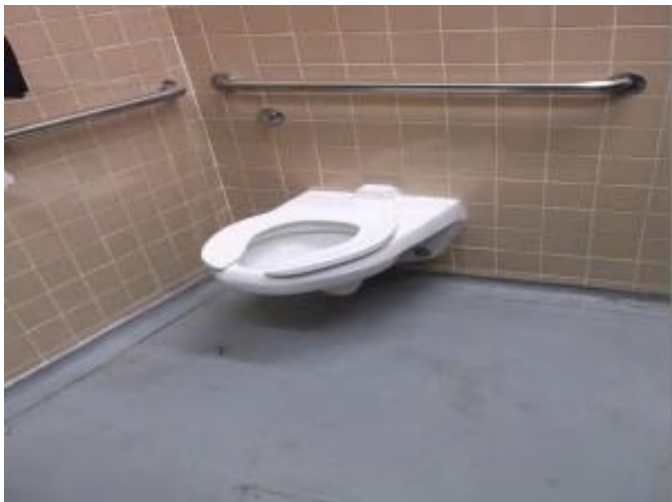
Location: Throughout the building

System: D2010 - Plumbing Fixtures

Distress: Beyond Service Life

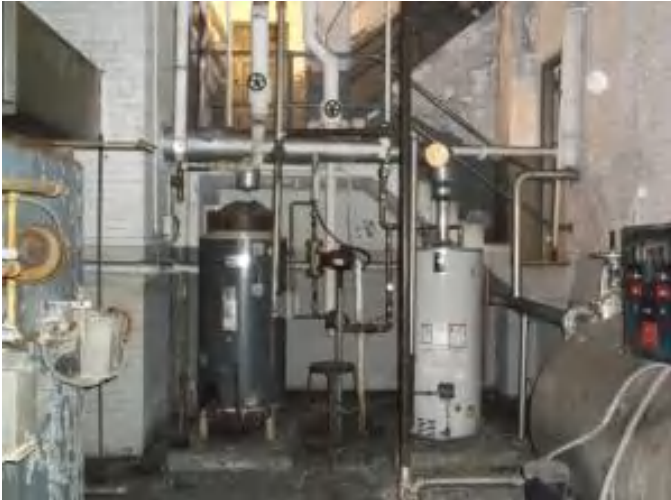
Location: Main boiler mechanical equipment room

System: D2020 - Domestic Water Distribution

Distress: Beyond Service Life

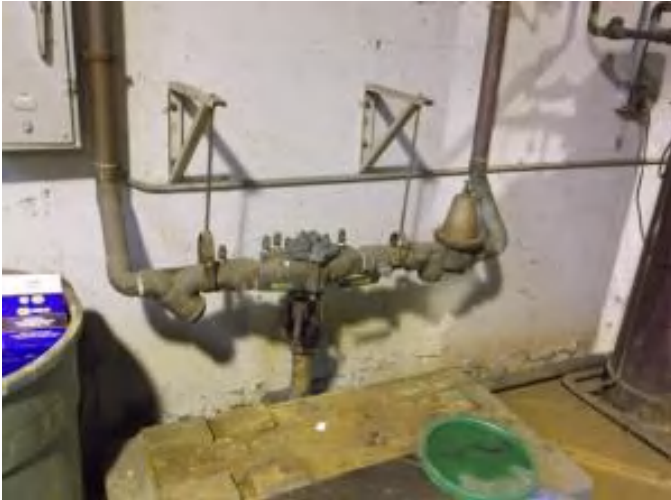
Location: Throughout the building

System: D2020 - Domestic Water Distribution

Distress: Beyond Service Life

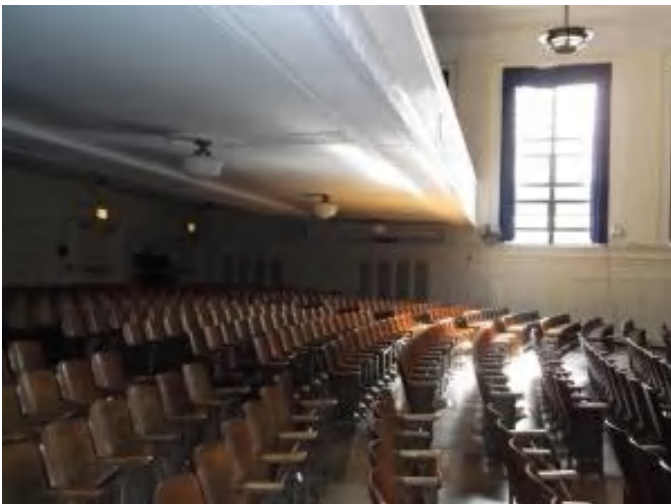
Location: Roof

System: D3040 - Distribution Systems

Distress: Beyond Service Life

Notes: Provide ventilation, heating and cooling for the auditorium by installing a packaged roof top unit.

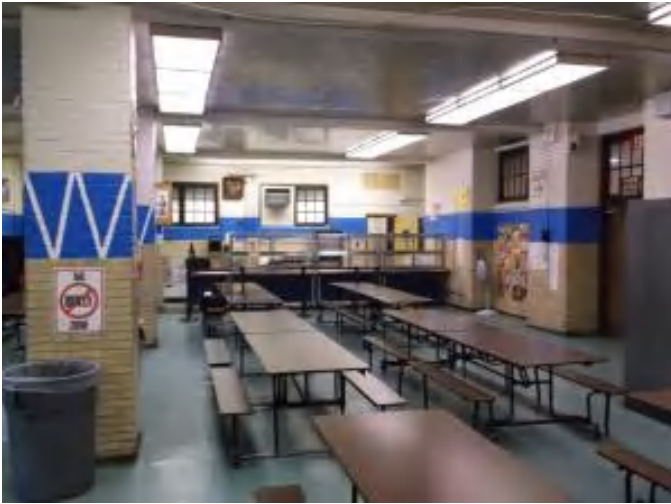
Location: Roof

System: D3040 - Distribution Systems

Distress: Beyond Service Life

Notes: Provide ventilation, heating and cooling for the Cafeteria by removing the existing radiators and installing a package rooftop constant volume air handling unit with distribution ductwork and registers.

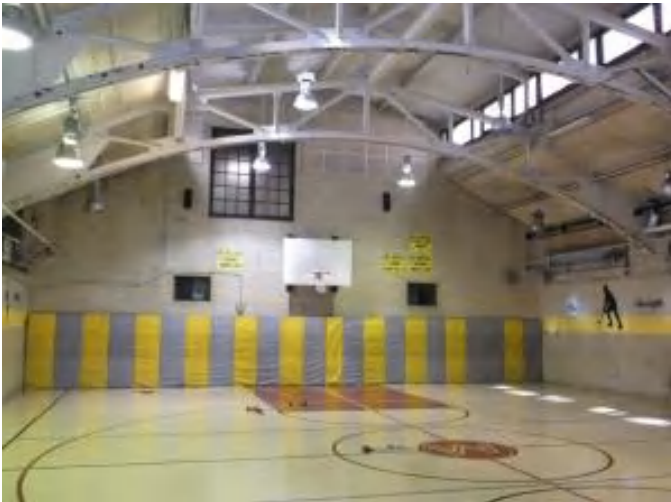
Location: Roof

System: D3040 - Distribution Systems

Distress: Beyond Service Life

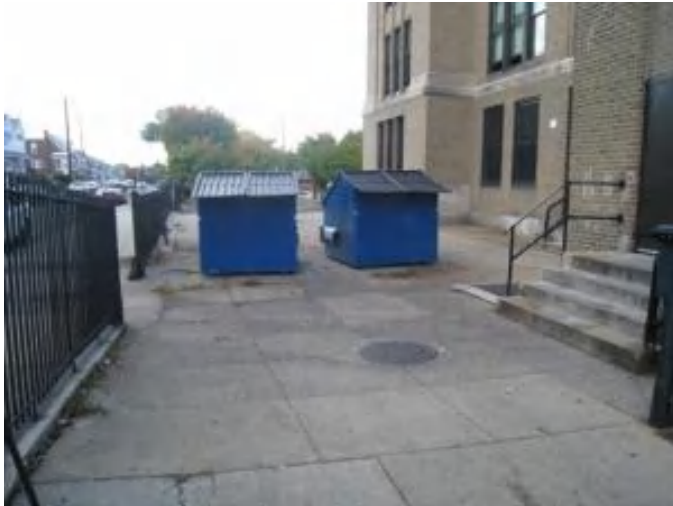
Location: exterior stairs

System: G2040 - Site Development

Distress: Building / MEP Codes
