Facility Condition Assessment Summary Report

Hamilton School

School District of Philadelphia
S129001;Hamilton
Final
Site Assessment Report
January 30, 2017

Facility Assessment
October 2015

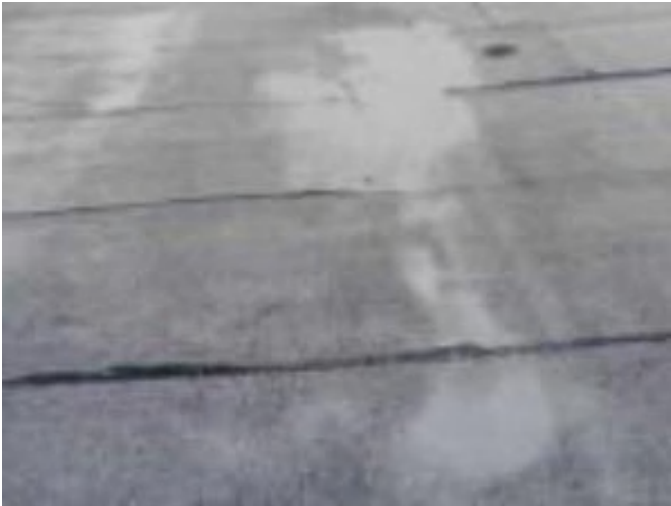
Location: Roof

System: B3010105 - Built-Up

Distress: Beyond Service Life

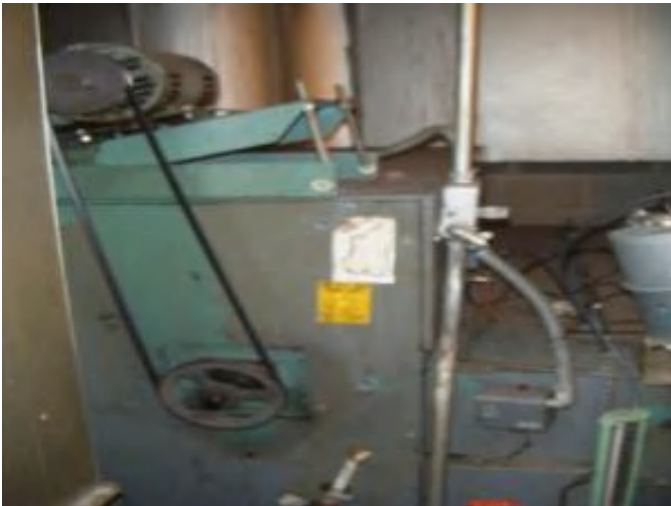
Location: Auditorium

System: D3040 - Distribution Systems

Distress: OSHA

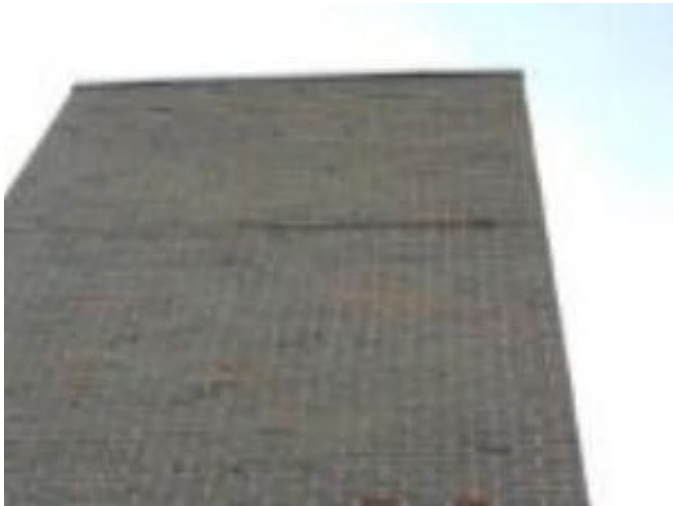
Location: Exterior walls

System: B2010 - Exterior Walls

Distress: Appearance

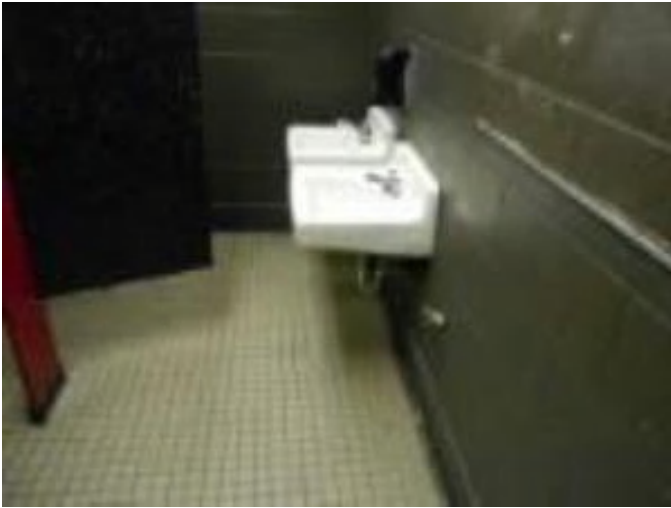
Location: Throughout the building

System: C1010 - Partitions

Distress: Accessibility

Notes: Provide accessible faculty/staff restrooms on each floor and at the nurse office. Based on three restrooms for the building.

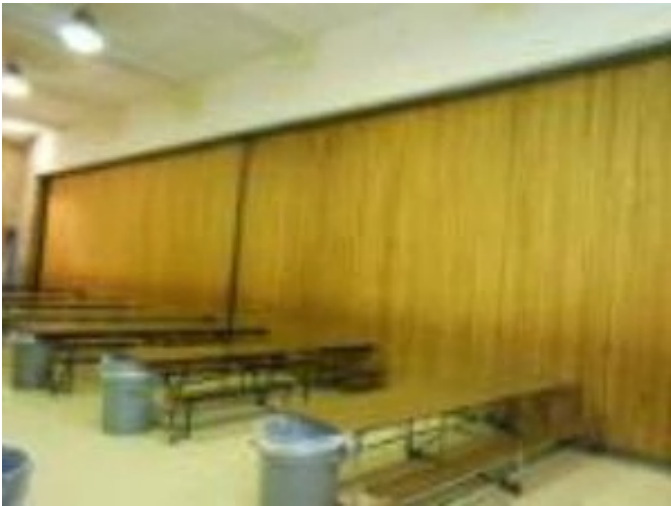
Location: Cafeteria/Auditorium

System: C1010 - Partitions

Distress: Beyond Service Life

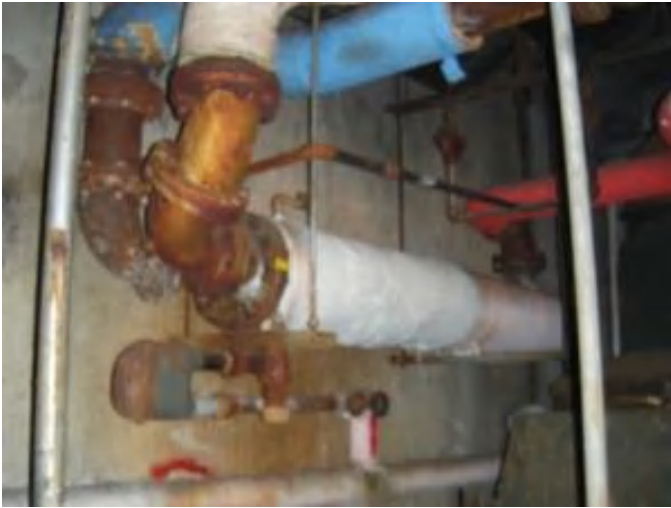
Location: Boiler Room

System: D3040 - Distribution Systems

Distress: Beyond Service Life

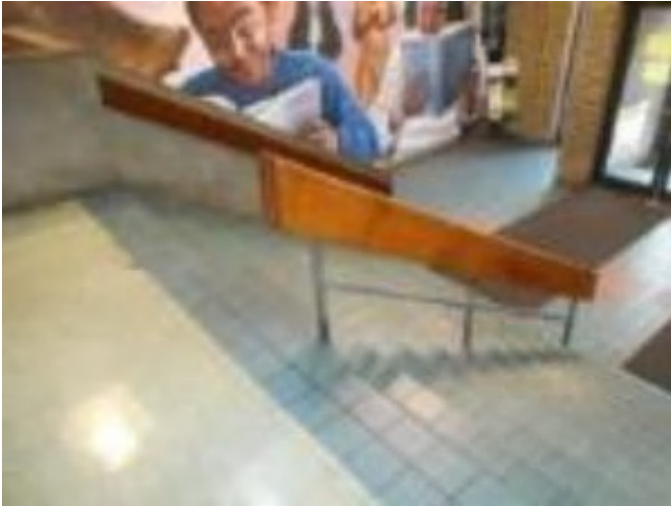
Location: Entrance area

System: A1030 - Slab on Grade

Distress: Accessibility

Notes: Install interior accessibility ramp at stairs in main entrance

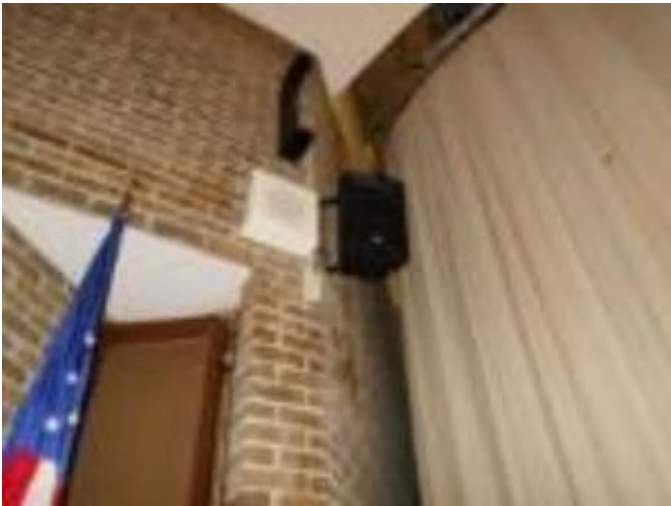
Location: Painted ceilings

System: C3030 - Ceiling Finishes

Distress: Appearance

Notes: Repaint third floor and auditorium ceilings and other ceilings

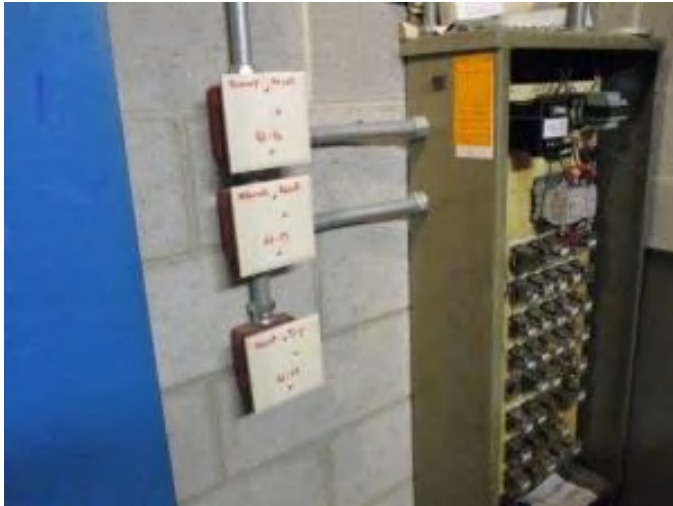
Location: Elevator Machine Room

The school has a hydraulic elevator rated 20HP (estimated) at 208V. The elevator controller is relay type approximately 20 years old and should be replaced with a microprocessor type controller. Since the hydraulic elevator is not connected to the emergency power system provide a battery lowering device.

System: D1010 - Elevators and Lifts

Distress: Obsolete

Notes: Provide new elevator controller.

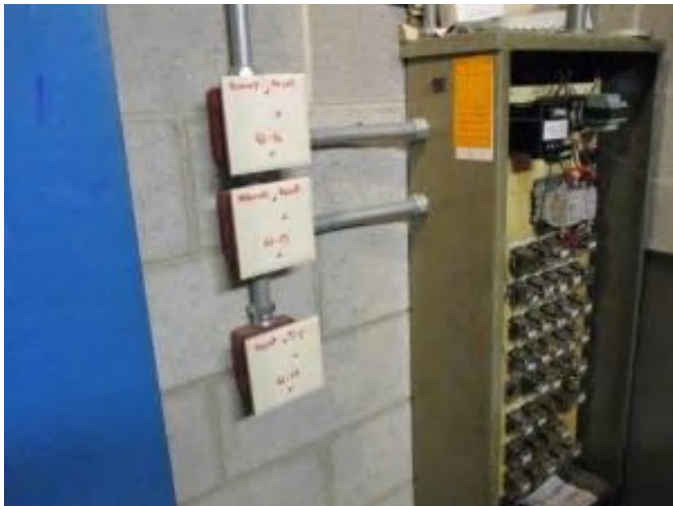
Location: Elevator Machine Room

System: D1010 - Elevators and Lifts

Distress: Security Issue

Notes: Provide the elevator with battery lowering device.

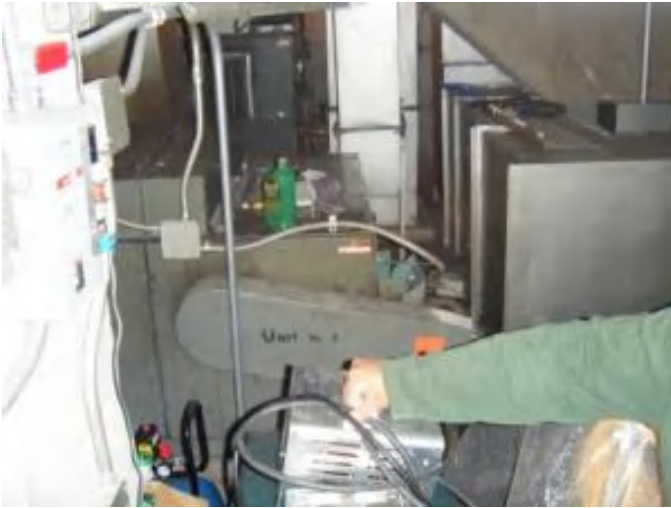
Location: Music room

System: D3040 - Distribution Systems

Distress: OSHA

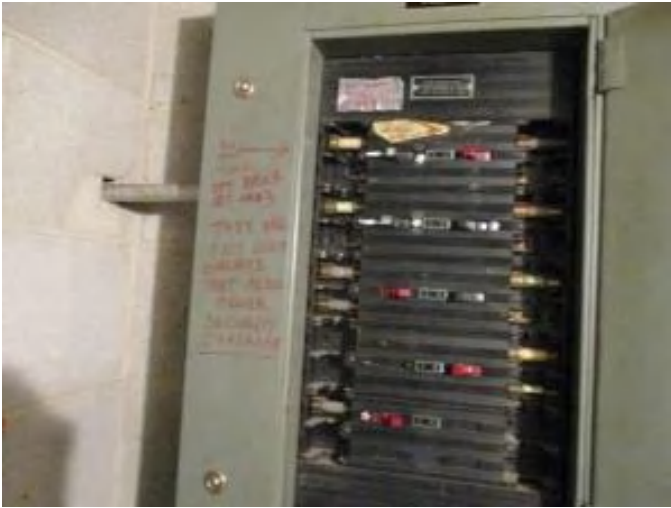
Location: Entire Building

System: D5010 - Electrical Service/Distribution

Distress: Beyond Service Life

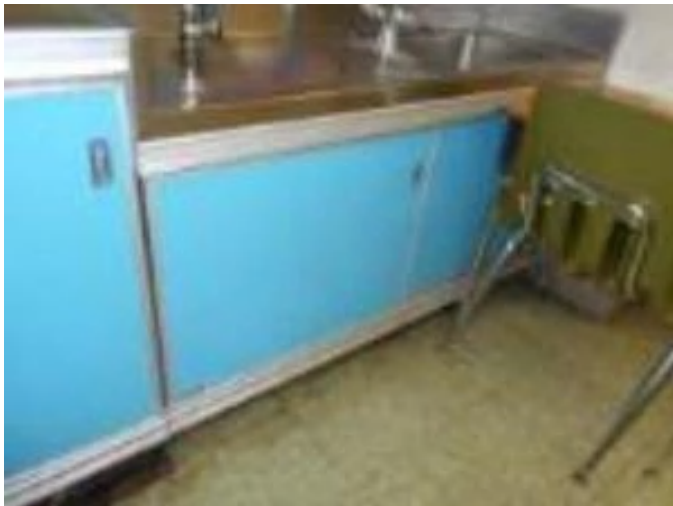
Location: Classrooms

System: E1020 - Institutional Equipment

Distress: Beyond Service Life

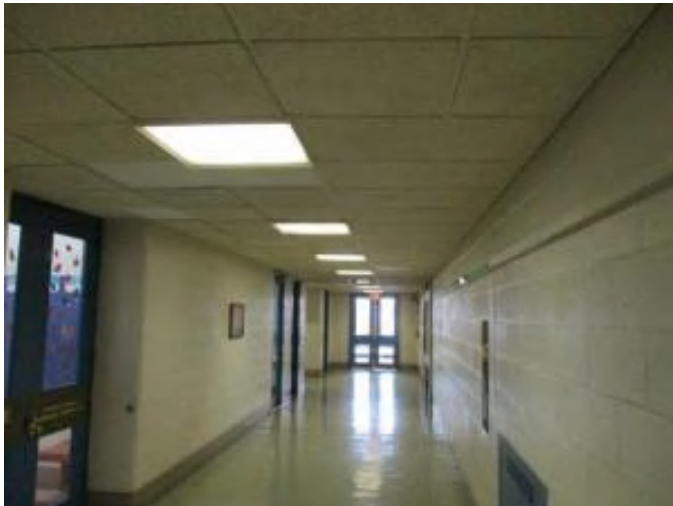
Location: Entire Building

System: D5020 - Lighting and Branch Wiring

Distress: Obsolete

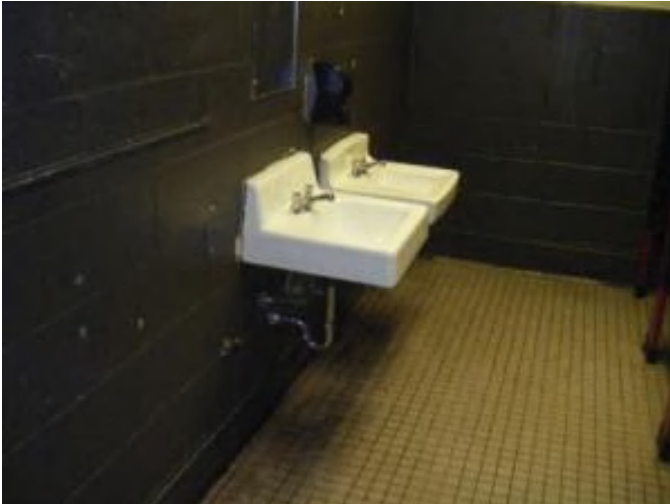
Location: Restrooms

System: D2010 - Plumbing Fixtures

Distress: Beyond Service Life

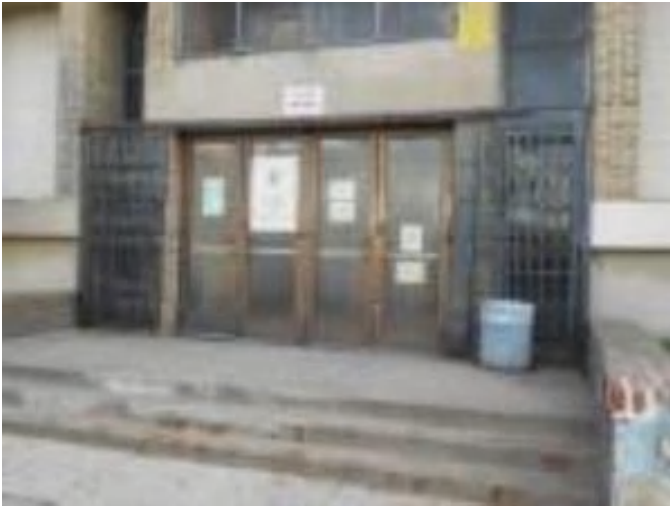
Location: Main entrance

System: G2030 - Pedestrian Paving

Distress: Accessibility

Notes: Install handicap ramp to main/visitor entrance from street level, exterior. Two ramps at 36" of rise.

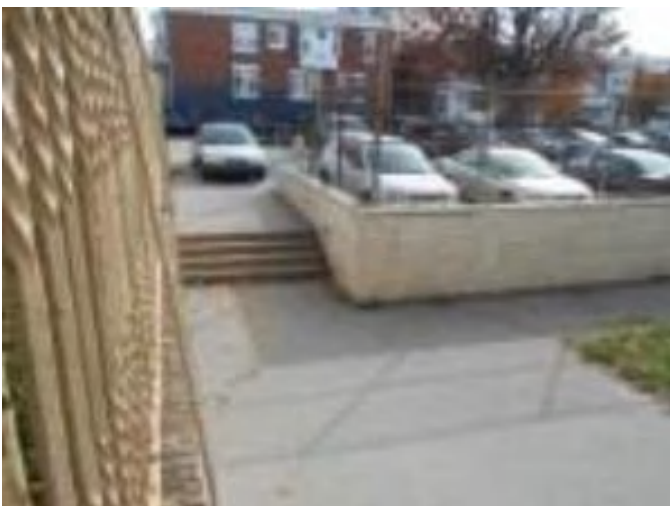
Location: Parking lot

System: G2030 - Pedestrian Paving

Distress: Accessibility

Notes: Install handicap ramp from parking level to northeast or southeast entrance

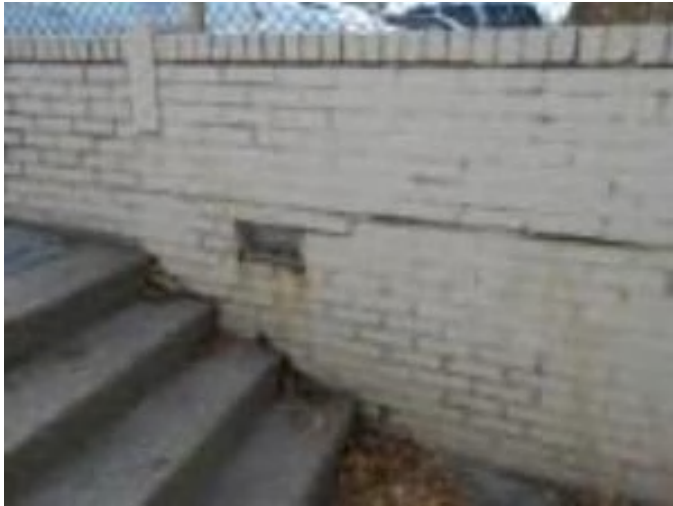
Location: Steps

System: G2040 - Site Development

Distress: Accessibility

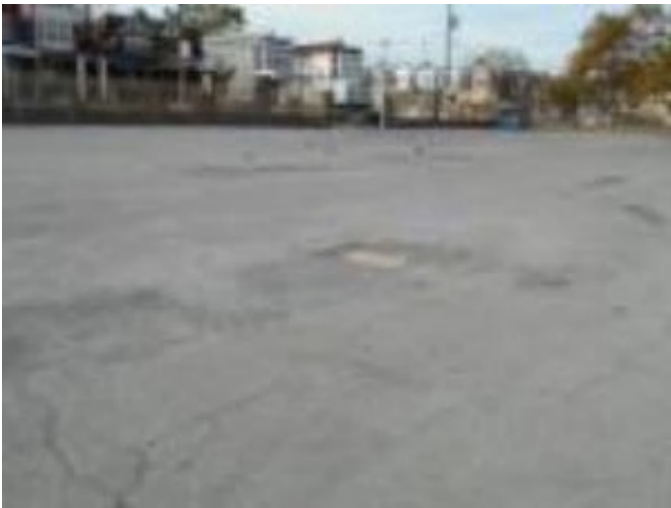
Location: Playground

Pedestrian paving is asphalt at playgrounds fair to poor condition with potholes, ponding, and alligating. The play ground is at grade with the first floor at the south and east sides of the building. Deliveries to the building are made through double gates at a driveway on Pine St, across the playground to the southwest entry. This is an unsafe configuration. City sidewalks surrounding the site are in fair condition. Concrete steps have damaged nosings and improper or missing handrails. There is no accessible ramp to the main entrance. There is a ramp to the southwest entrance.

System: G2030 - Pedestrian Paving

Distress: Beyond Service Life
